PUBLIC WORKS DEPARTMENT MEMORANDUM
#06-2020

DATE: March 9, 2020
TO: Honorable Mayor Meredith Leighty and City Council Members
THROUGH: Heather Geyer, City Manager *hmg*
FROM: Kent Kisselman, PE – Director of Public Works *KHK*
SUBJECT: CR-57 – Community Center Drive Bridge Rehabilitation Addendum #1

STRUCTURE REHABILITATION REPORT

Community Center Drive Bridge Over I-25

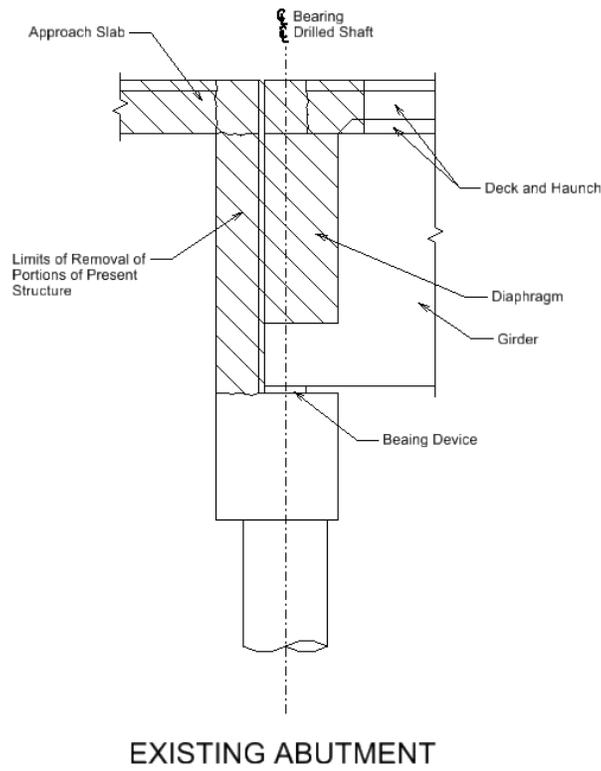
Figure 1 Removal of Portions of Existing Structure

The removal of structure will require the use of temporary shoring placed in the median of the approach slabs and potentially at the end of wingwalls to allow the approach slabs, sidewalk and bridge rails to be removed up to the expansion joint and partially onto the bridge in two phases. The mechanically stabilized backfill (MSE) will need to be excavated to approximately 2.5 ft below the top of the abutment seat. The backwall will then need to be removed with care given to avoid hitting the bridge girders and tensioned strands within the girders as well as portions of the wingwall where the backwall is currently tied into. This will allow the contractor to repair portions of the wingwall that have deteriorated. After removal of the backwall, the reinforcing in the diaphragms will need to be exposed along with portion of the deck with care given to protecting the reinforcing. Any excess concrete from when the backwall spilled past the forms during the original pour will need to be removed from the girders. See figure below.

The primary constructability challenge will be the removal of concrete portions on the abutment and wingwall while keeping rebar and girders protected. Protection of existing reinforcement during the removal of concrete will save time and cost during the repair. These challenges should be within the means and methods of an experienced General Contractor.

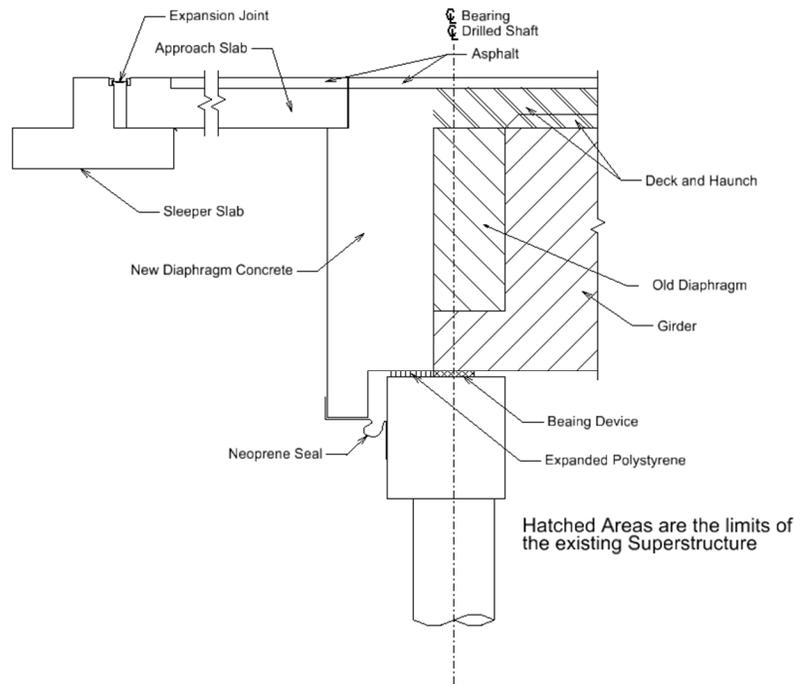
Figure 2 Abutment Repair

After the backwall and portions of the wingwall have been removed, exposing the girders, diaphragms and bearing devices, the repair can begin. Due to the shear deformations in the bearing devices, the bearings at each abutment should be replaced. The contractor will be able to access the bearings from the back of the abutment and will be required to jack each girder up enough to remove and replace the bearings. The girder jacking points and procedure for the bearing replacement will be included in the design plans. The bearings should be replaced before the exposure of the existing diaphragms. When the bearings have been replaced the expanded polystyrene, new reinforcing and form work should be put into place to pour the new abutment diaphragm. The new diaphragm will overhang the abutment seat and remove the need for an expansion joint at the abutment. The new expansion joint will be moved to the end of the approach slab in accordance with CDOT standards, thereby removing any recurrence of current issues of the girder and deck pushing against backwall and will remove any future water damage to the abutment due to the expansion joint seals leaking over time. See the figure below.

PROPOSED ABUTMENT FIX

With the use of temporary shoring and construction phasing, access to only half the width of the bridge will occur at a time. The overhanging diaphragm, wingwall, MSE fill and approach slab will be placed in phase one leaving a gap for reinforcement. This means that the rebar from the first phase will be exposed during the second phase of the repair and will need to be protected until the second phase can be poured allowing the approach slab, diaphragm portions and deck to work as continuous units within themselves. The mechanical portions of the expansion joint will be put in place during each phase with the neoprene seal for the joint installed at the end of the project to provide a continuous seal.

Once the overhanging diaphragm has been placed the MSE backfill can be put in place. The new overhanging diaphragm will have a pinned connection to the approach slab allowing the approach slab to move without causing rotation in the diaphragm. After the approach slab has been poured the sidewalk, median and bridge rails can be replaced. The expansion joint, at the end of the approach slab, and asphalt surfacing will finish out the bridge work.
