## **AGENDA**

Historic Preservation Commission  
Tuesday August 11, 6:00 PM

Northglenn Historic Preservation Commission  
June 9, 2026  
Minutes

The applicant, Travis Glaser, property owner of 9840 Palmer Ln, is requesting Alteration Certificate to remove an enclosed carport with associated room addition, build an addition to the original structure, as well as renovating the original portion of property through window and roofing replacement as shown in Exhibit B. The property owner is proposing two phases to the project. Phase 1 removes all the non-original parts and non-permitted areas of the house. (Note: An unpermitted and dilapidated shed attached to the northern section of the house has already been removed). Phase 2 includes the building of the new addition to include a garage, master bedroom and bathroom in the rear of the property, window and roof replacement.

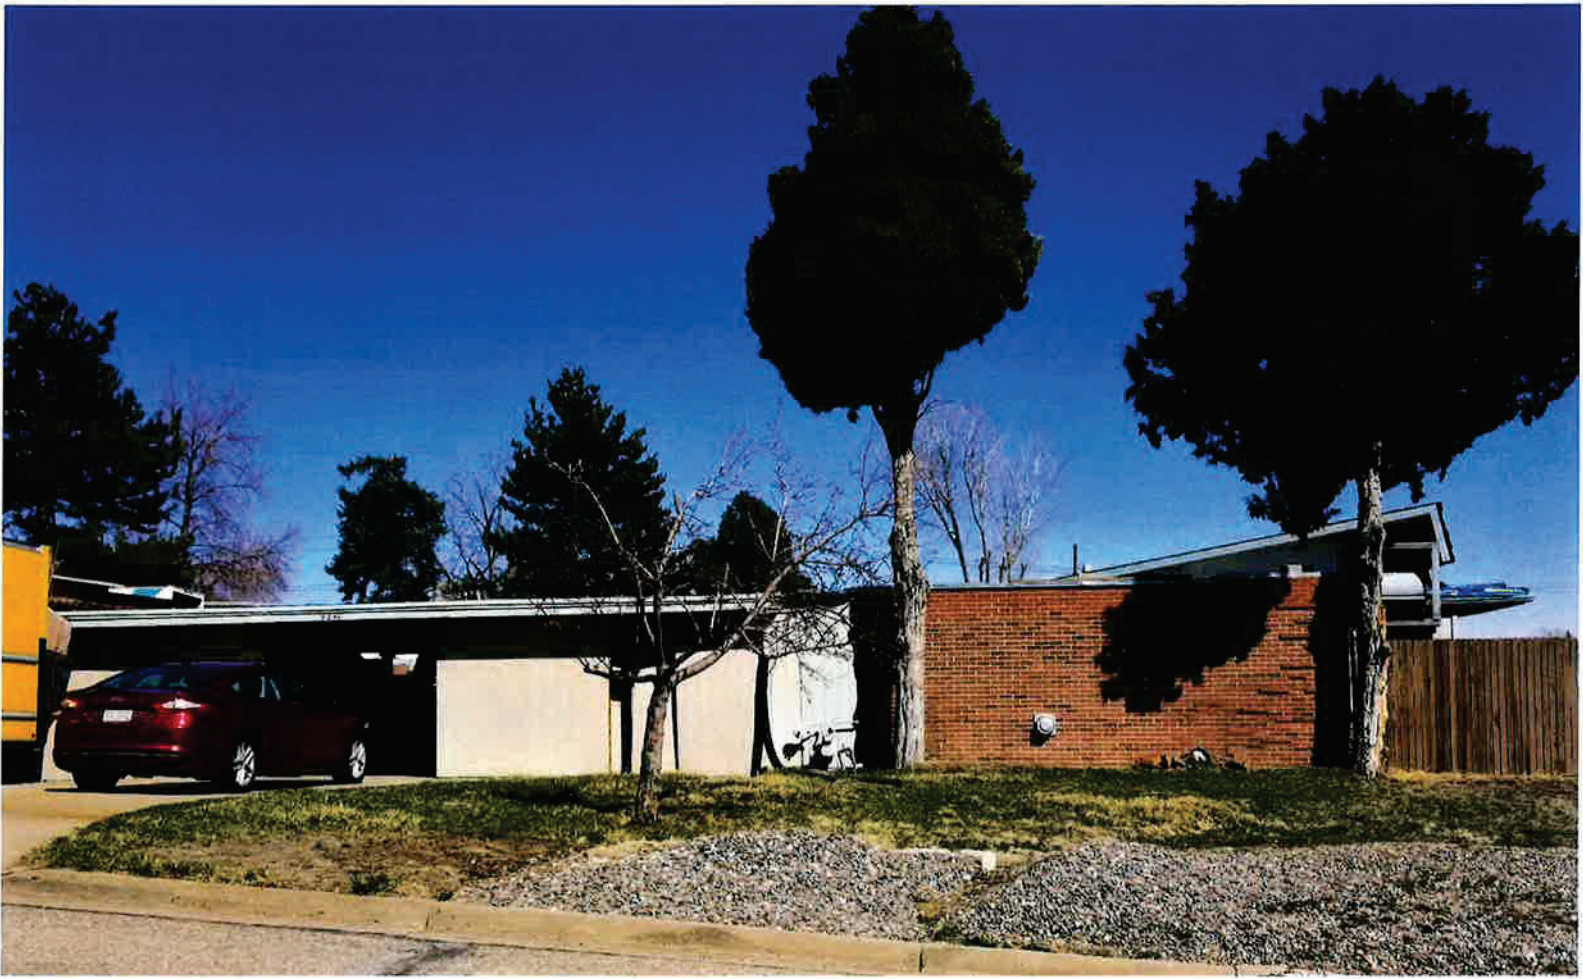
**palmerln9840-1.tiff**

9840 Palmer Lane, Northglenn, Adams County, Colorado; view to east; photo by Mary Therese Anstey, HistoryMatters, LLC; Northglenn Deza Estates Survey; Certified Local Government Grant 2018-M2-001

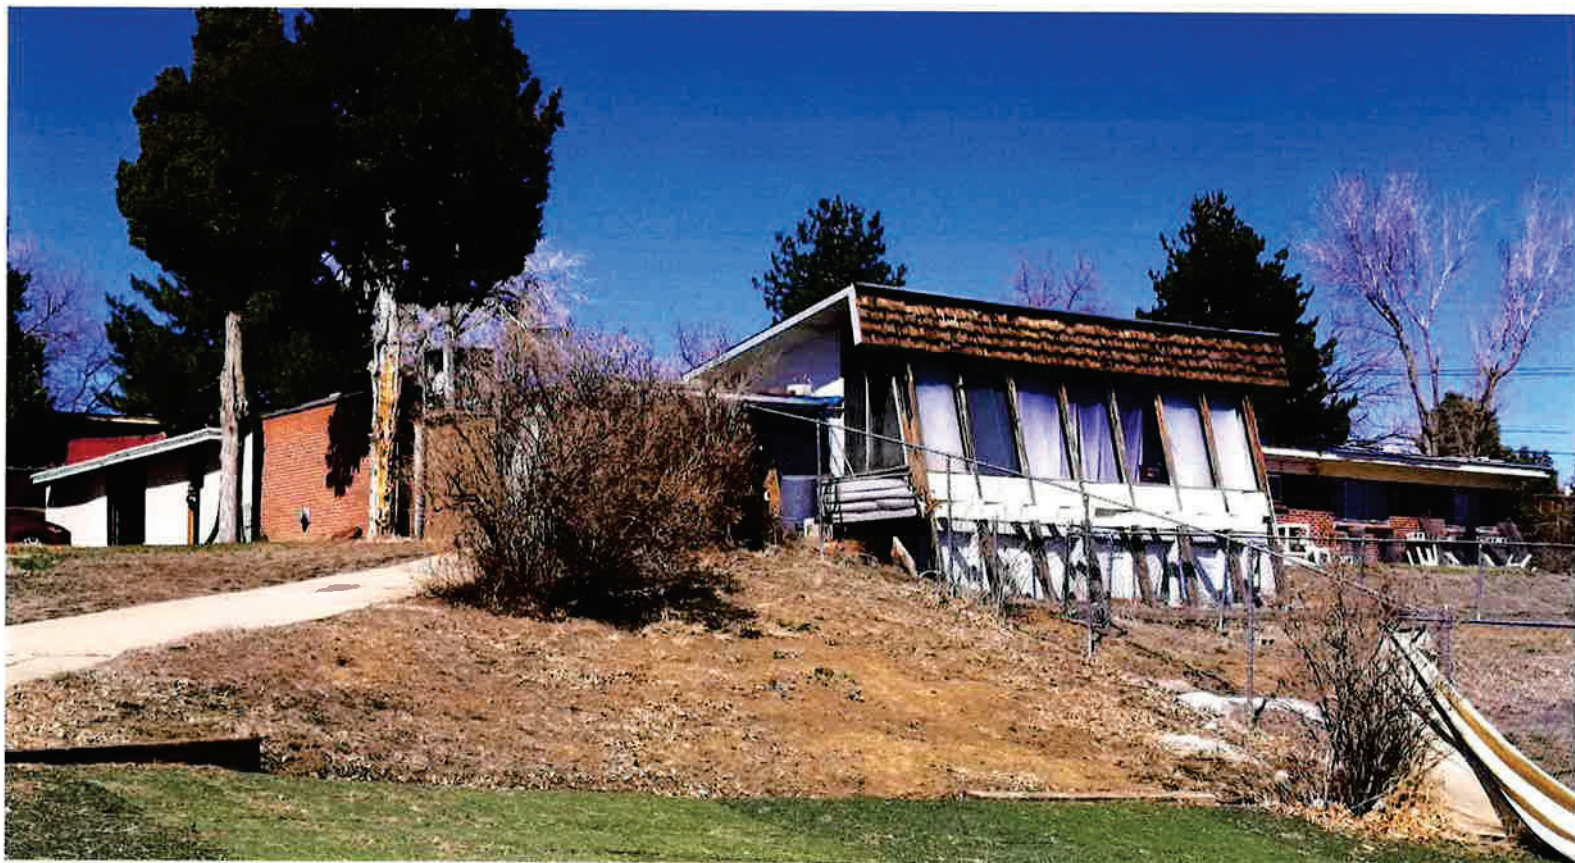
**palmerIn9840-2.tiff**

9840 Palmer Lane, Northglenn, Adams County, Colorado; view to northeast; photo by Mary Therese Anstey, HistoryMatters, LLC; Northglenn Deza Estates Survey; Certified Local Government Grant 2018-M2-001

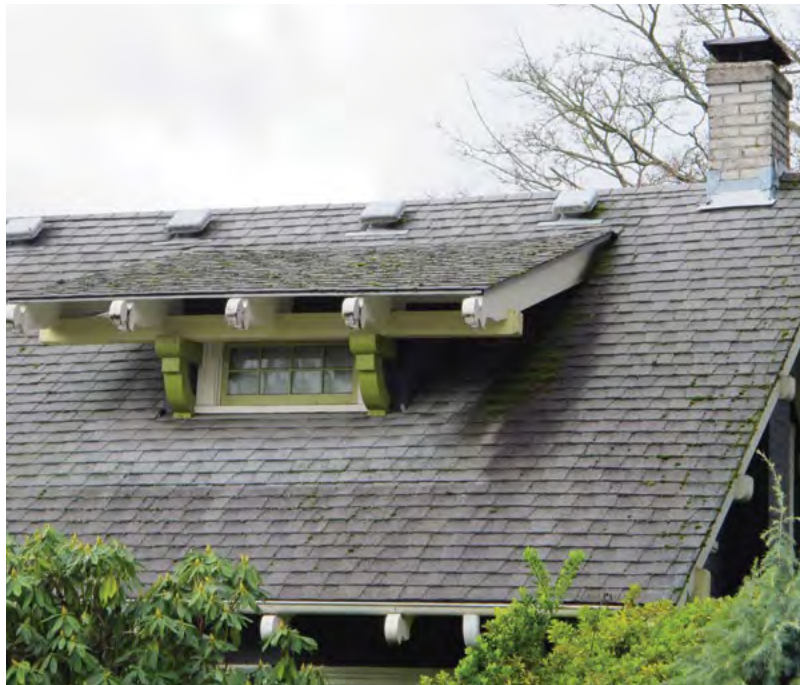
Throughout all periods of American history, with only minor exception, *wood* has been used for roofing; despite the early use of many other materials, wood shingles remained the most common roofing material throughout much of the 19th century. Initially the species of wood used would have been specific to a region, but the quality and design of a building were usually the prime determinants in the way wood was used, ranging from wide, lapped boards to small, uniform, geometrically-shaped shingles.

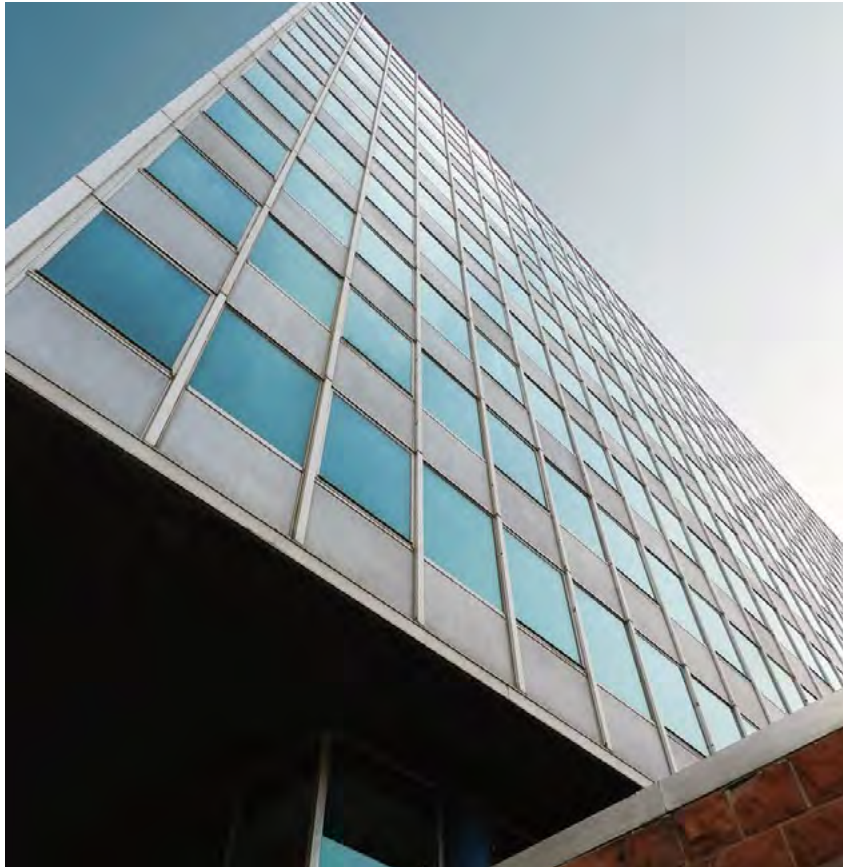
Curtain wall construction was originally based on a steel framework. Today, most curtain wall construction utilizes an extruded aluminum framework, which became popular in the 1930s in the U.S. and came into its own after World War II. A curtain wall is not a structural system and, although it is self supporting, does not carry the weight of the building. Rather, it is an exterior wall hung or attached to the structural system. Curtain wall construction most frequently employs glass, metal panels, thin stone veneer, and other cladding materials, although louvers and vents, like glass panels, can also be set into the metal framework. Newer curtain wall systems may

incorporate rain screens and glass fiber reinforced concrete panels (GFRC). Because curtain wall construction uses relatively lightweight and less expensive materials, it reduces building costs, which, in part, explains its popularity.

There are essentially two types of curtain wall systems: *stick* systems and *unitized* or *modular* systems. A *stick* system is a framing system composed of long metal pieces (sticks) put together individually using vertical pieces (mullions) between floors and horizontal pieces between the vertical members. The framing members may sometimes be assembled in a factory, but the installation and glazing is done on site. A *unitized* or *modular* curtain wall system consists of ready-to-hang, pre-assembled modules which already include glazing or other panel infill. These modular units are usually one story in height and approximately five- to six-feet wide. Both types of curtain walls are attached to floor slabs or columns with field-drilled bolts in mated, adjustable anchor brackets.

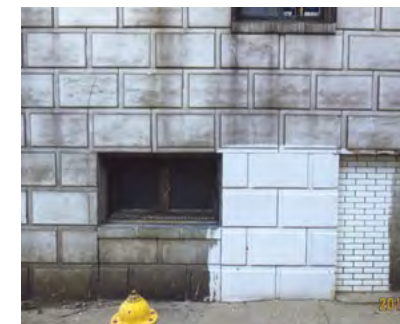
[1] A test patch should always be done before using a chemical cleaner to ensure that it will not damage historic masonry, as in this instance, terra cotta.

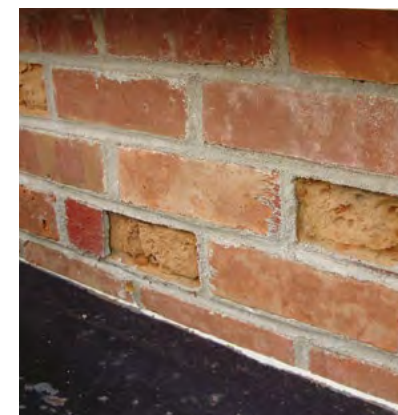
[2] **Not Recommended:** The use of inappropriate Portland cement mortar to repoint these soft 19th-century bricks has caused some of them to spall. *Photo: Courtesy Nebraska State Historic Preservation Office.*

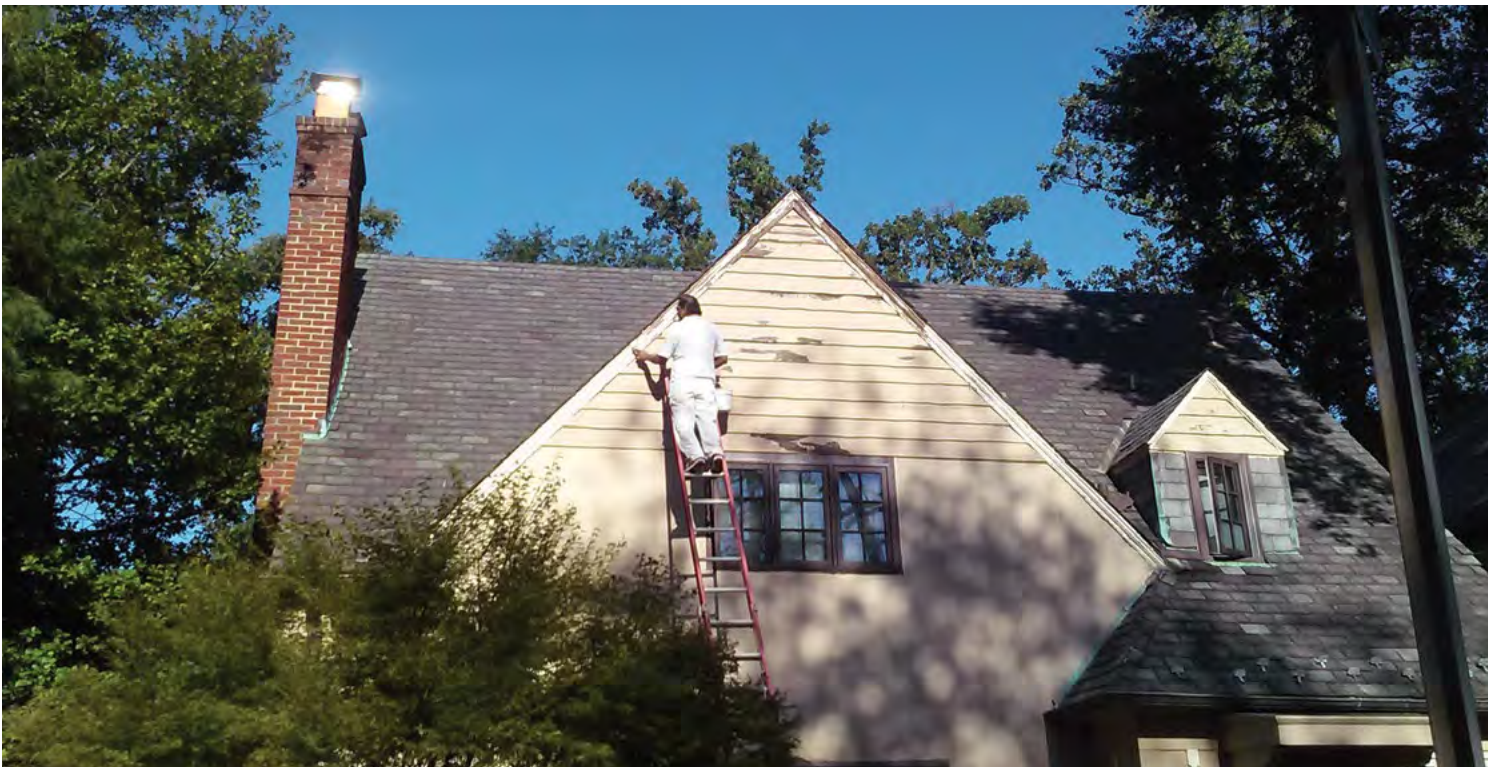
[4] Hand scraping to remove peeling paint from wood siding in preparation for repainting is an important part of regularly-scheduled maintenance.

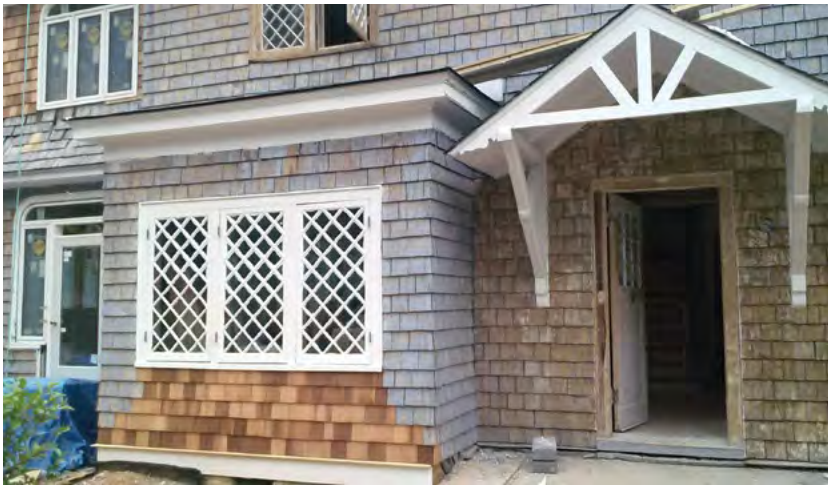
[5] Rotted wood shingles have been replaced in kind with matching wood shingles.

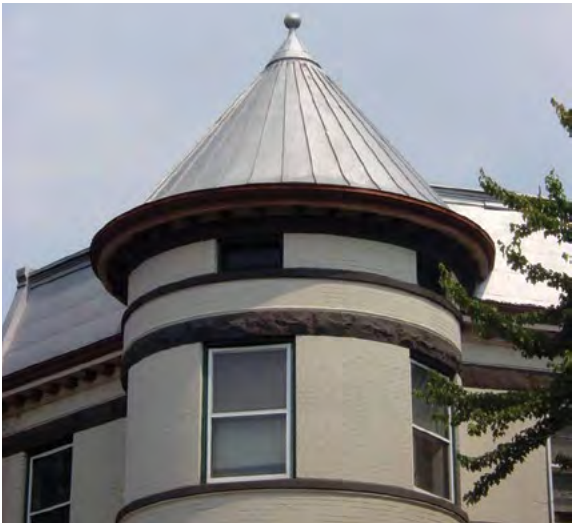
[6] A standing-seam sheet metal roof, like the one on the turret of this late 19<sup>th</sup> century row house, must be kept painted to ensure its preservation.

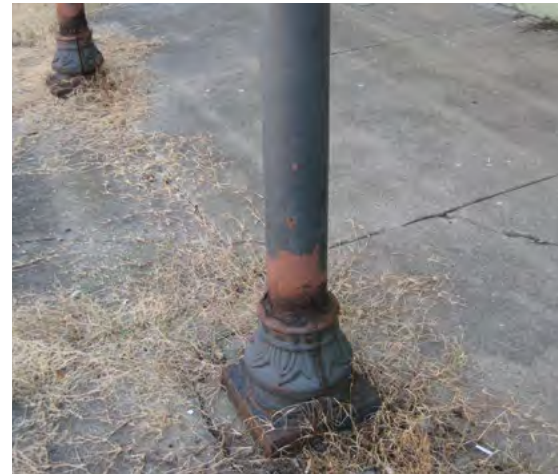
[7] (a) After the damaged portions of the base were repaired, (b) the cast-iron columns were cleaned and repainted to protect the metal from rusting.

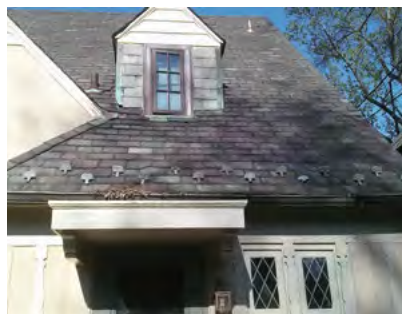
[8] Regular maintenance includes removing leaves that can clog gutters and cause water damage to the exterior and interior walls of a house.

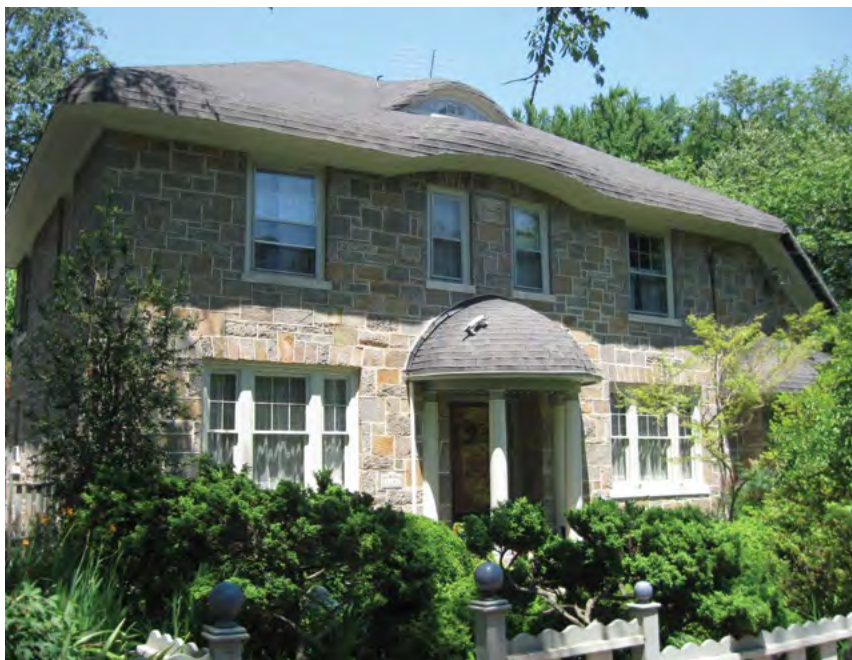
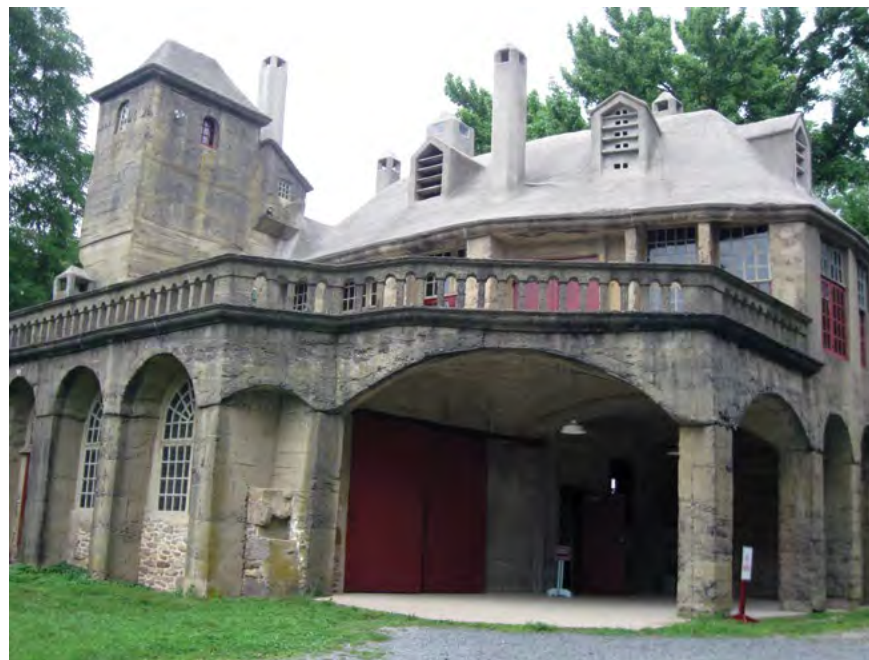
[9] Distinctively-shaped roofs are important in defining the historic character of these early 20<sup>th</sup>-century structures: (a) an asphalt shingle roof on a house; (b) and a concrete roof on Fonthill, Doylestown, PA (1908-1912), designed and built by Henry Chapman Mercer.

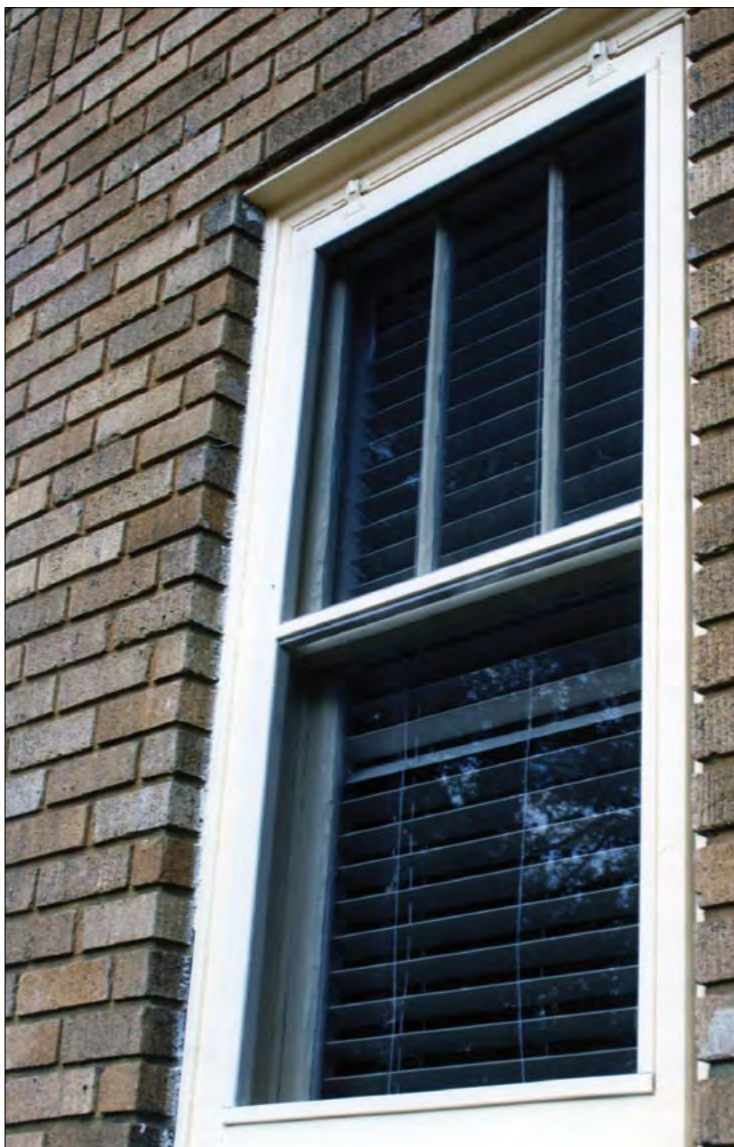
[10] Historic exterior storm windows preserve and help to insulate wood windows.

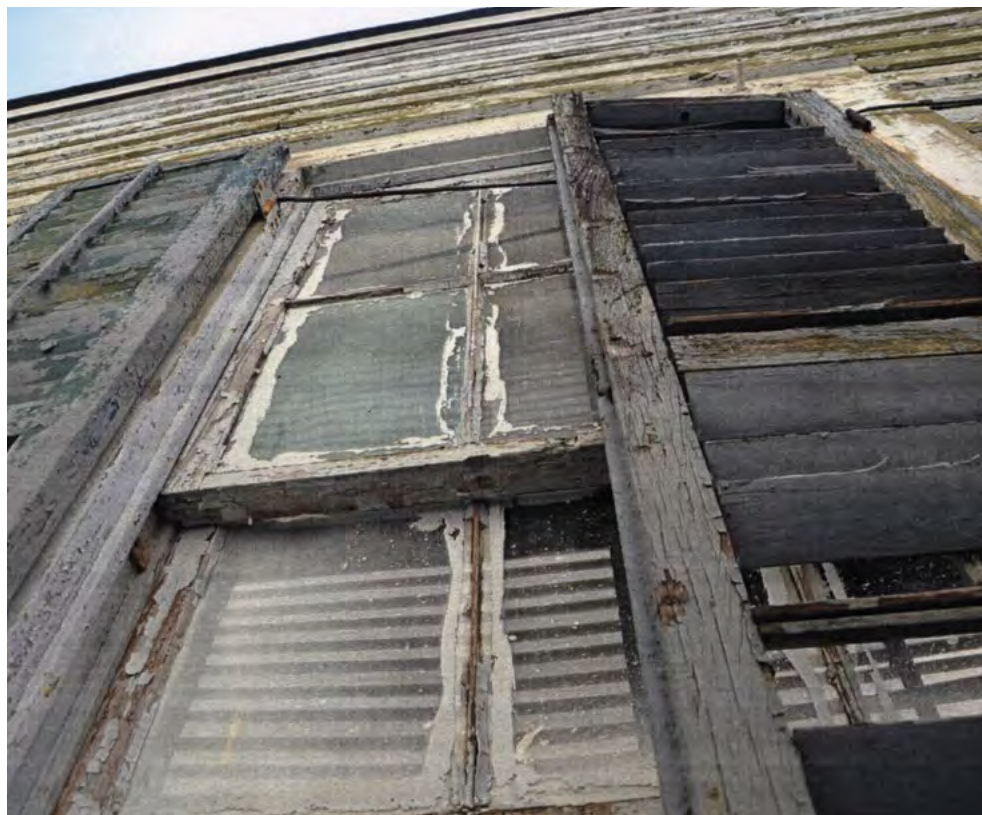
[11] Old and brittle glazing putty should be removed carefully before reputtying to keep window glazing weathertight.

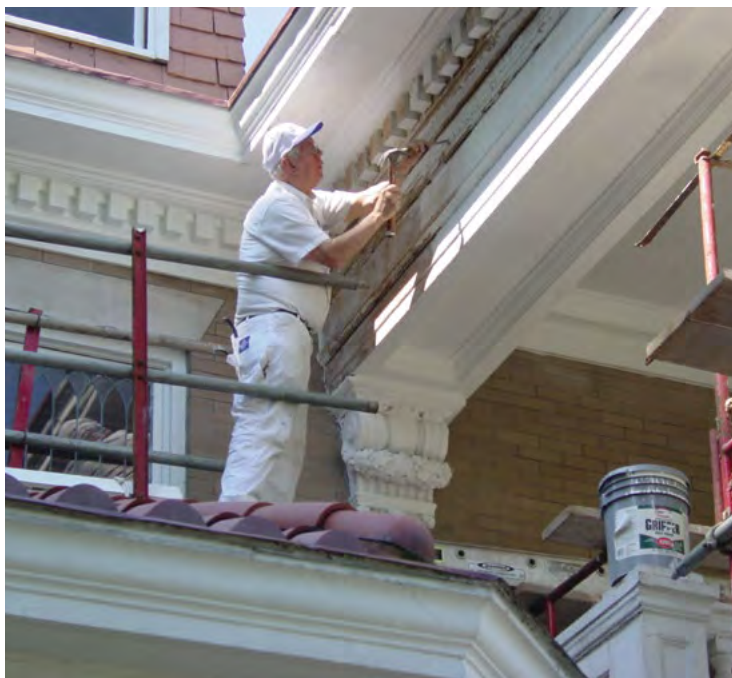
[12] Repair and limited replacement in kind to match deteriorated wood porch features is always a recommended preservation treatment.

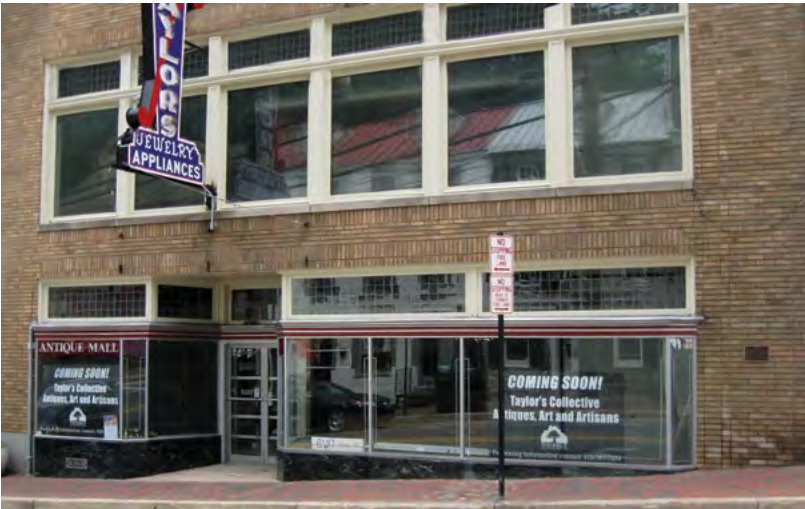
[15] Regular maintenance has helped to preserve this historic storefront, which retains all of its character-defining features, including the granite bulkhead, multi-paned transom glazing, and recessed entrance.

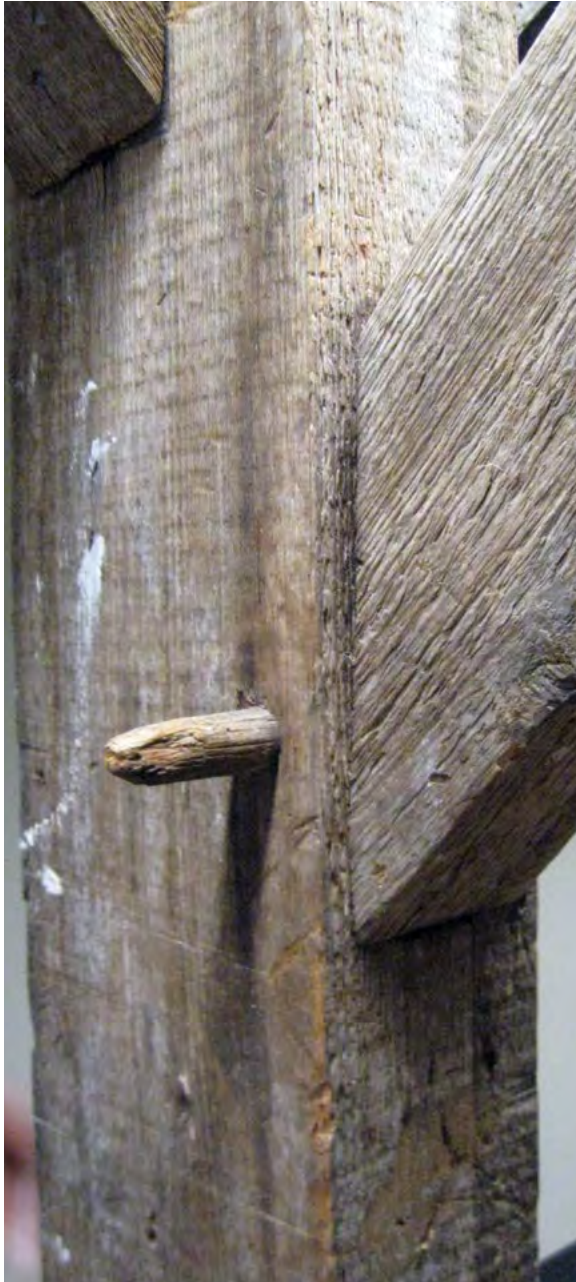
[17] Distinctive examples of traditional construction techniques should be preserved, such as this wooden peg, which is part of the structural system of this late-19th-century warehouse.

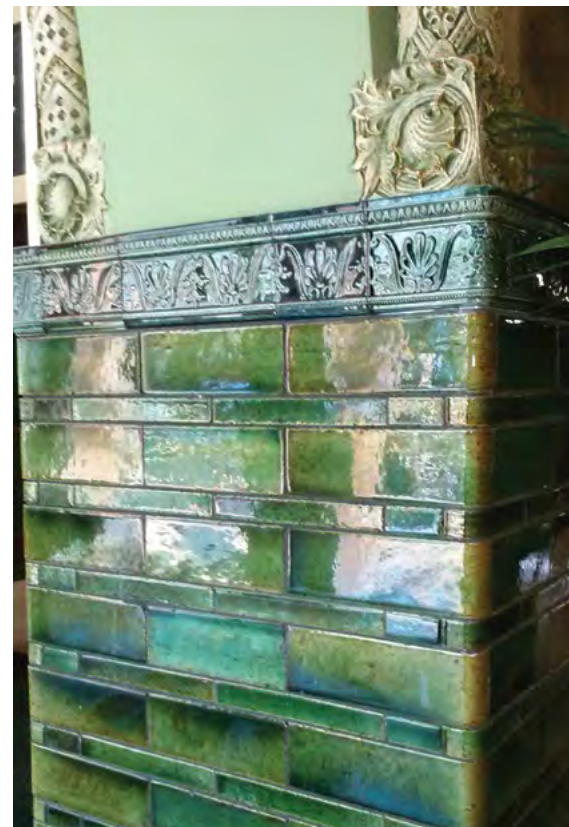
[20] It is important to protect decorative interior features, such as this highly-glazed tile wainscoting in a historic train station, when painting the walls above it.

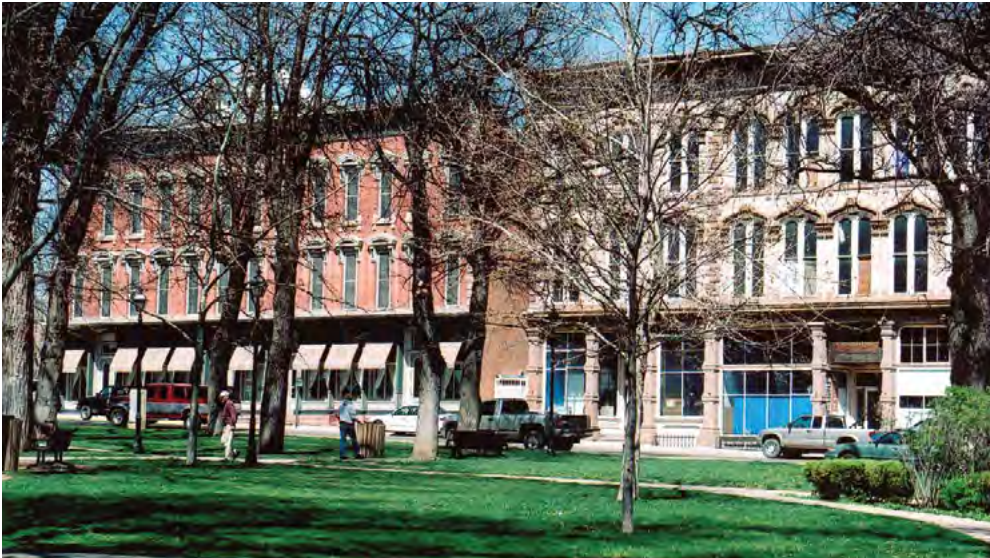
[23] The city square is important in defining the character of the historic setting in this small town.

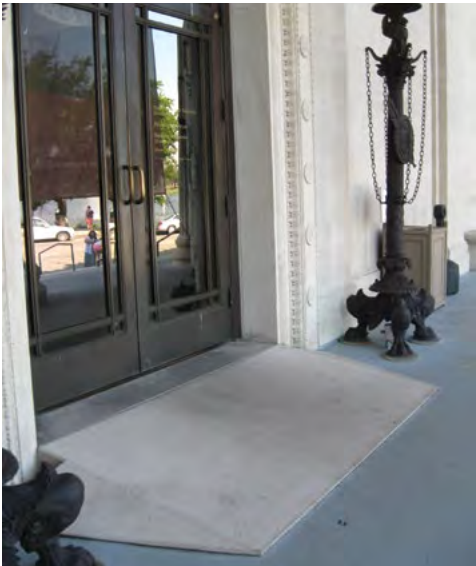
[26] A temporary ramp—unobtrusive and easily removed—facilitates access to the entrance of this museum and does not affect its historic character.

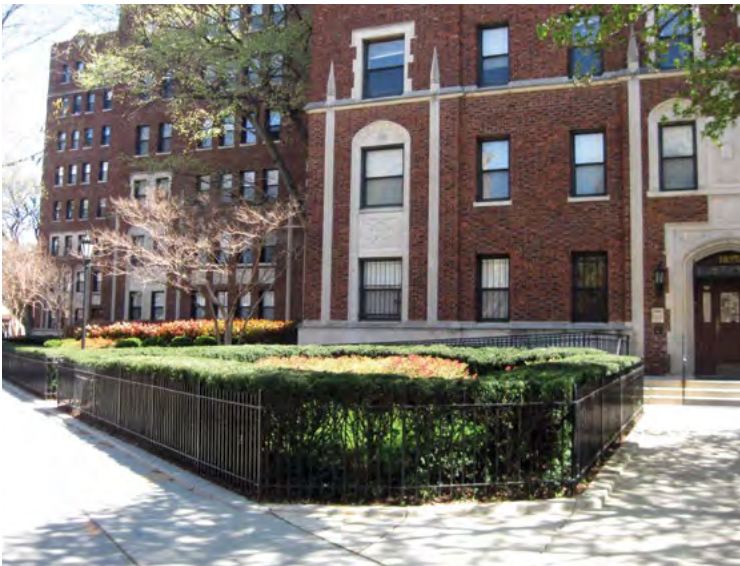
[27] The access ramp at the left of the entrance is concealed by a hedge which minimizes its visibility and impact on the character of the historic apartment building.

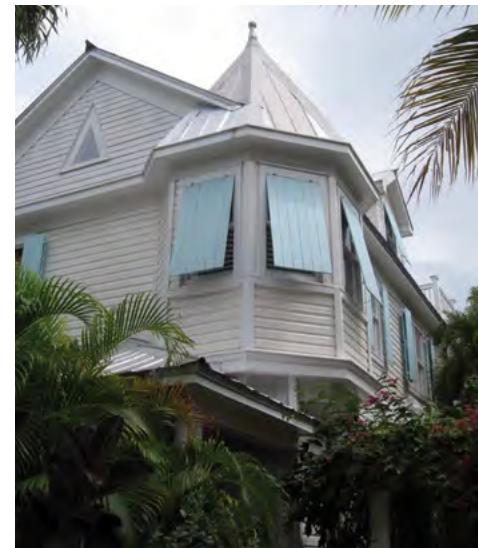
[30] Historic window shutters still serve their original function as protection in hurricane-prone areas.

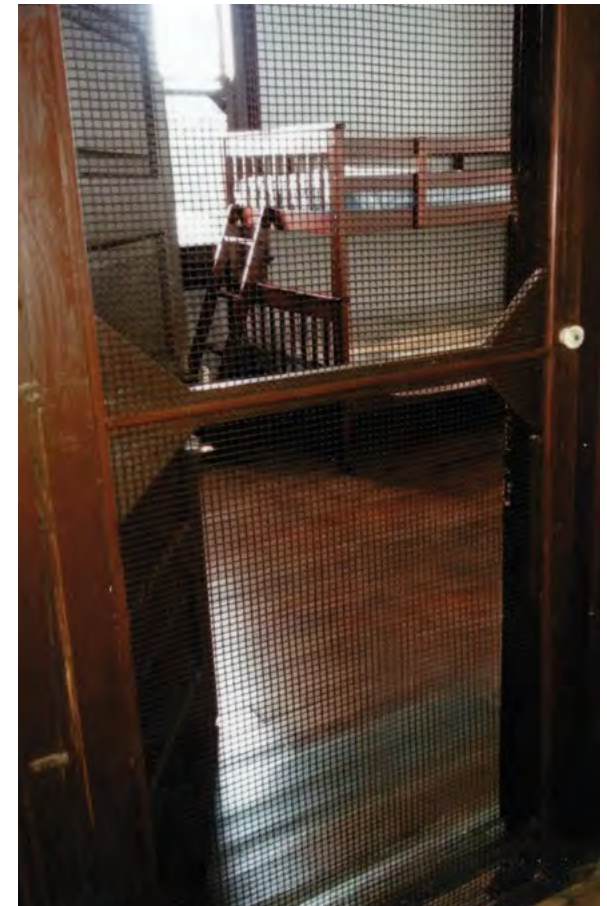
[31] An interior screen door at the entrance to individual apartments is a historic feature traditionally used to help circulate air throughout the building.

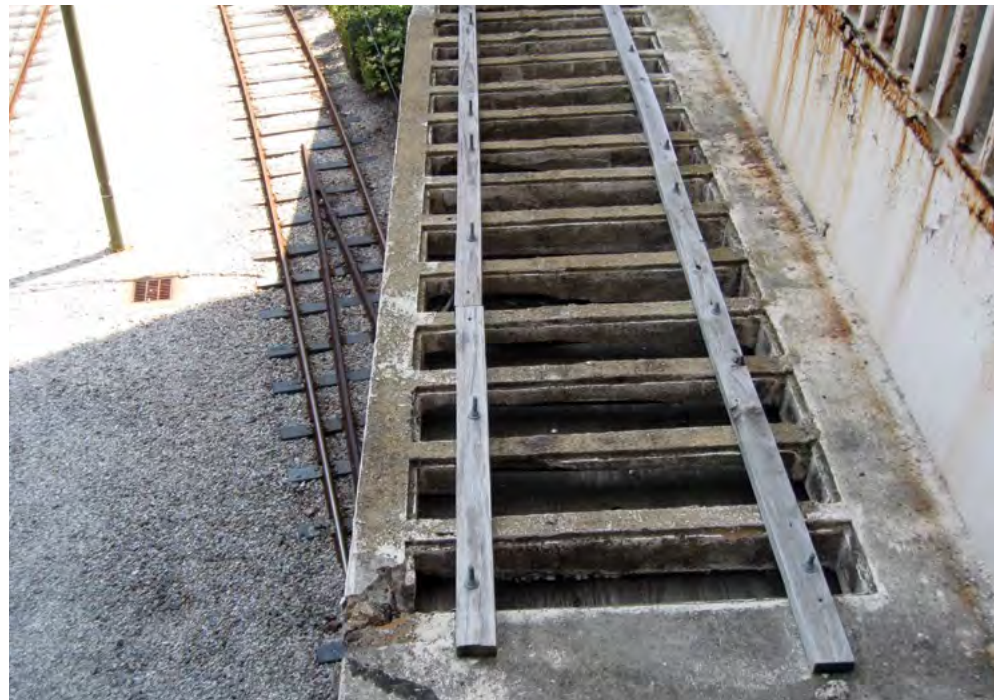
[6] Some areas of the concrete brise soleil screen on this building constructed in 1967 are badly deteriorated. If the screen cannot be repaired, it may be replaced in kind or with a composite substitute material with the same appearance as the concrete.

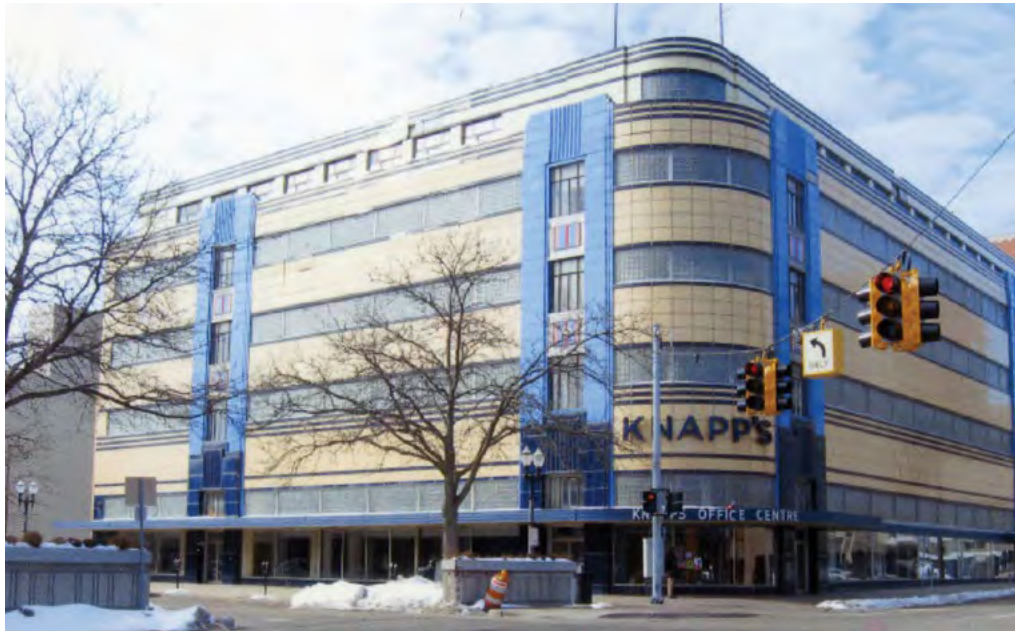
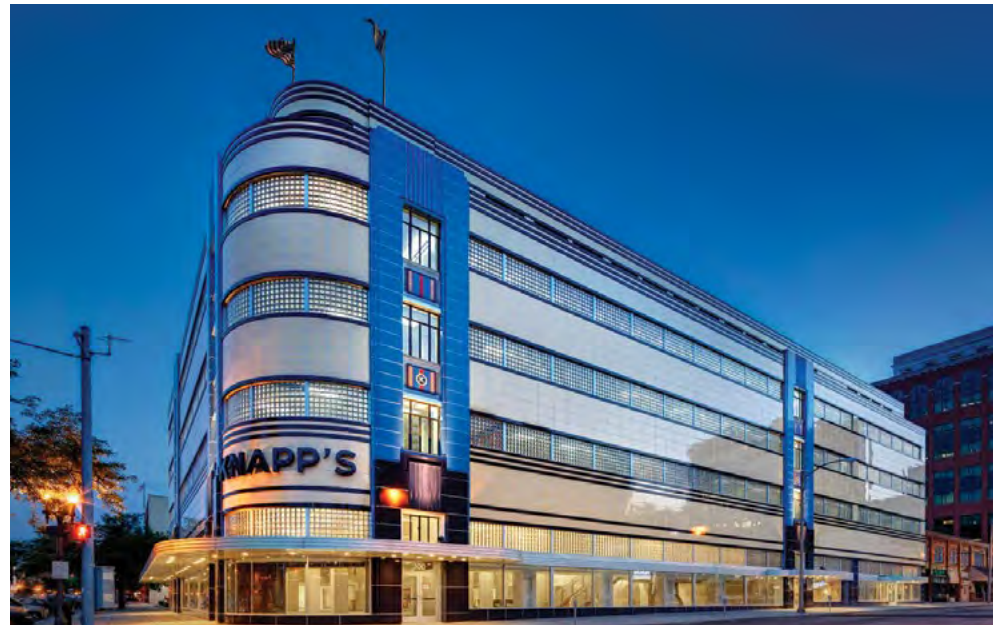
[7] (a) J.W. Knapp's Department Store, built 1937-38, in Lansing, MI, was constructed with a proprietary material named "Maul Macotta" made of enameled steel and cast-in-place concrete panels. Prior to its rehabilitation, a building inspection revealed that, due to a flaw in the original design and construction, the material was deteriorated beyond repair. The architects for the rehabilitation project devised a replacement system (b) consisting of enameled aluminum panels that matched the original colors (c). Photos and drawing (a-b): Quinn Evans Architects; Photo (c): James Haefner Photography.

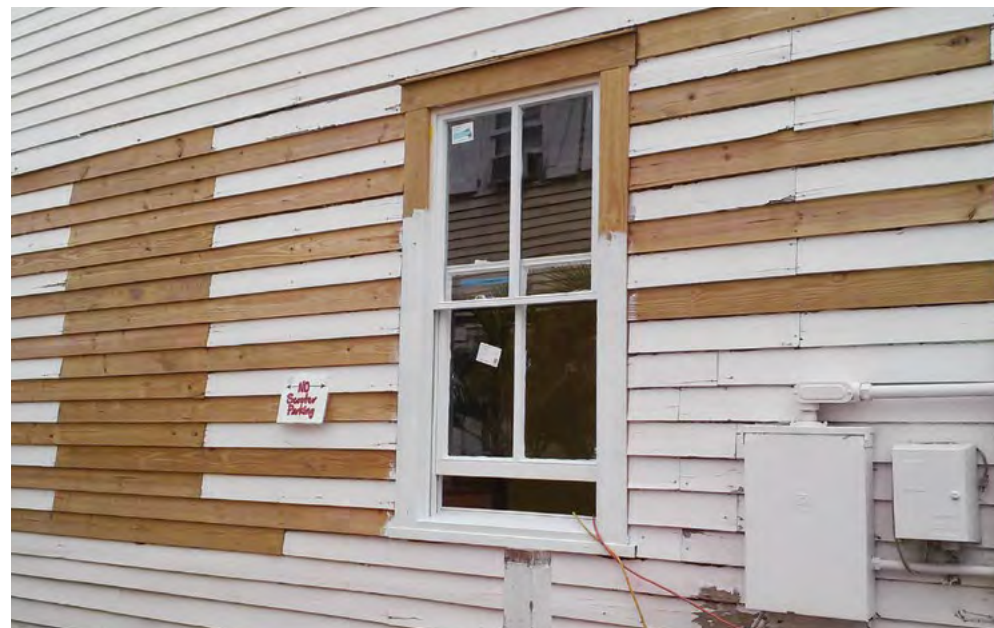
[8] Rotted clapboards have been replaced selectively with new wood siding to match the originals.

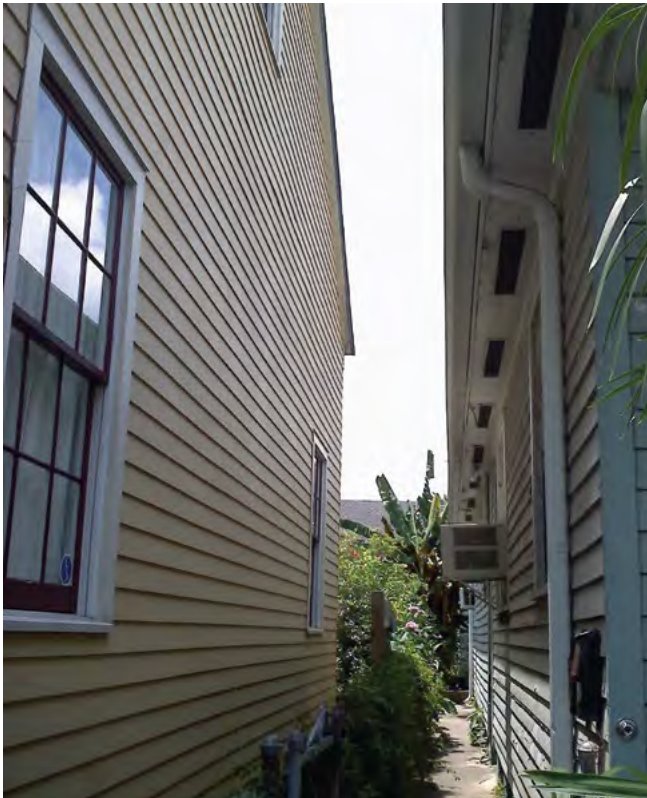
[9] Smooth-surfaced cementitious siding (left) may be used to replace deteriorated wood siding only on secondary elevations that have minimal visibility.

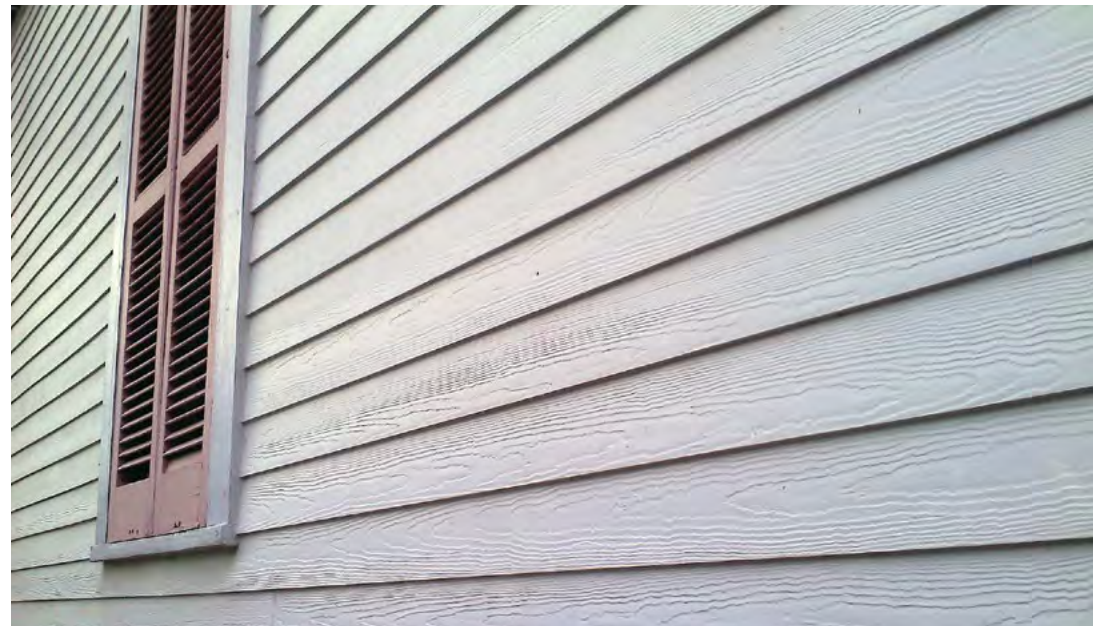
[10] **Not Recommended:** Cementitious siding with a raised wood-grain texture is not an appropriate material to replace historic wood siding, which has a smooth surface when painted.

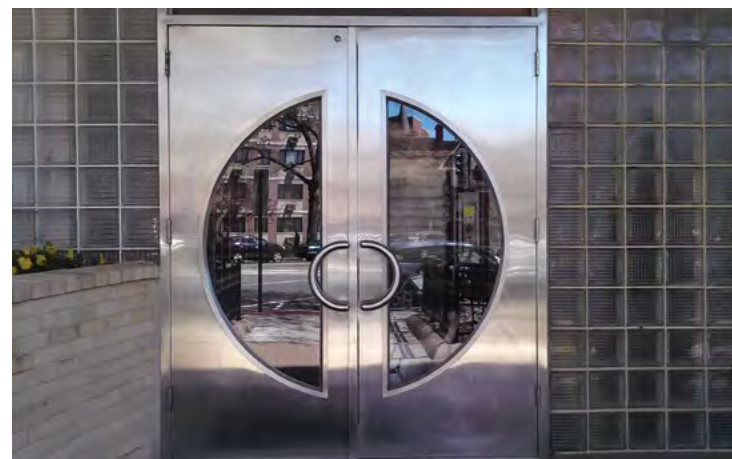
[11] The stainless steel doors at the entrance to this Art Deco apartment building are important in defining its historic character and should be retained in place.

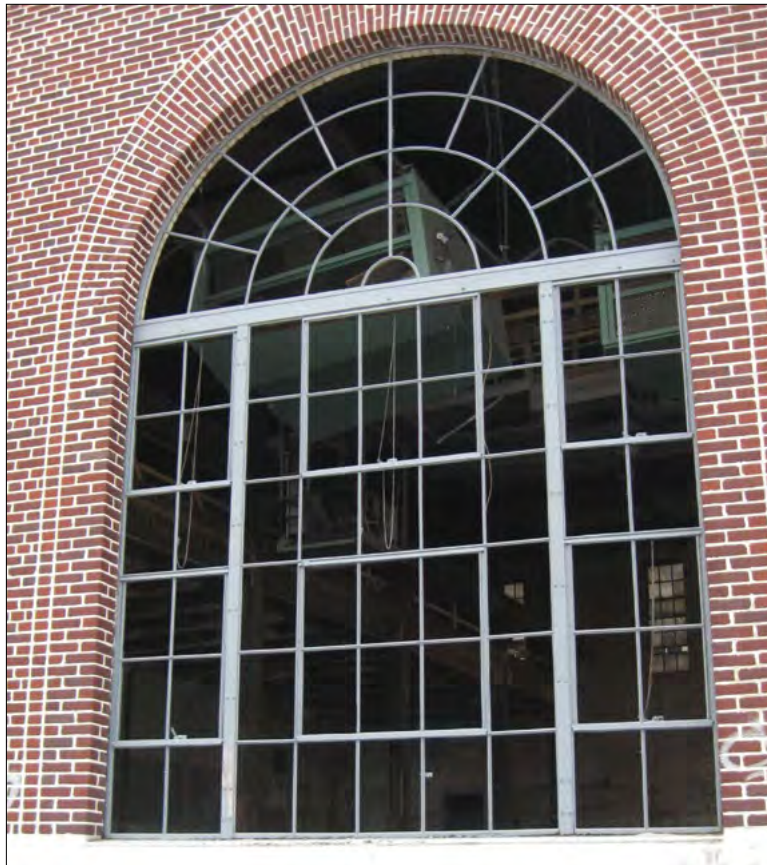
[12] This historic steel window has been cleaned, repaired, and primed in preparation for painting and reglazing.

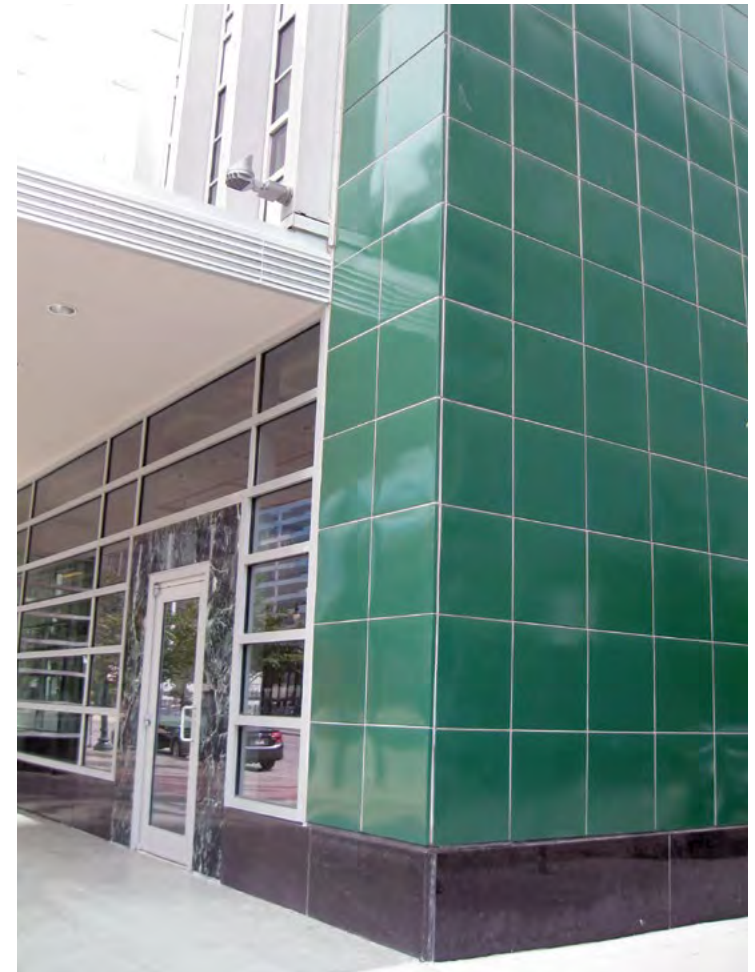
[15] New enameled-metal panels were replicated to replace the original panels, which were too deteriorated to repair, when the storefront of this early 1950s building was recreated.

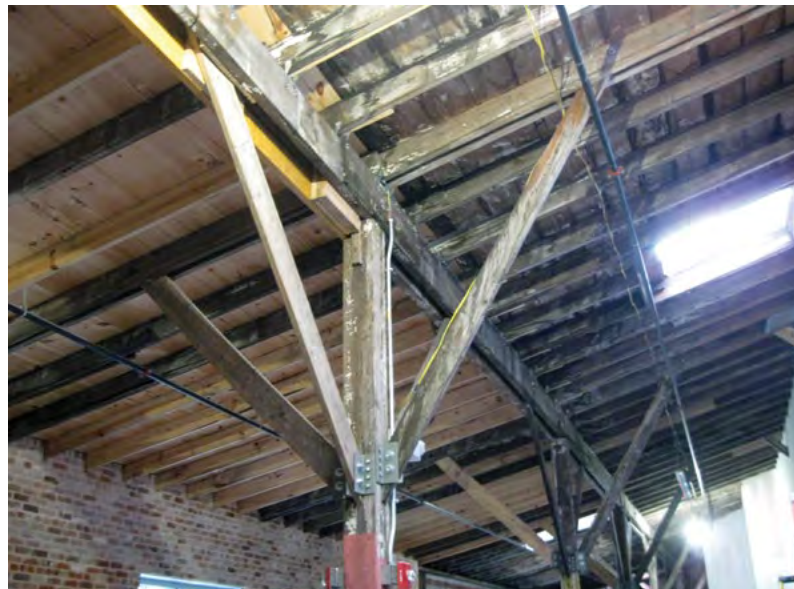
[17] New wood elements have been used selectively to replace rotted wood on the underside of the roof in this historic warehouse.

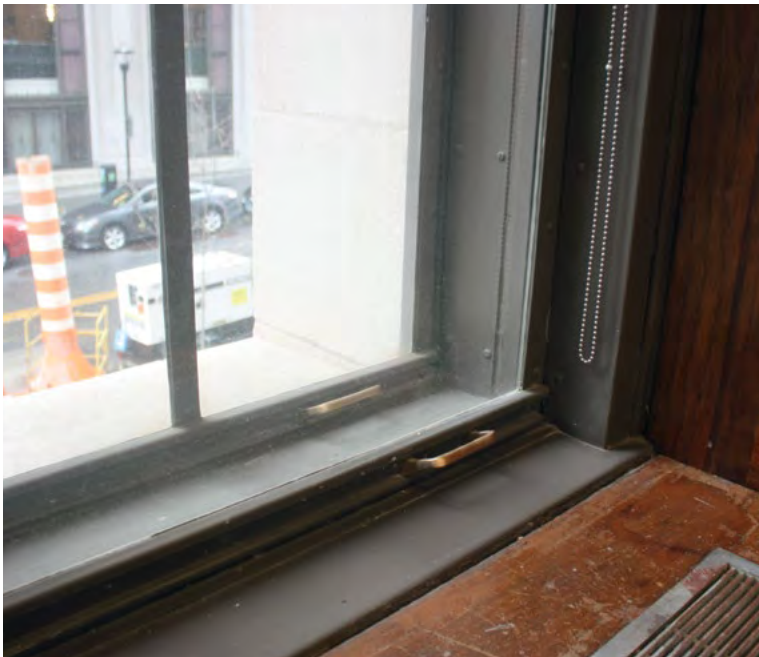
[18] The historic metal storm windows in this 1920s office building were retained and repaired during the rehabilitation project.

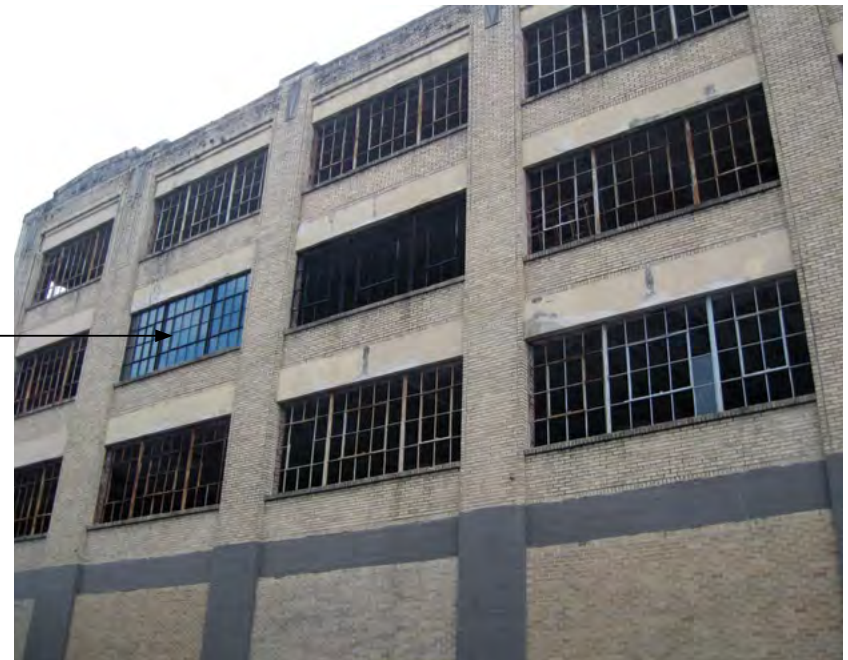
[19] Installing a mockup of a proposed replacement window can be helpful to evaluate how well the new windows will match the historic windows that are missing or too deteriorated to repair.
