## **AGENDA**

Historic Preservation Commission  
Tuesday August 11, 6:00 PM

Northglenn Historic Preservation Commission  
June 9, 2026  
Minutes

The applicant, Travis Glaser, property owner of 9840 Palmer Ln, is requesting Alteration Certificate to remove an enclosed carport with associated room addition, build an addition to the original structure, as well as renovating the original portion of property through window and roofing replacement as shown in Exhibit B. The property owner is proposing two phases to the project. Phase 1 removes all the non-original parts and non-permitted areas of the house. (Note: An unpermitted and dilapidated shed attached to the northern section of the house has already been removed). Phase 2 includes the building of the new addition to include a garage, master bedroom and bathroom in the rear of the property, window and roof replacement.

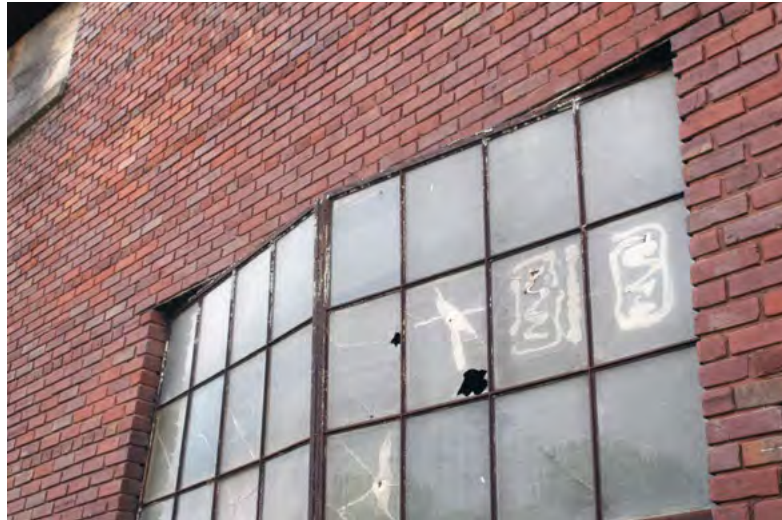
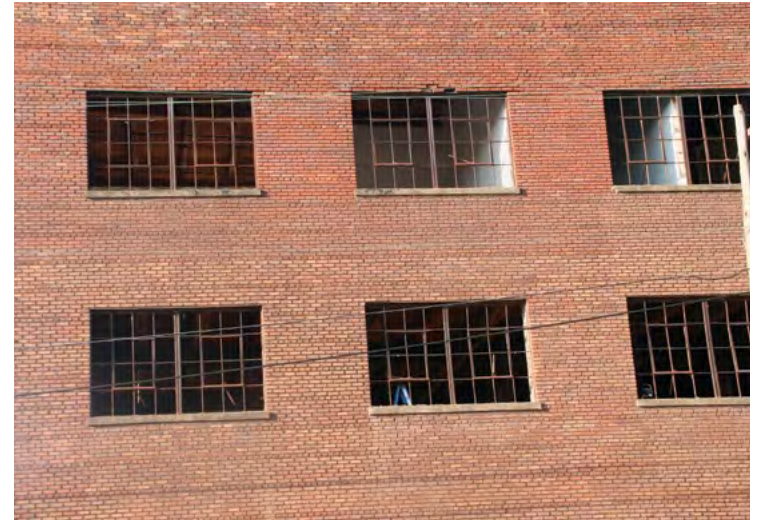
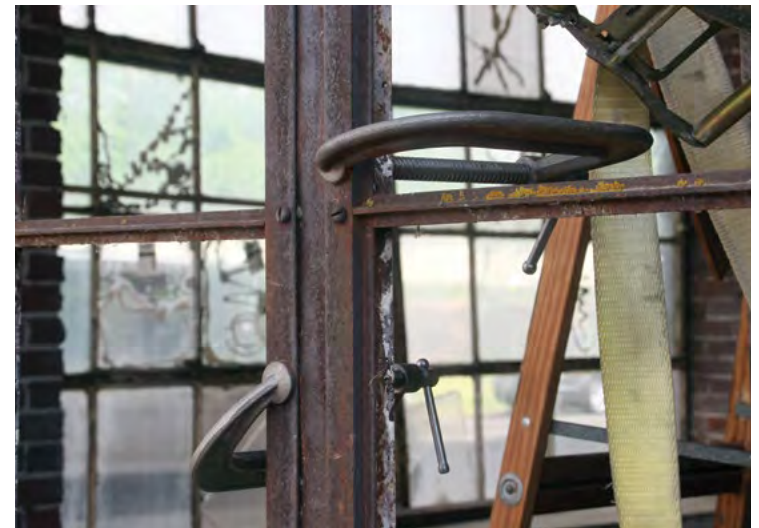
[20 a-d] The original steel windows in this industrial building were successfully repaired as part of the rehabilitation project (left).

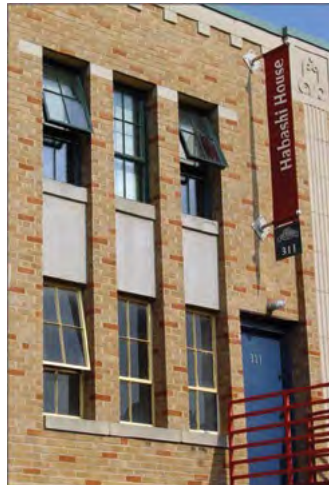
[21] The windows on the lower floor, which were too deteriorated to repair, were replaced with new steel windows matching the upper-floor historic windows that were retained.

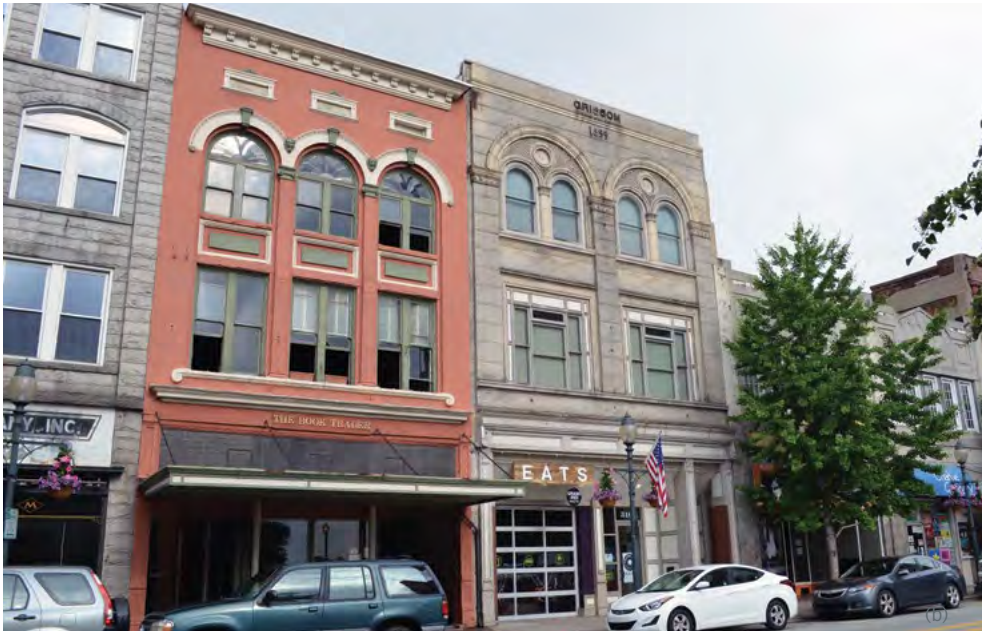
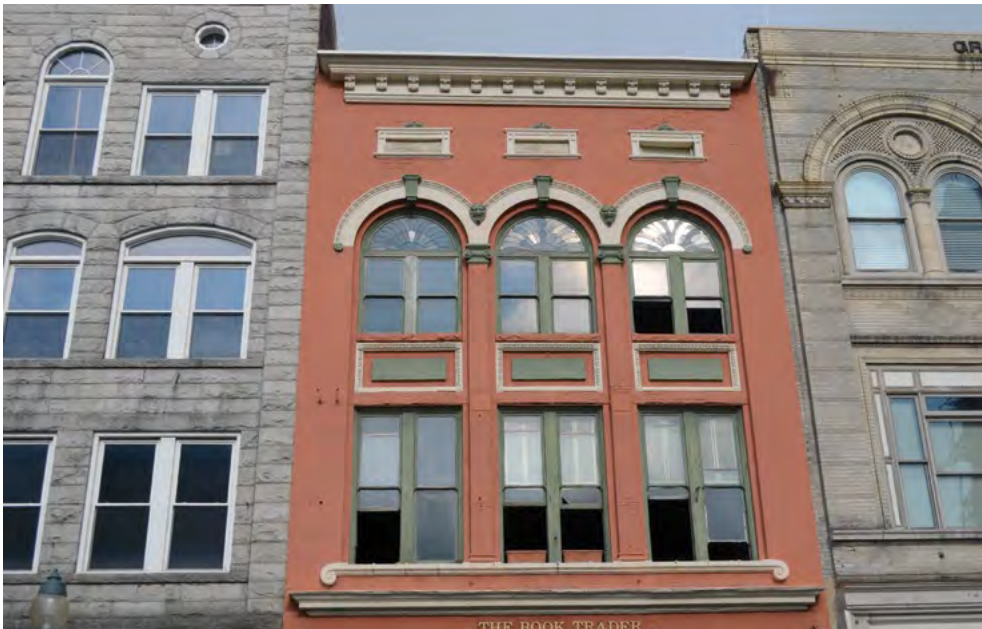
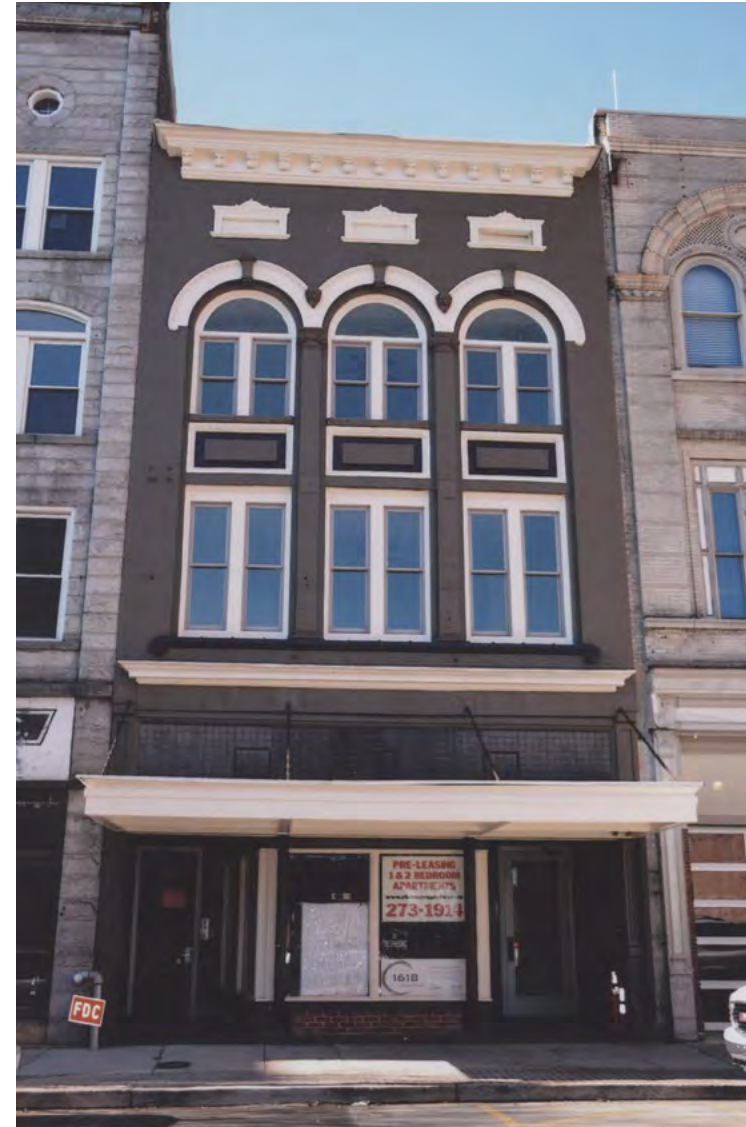
[22] **Not Recommended:** (a-b) The original wood windows in this late-19<sup>th</sup>-century building, which were highly decorative, could likely have been repaired and retained. (c) Instead, they were replaced with new windows that do not match the detailing of the historic windows and, therefore, do not meet the Standards (above).

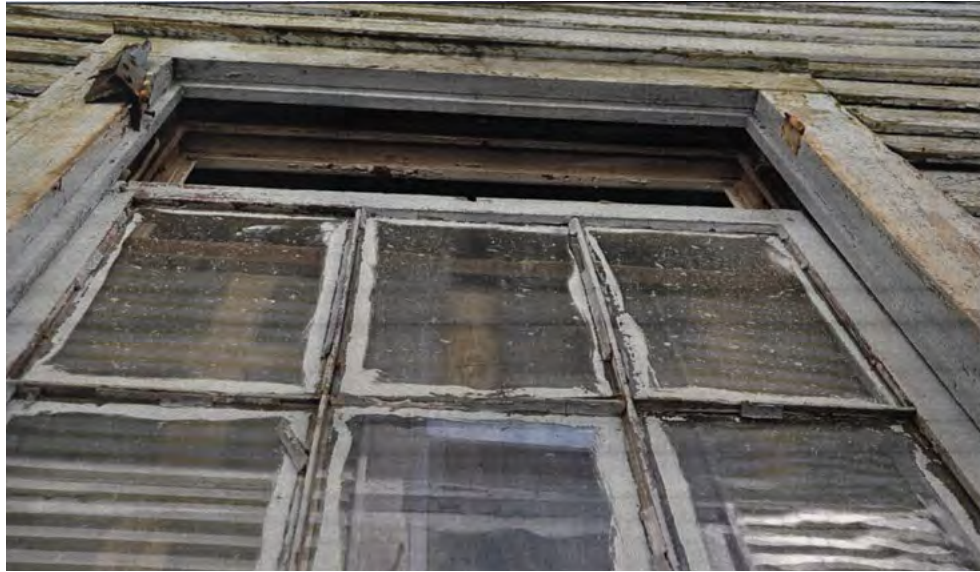
[23] (a) This deteriorated historic wood window was repaired and retained (b) in this rehabilitation project.

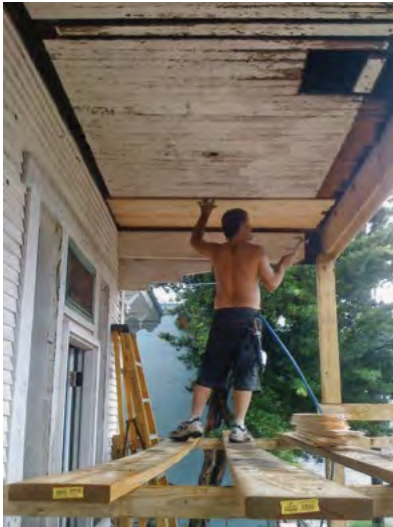
[24] Rotted boards in the beaded-board porch ceiling are being replaced with new matching beaded board.

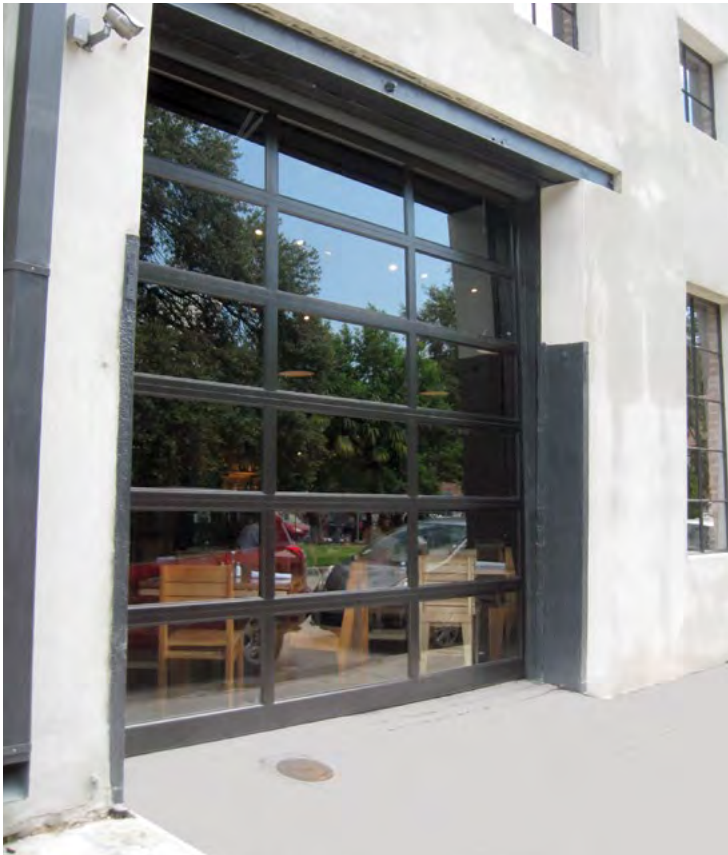
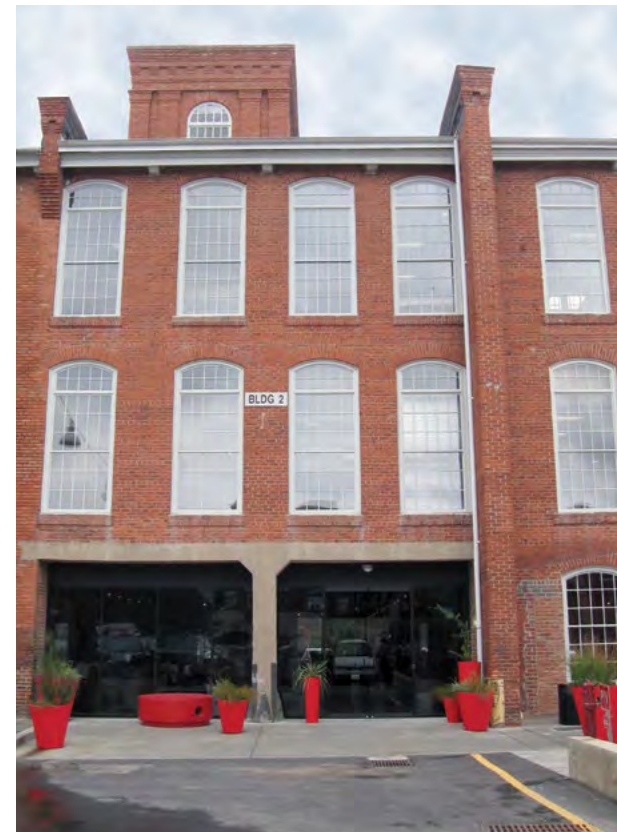
[25] The new infill designs for the garage door openings in this commercial building (a) converted for restaurant use and in this mill building (b) rehabilitated for residential use are compatible with the historic character of the buildings.

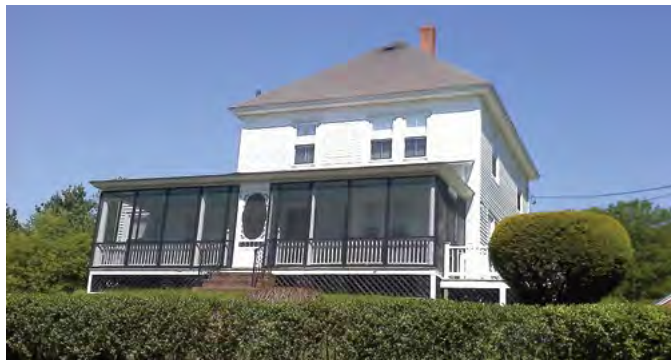
[26] **Not Recommended:** Installing a screened enclosure is never recommended on a front or otherwise prominent historic porch. In limited instances, it may be possible to add screening on a porch at the rear or on a secondary façade; however, the enclosure should match the color of the porch and be placed behind columns and railings so that it does not obscure these features.

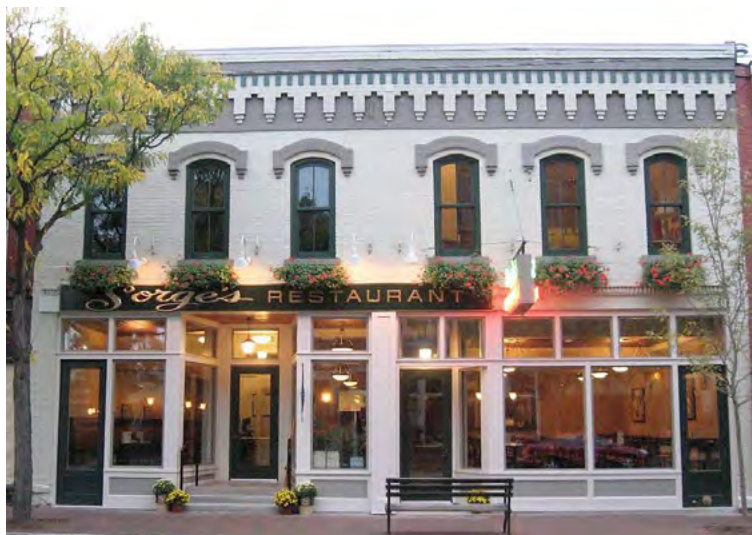
[28] This new storefront, which replaced one that was missing, is compatible with the historic character of the building.

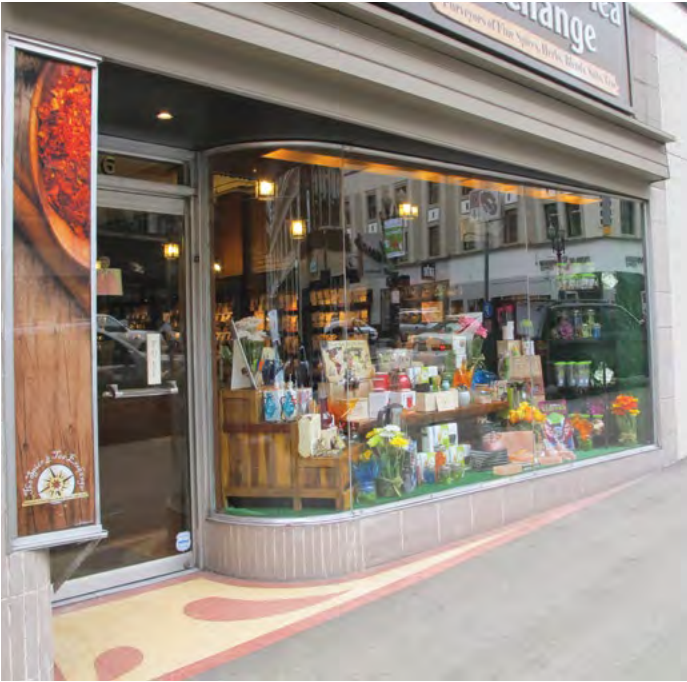
[27] This original c. 1940s storefront, with its character-defining angled and curved glass display window and recessed entrance with a decorative terrazzo paving, is in good condition and should be retained in a rehabilitation project.

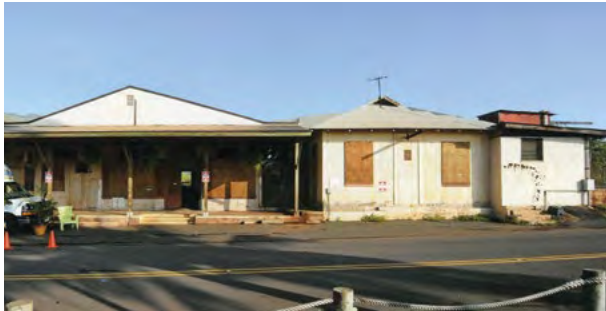
[29] The rehabilitation of the 1910 Māālaea General Store (a), which served the workers' camp at the Wailuku Sugar Company on the Hawaiian island of Maui, included the reconstruction of the original parapet (b).

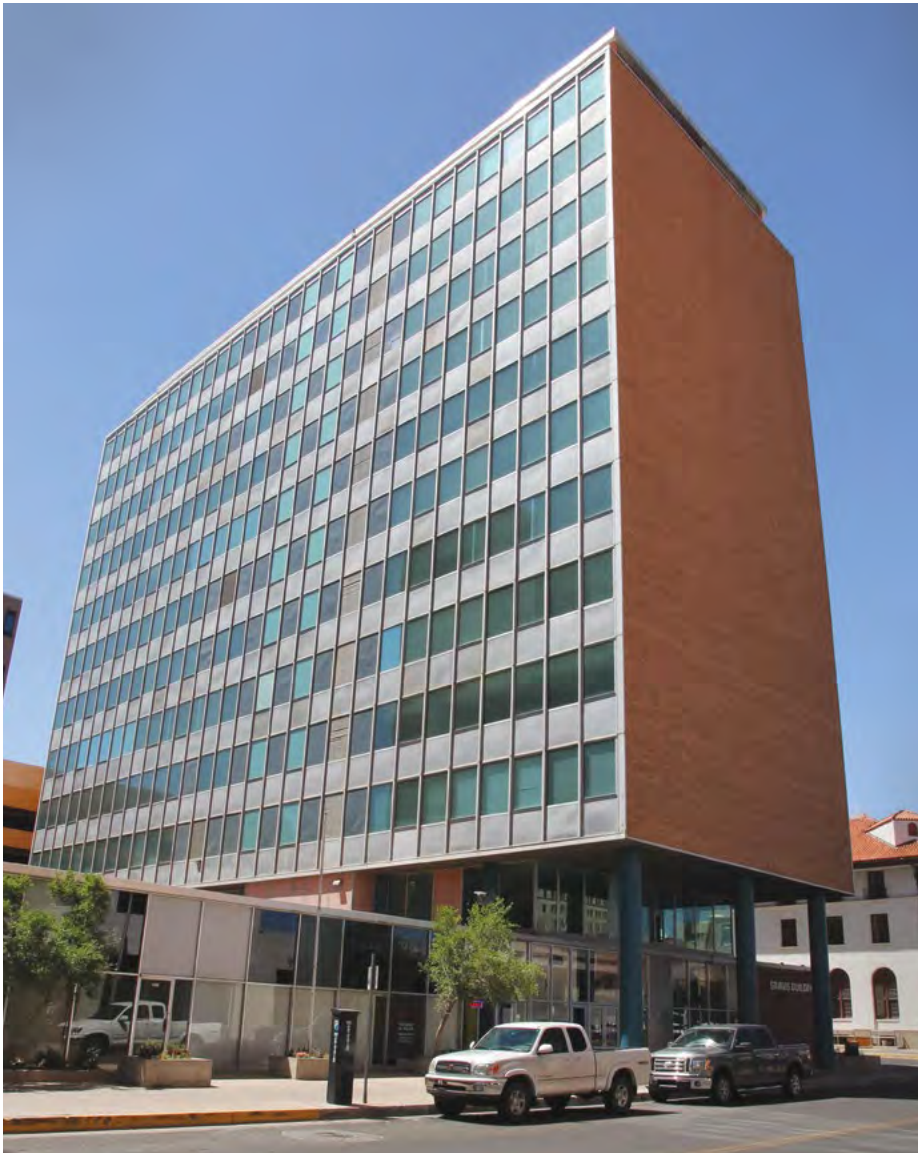
[30] Rather than replace the original curtain wall system of the 1954 Simms Building in Albuquerque, NM, with a different color tinted glass or coat it with a non-historic reflective film, the HVAC system was updated to improve energy efficiency. Photo: Harvey M. Kaplan.

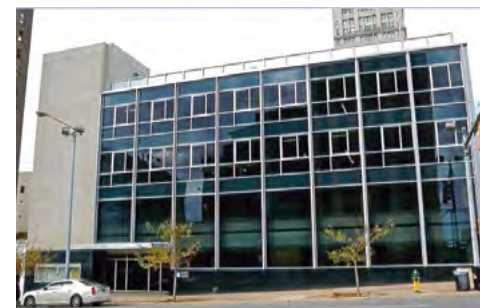
[31 a-c:] (a) The rehabilitation of the First Federal Savings and Loan Association building in Birmingham, AL, constructed in 1961, required replacing the deteriorated historic curtain wall system because the framing and the fasteners holding the spandrel glass and the windows had failed. (b) Comparative drawings show that the differences between the replacement system, which incorporated new insulated glass to meet wind-load requirements, and the original system are minimal. (c) The replacement system, shown after completion of the project, has not altered the historic character of the building.

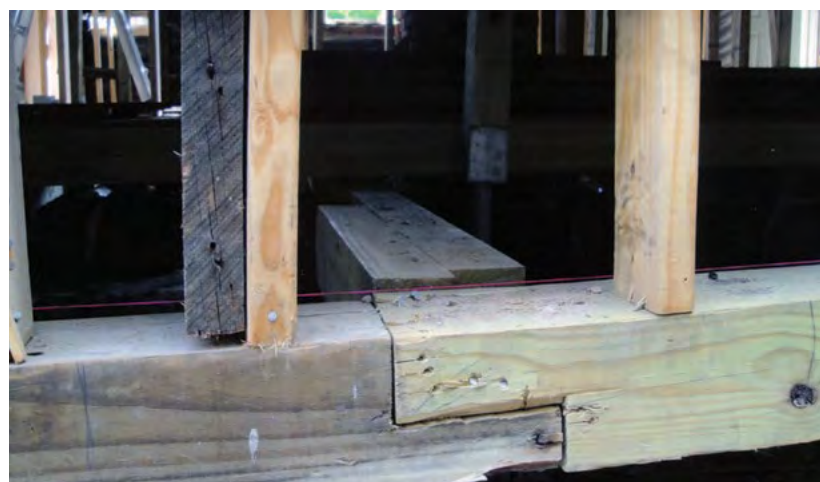
[33] Retaining as much as possible of the historic wood sill plate and replacing only the termite-damaged wood is always the preferred and recommended treatment.

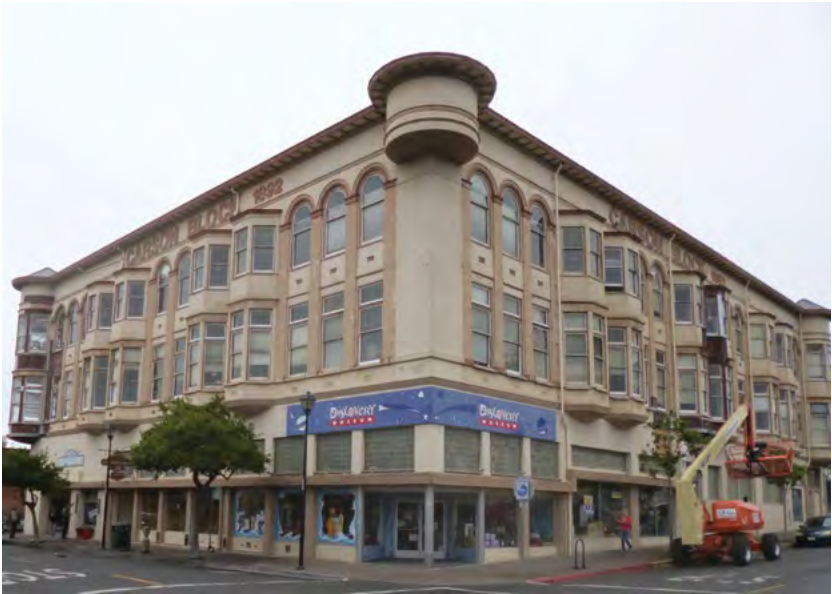
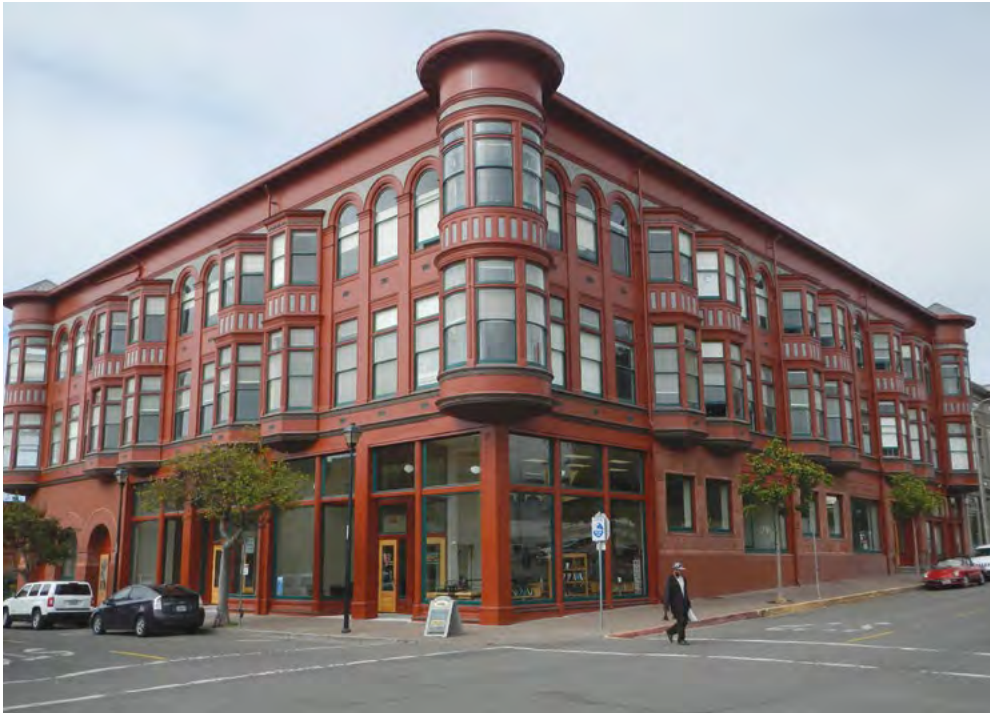
[32] (a-b) The rehabilitation of the 1892 Carson Block Building in Eureka, CA, for its owner, the Northern California Indian Development Council, included recreating the missing corner turret and sensitively introducing seismic reinforcement (c) shown here (opposite page) in a secondary upper floor office space. Photos: Page & Turnbull.

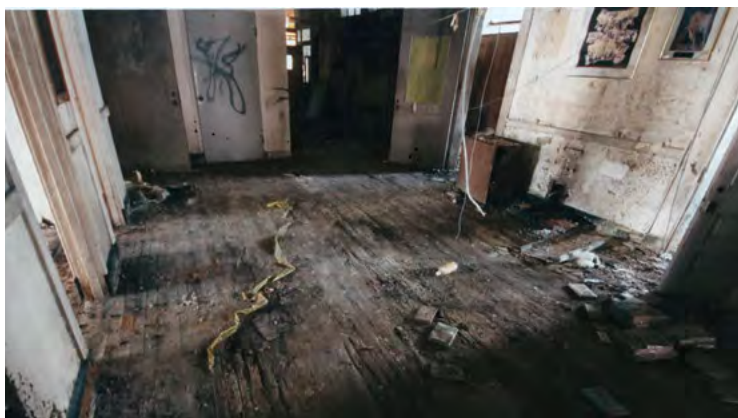
[35] (a) Although deteriorated, the historic school corridor, shown on the left, with its character-defining features, including doors and transoms, was retained and repaired as part of the rehabilitation project (b).

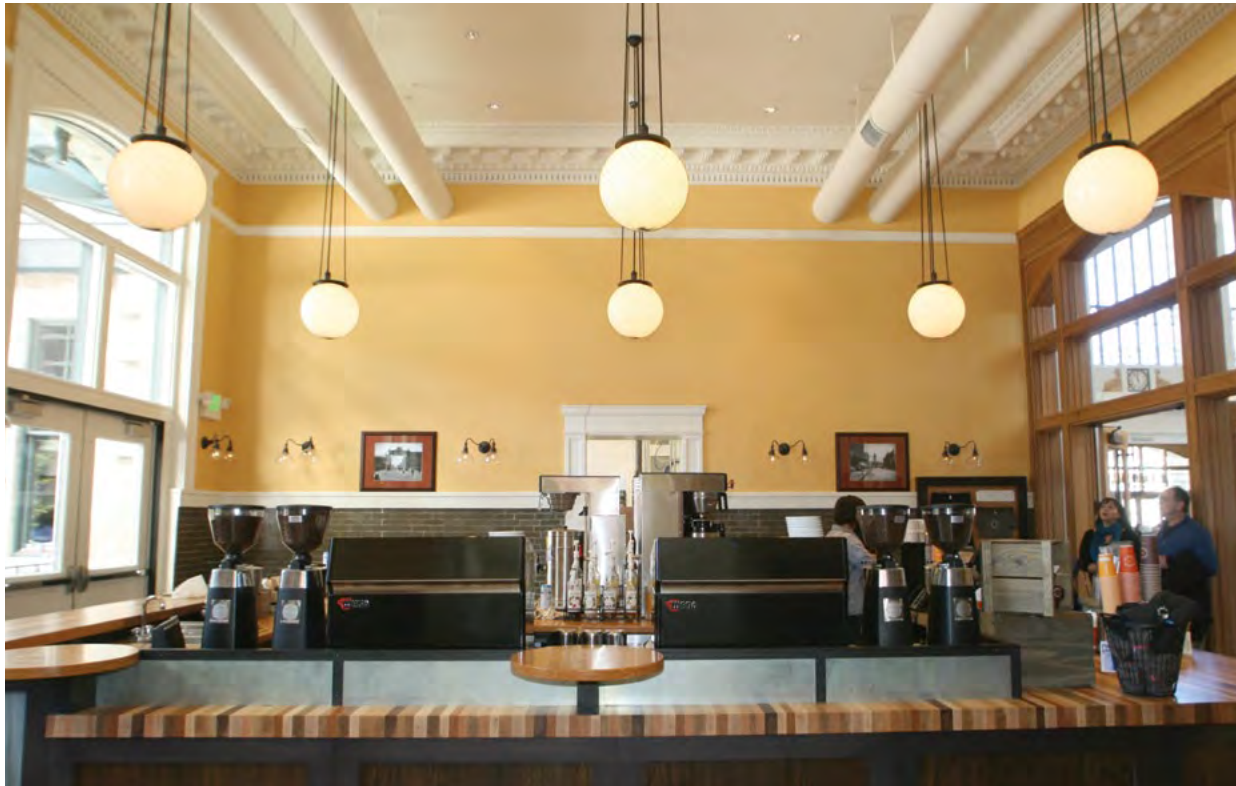
[37] Exposed and painted ducts were appropriately installed here in a retail space in Denver's historic Union Station after considering other options that would have impacted the ceiling height, or damaged or obscured the ornamental plaster crown molding. *Photo: Heritage Consulting Group.*

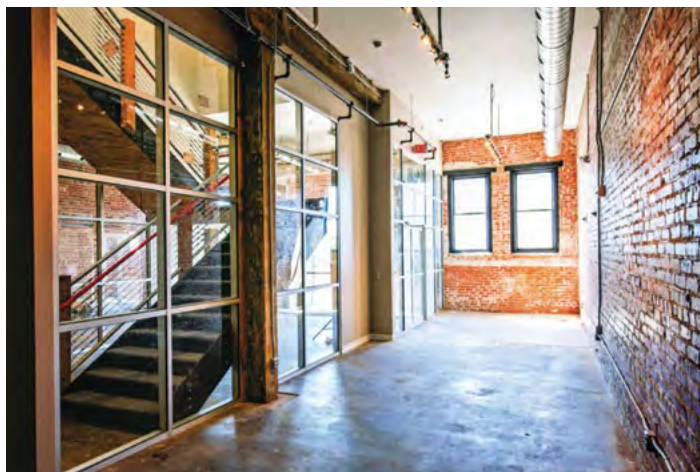
[38] The rehabilitation project retained the industrial character of this historic factory building, which included installation of a fire-rated, clear glass enclosure that allows the stairway, an important interior feature, to remain visible.

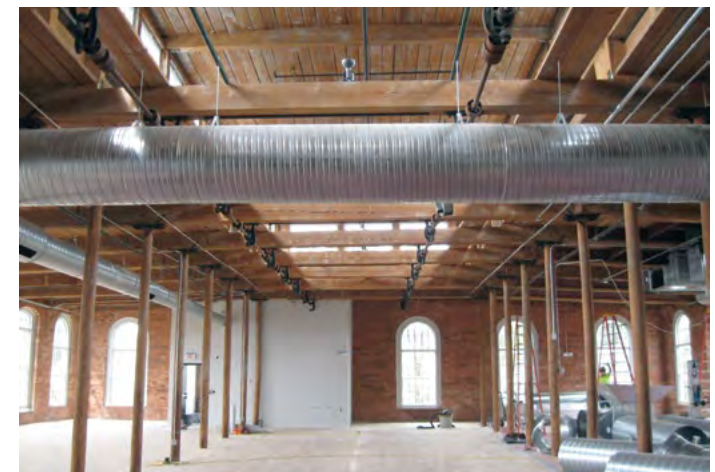
[39] Leaving the ceiling structure exposed and installing exposed ductwork where it does not impact the windows, are appropriate treatments when rehabilitating an industrial building for another use.

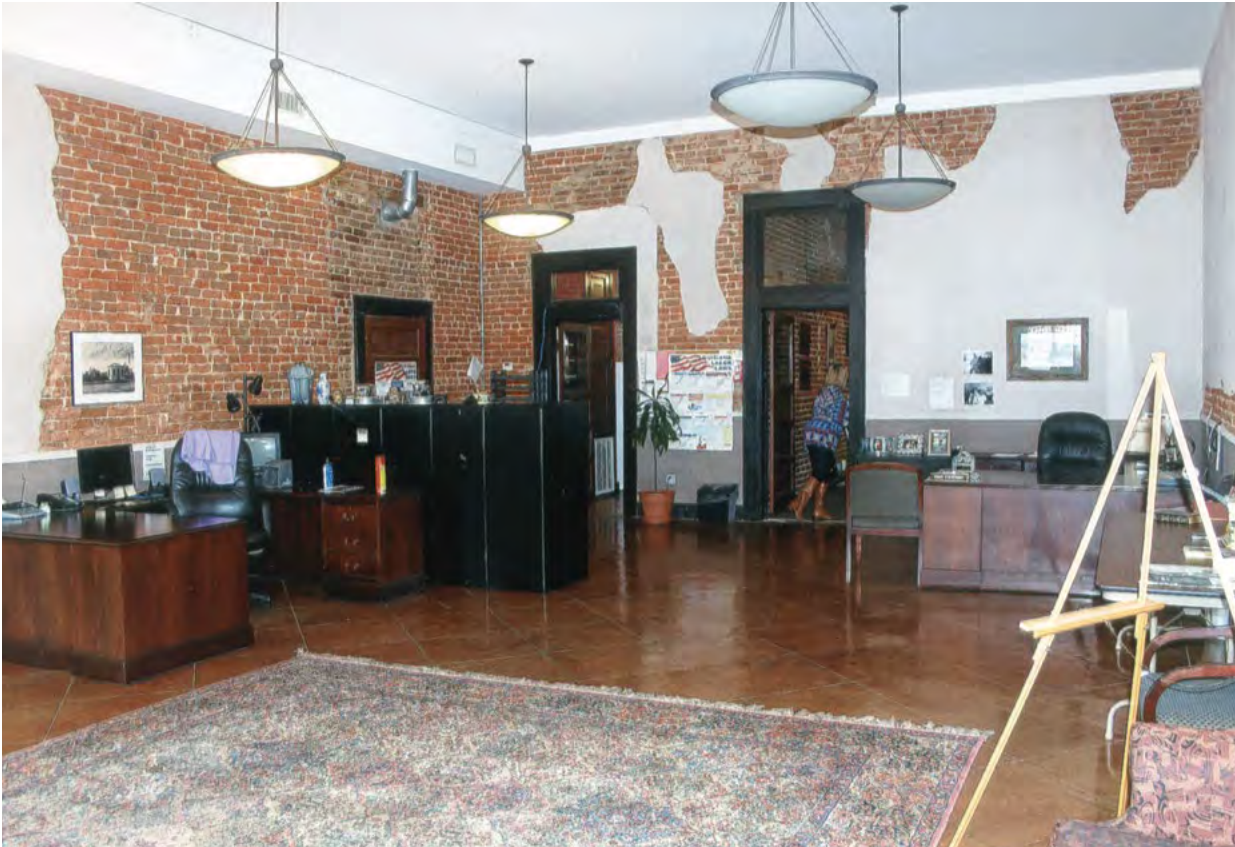
[41] **Not Recommended:**  
Leaving fragments of deteriorated or "sculpted" plaster is not a compatible treatment for either finished or unfinished interior spaces.

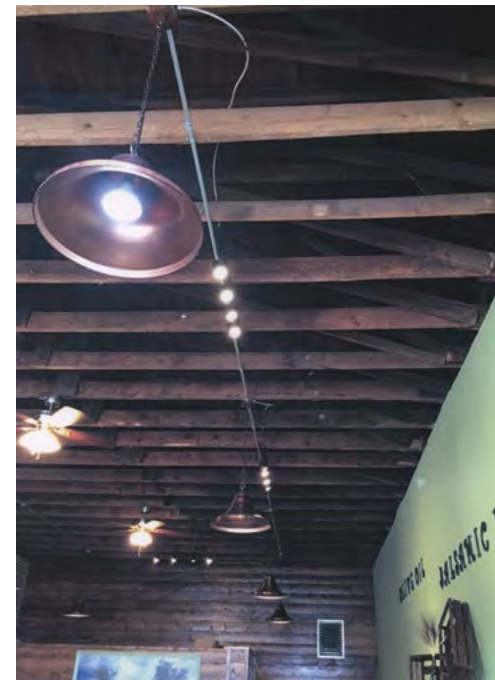
[40] **Not Recommended:**  
Removing a finished ceiling and leaving the structure exposed in a historic retail space does not meet the Standards for Rehabilitation.

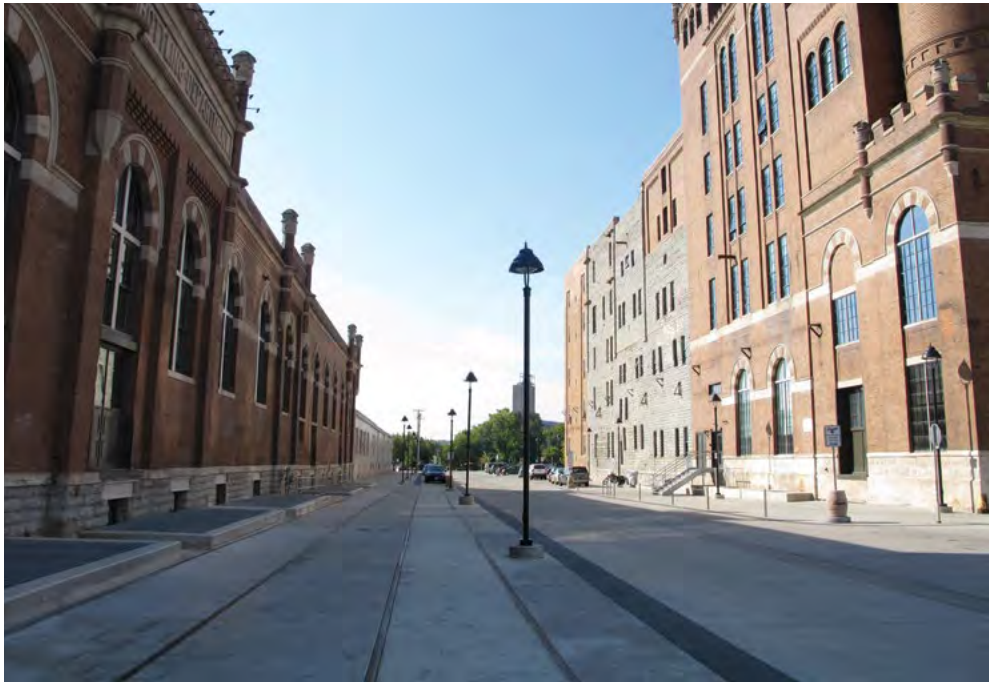
[43] The industrial character of the site was retained when this brewery complex was rehabilitated for residential use.

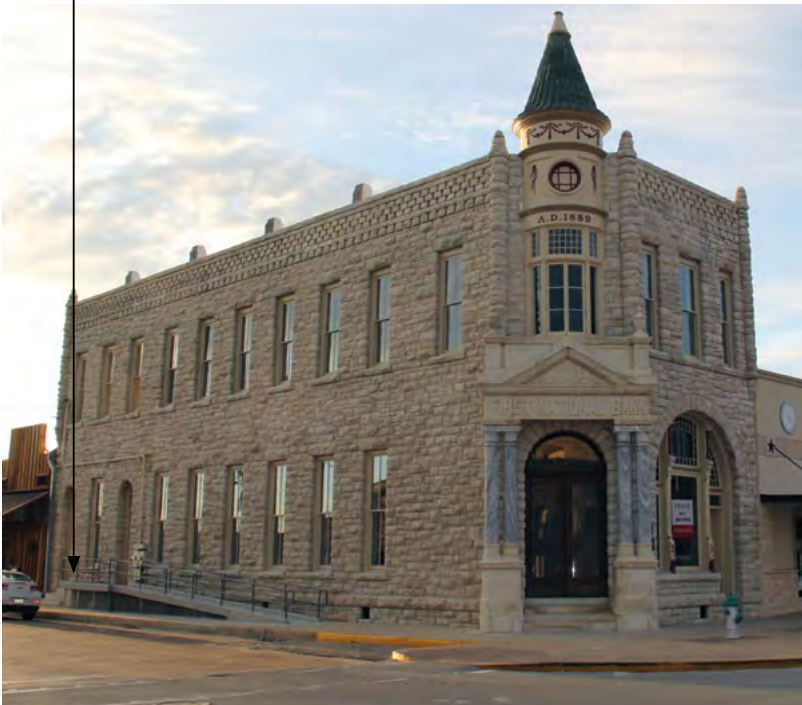
[53] This entrance ramp (right) is compatible with the historic character of this commercial building.

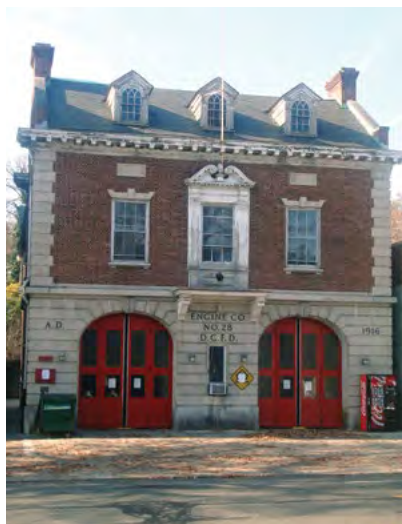
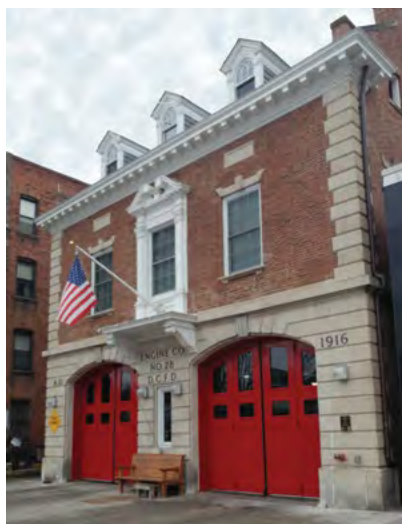
[56 a-b] In order to continue in its historic use, the door openings of this 1916 Colonial Revival-style fire station had to be widened to accommodate the larger size of modern fire trucks. Although this resulted in some change to the arched door surrounds, it is minimal and does not negatively impact the historic character of the building. (a) Above, before; Photo: Fire and Emergency Medical Services Department (FEMS), Washington, D.C.; below, after.

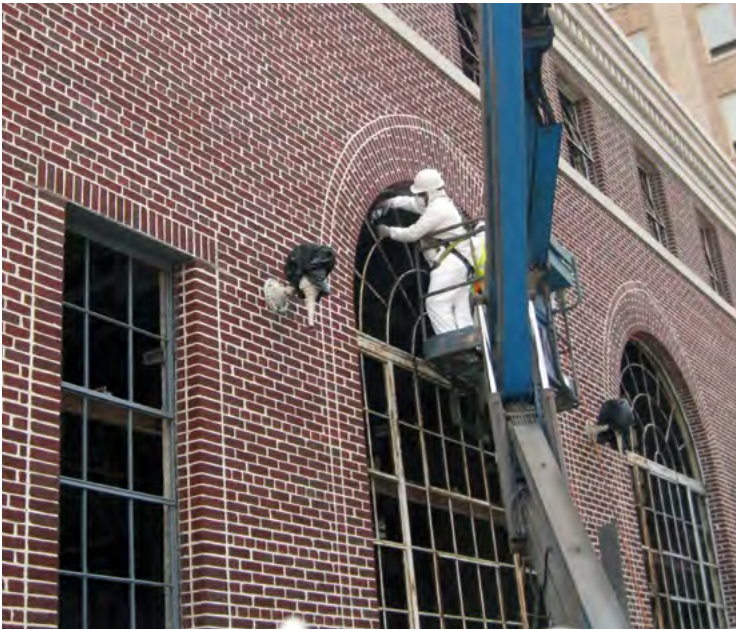
[57] Workers wear protective clothing while removing lead paint from metal features.

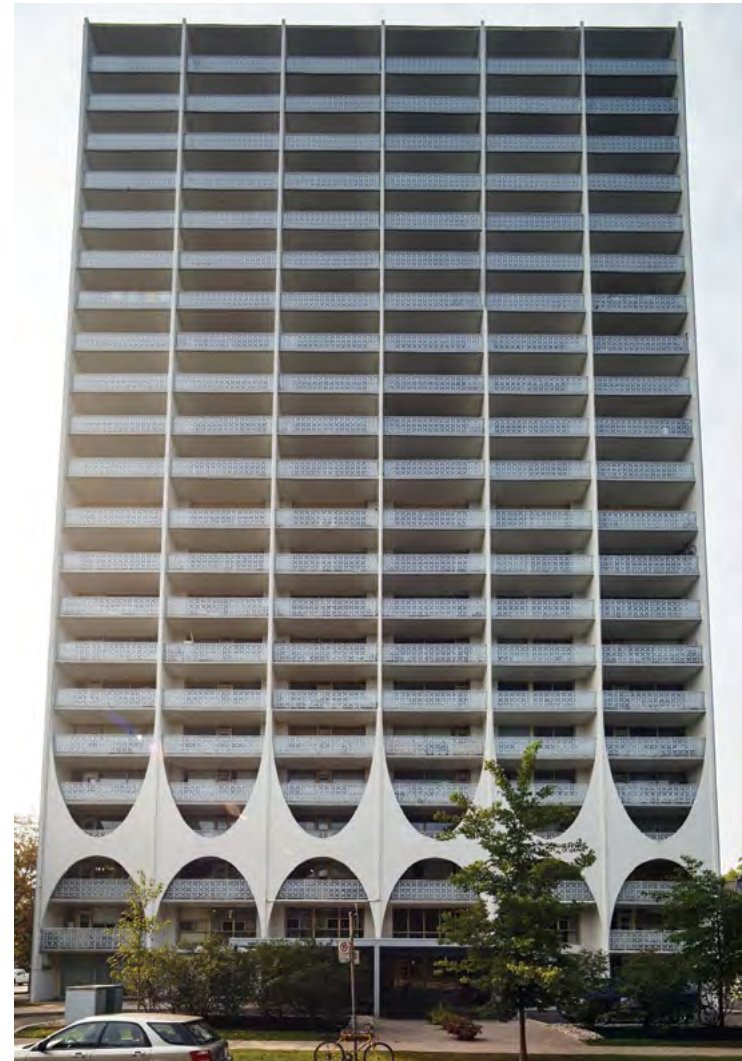
[59] (a-b) The decorative concrete balcony railings on this 1960s building did not meet life-safety code requirements. They were replaced with new glass railings with a fritted glass pattern matching the original design—a creative solution that satisfies codes, while preserving the historic appearance of the building when viewed from the street (c-d). Photos: (a, b, d) ERA Architects, Inc.; (c) Nathan Cyprys, photographer.

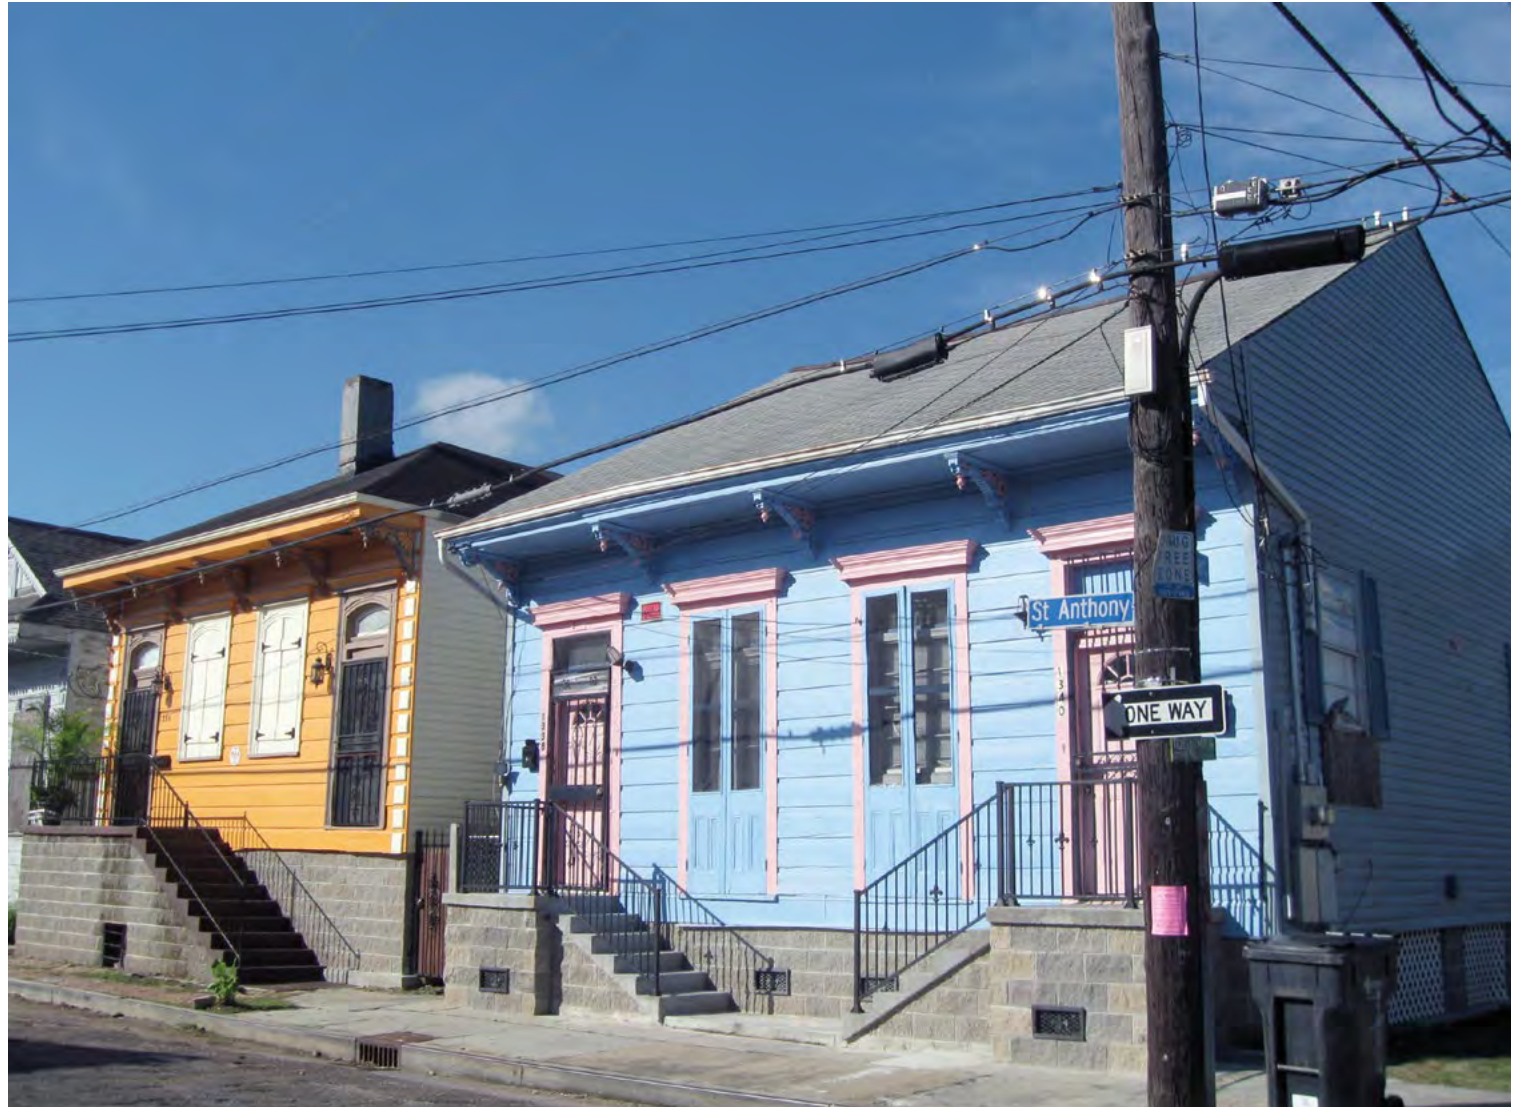
[60] In some instances, it may be necessary to elevate a historic building located in a floodplain to protect it. But this treatment is appropriate only if elevating the building will retain its historic character, including its relationship to the site, and its new height will be compatible with surrounding buildings if in a historic district. The house on the right, which has been raised only slightly, has retained its historic character. The house on the left has been raised several feet higher, resulting in a greater impact on the historic character of the house and the district.

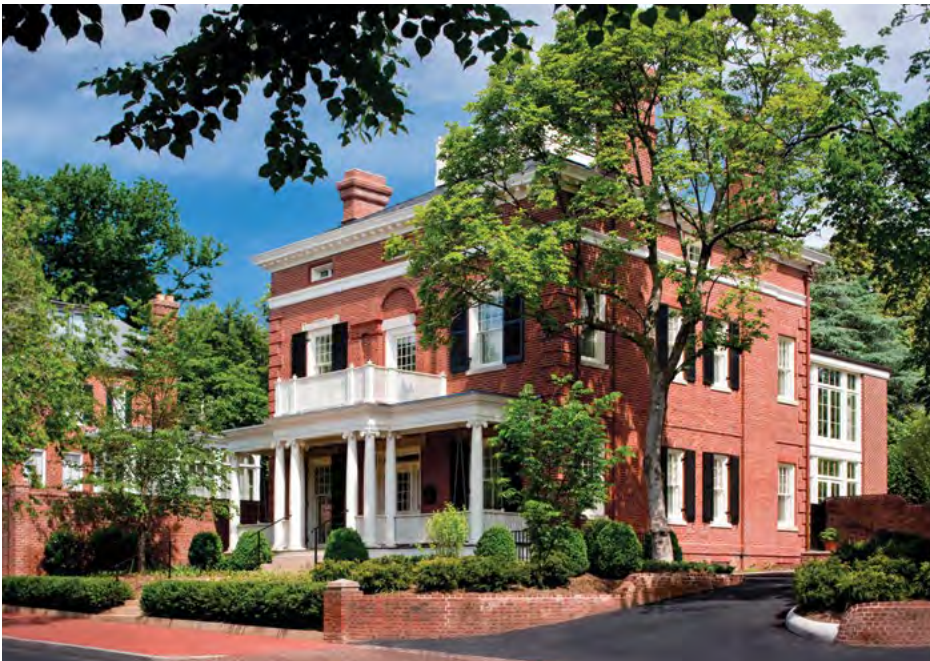
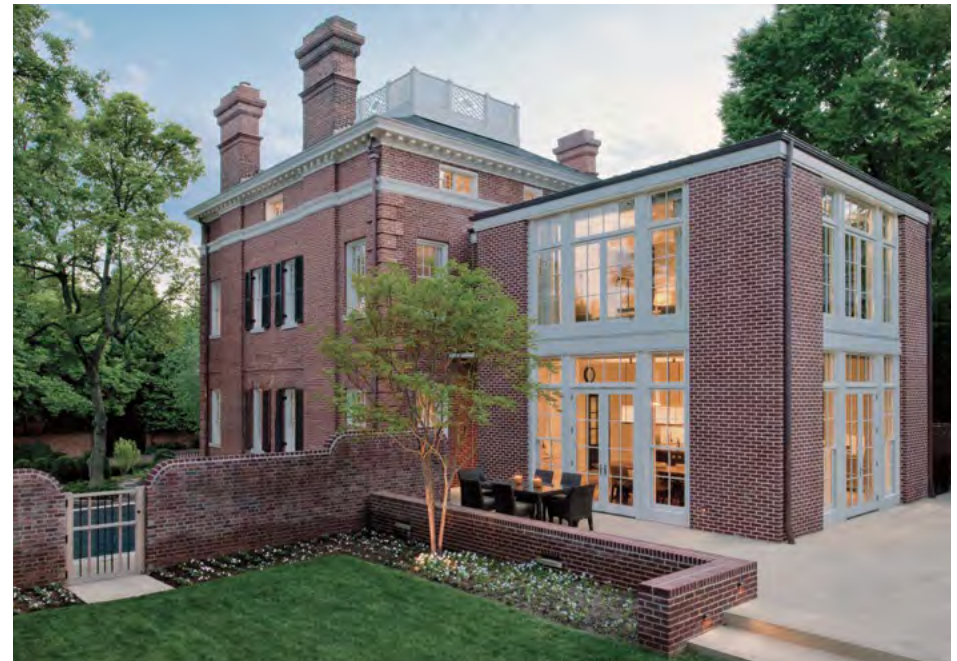
[61 a-b] The materials, design, and location at the back of the historic house are important factors in making this a compatible new addition. Photos: © Maxwell MacKenzie.

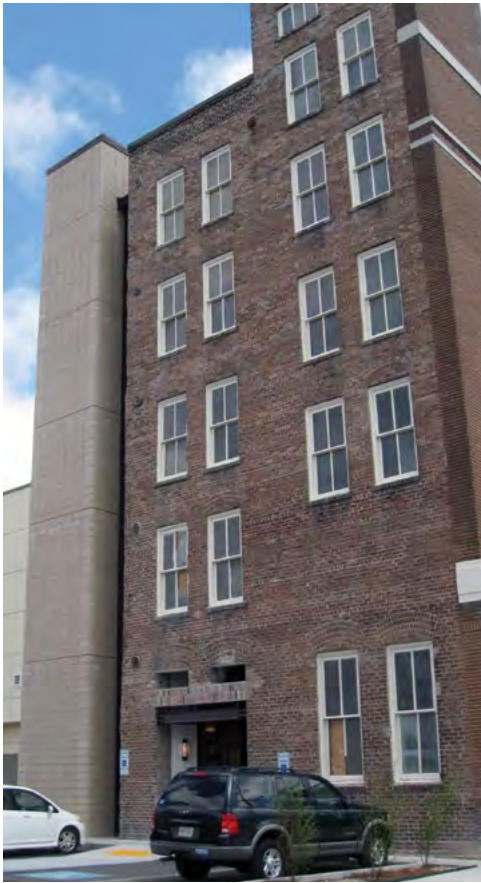
[62] The stair tower at the rear of this commercial building is a compatible new addition.

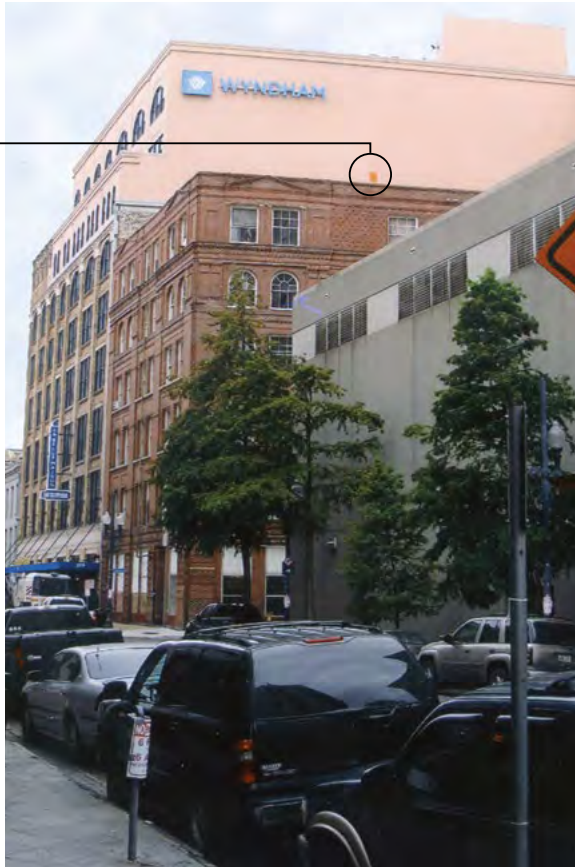
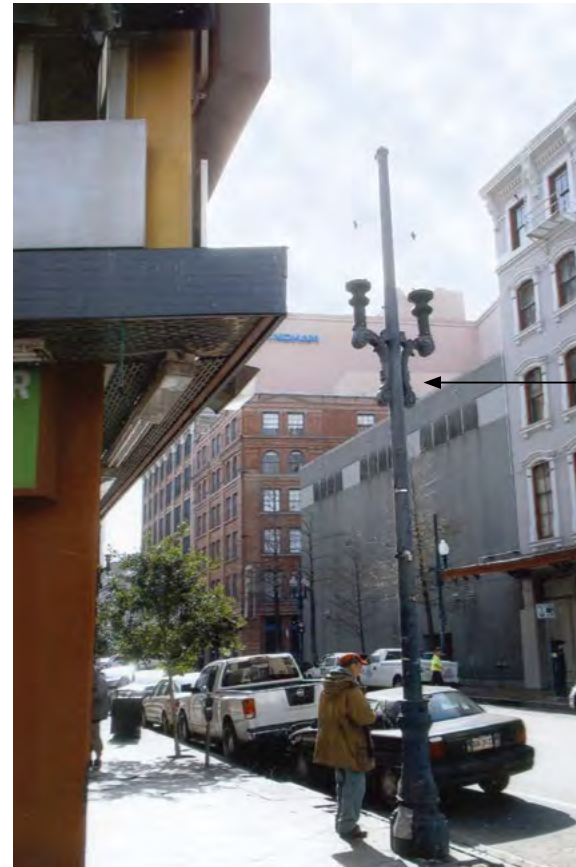
[ 63] (a) A mockup should be erected to demonstrate the visibility of a proposed rooftop addition and its potential impact on the historic building. Based on review of this mockup (orange marker), it was determined that the rooftop addition would meet the Standards (b). The addition is unobtrusive and blends in with the building behind it.

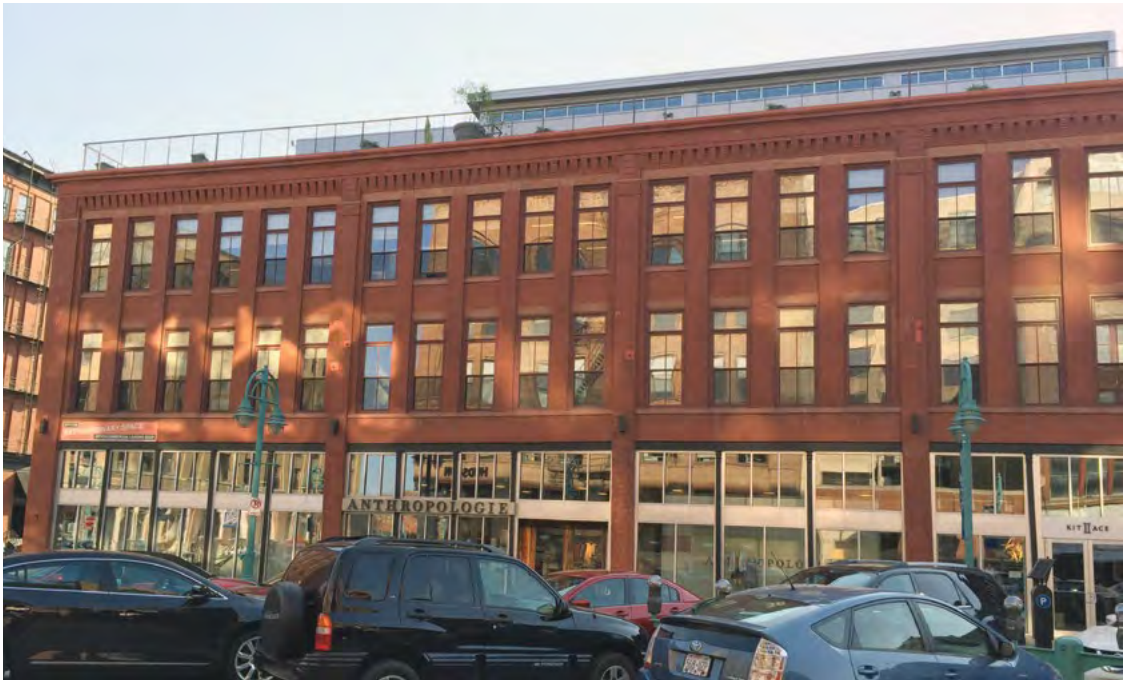
[64] **Not Recommended:**  
It is generally not appropriate to construct a rooftop addition on a low-rise, two- to three-story building such as this, because it negatively affects its historic character.
