## **AGENDA**

Historic Preservation Commission  
Tuesday August 11, 6:00 PM

Northglenn Historic Preservation Commission  
June 9, 2026  
Minutes

The applicant, Travis Glaser, property owner of 9840 Palmer Ln, is requesting Alteration Certificate to remove an enclosed carport with associated room addition, build an addition to the original structure, as well as renovating the original portion of property through window and roofing replacement as shown in Exhibit B. The property owner is proposing two phases to the project. Phase 1 removes all the non-original parts and non-permitted areas of the house. (Note: An unpermitted and dilapidated shed attached to the northern section of the house has already been removed). Phase 2 includes the building of the new addition to include a garage, master bedroom and bathroom in the rear of the property, window and roof replacement.

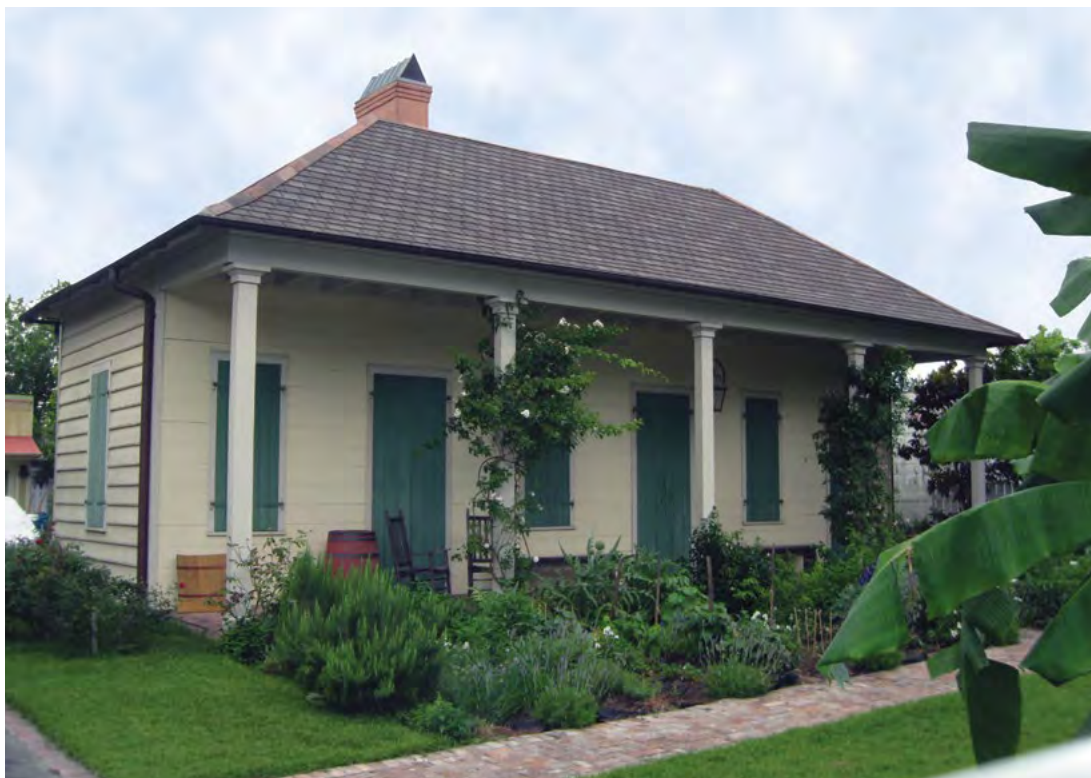
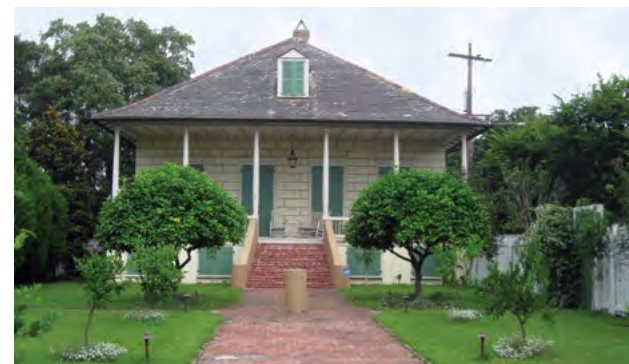
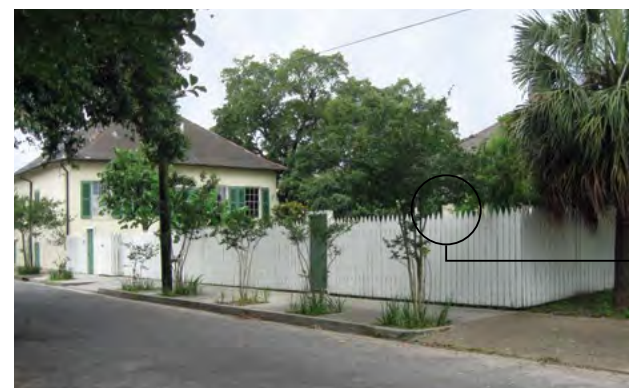
[65] (a) This (far left) is a compatible new outbuilding constructed on the site of a historic plantation house (b). Although traditional in design, it is built of wood to differentiate it from the historic house (which is scored stucco) located at the back of the site so as not to impact the historic house, and minimally visible from the public right-of-way (c).

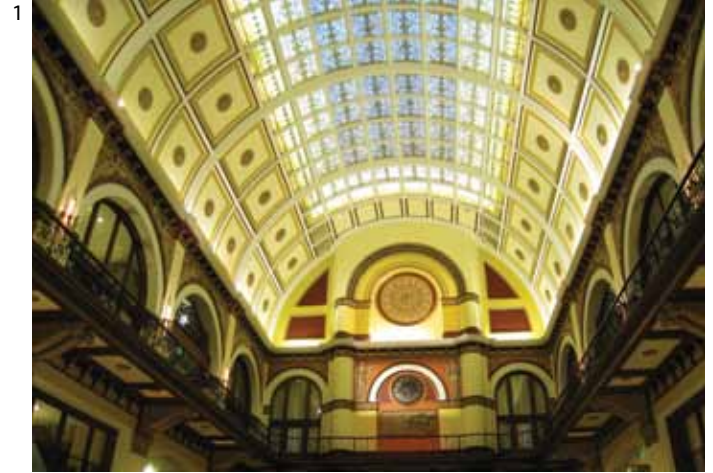
[1] Stained glass skylight provides natural light in a historic train station.

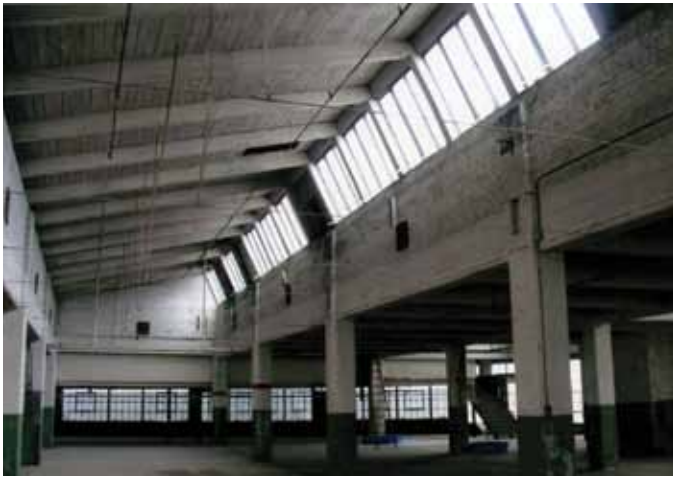
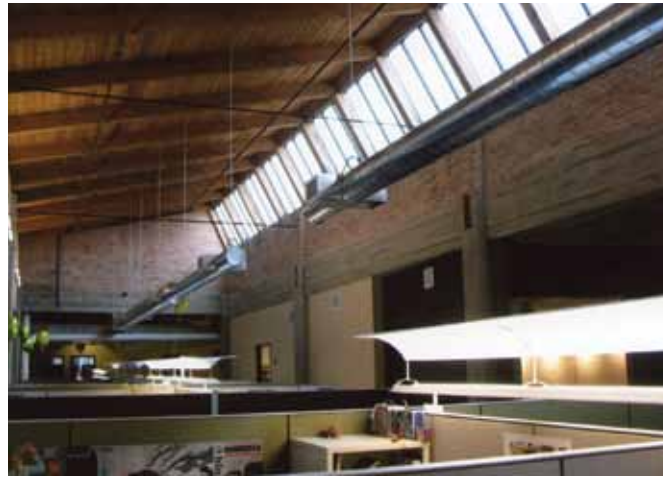
[2-3] Clerestory windows provide natural light in a historic industrial building: Before and after rehabilitation.

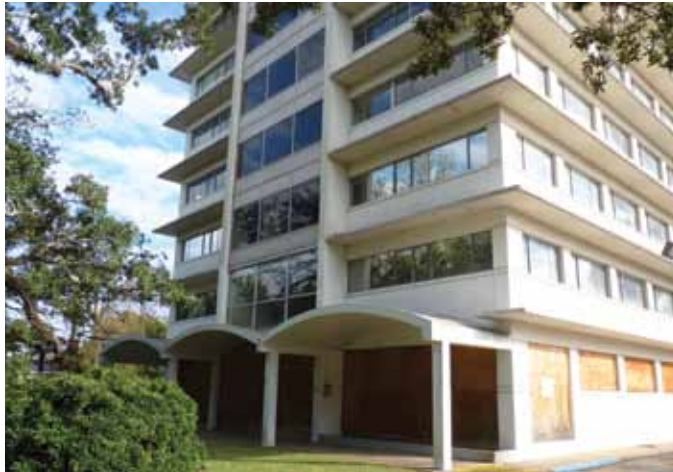
[4] Covered walkways and horizontal sun screens are distinctive and sustainable features in some mid-century modern office buildings.

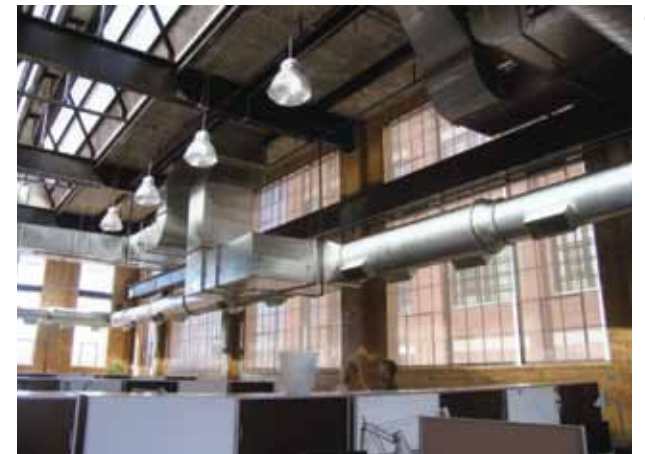
[5-6] Large windows and a roof monitor provide natural illumination in a historic industrial building.

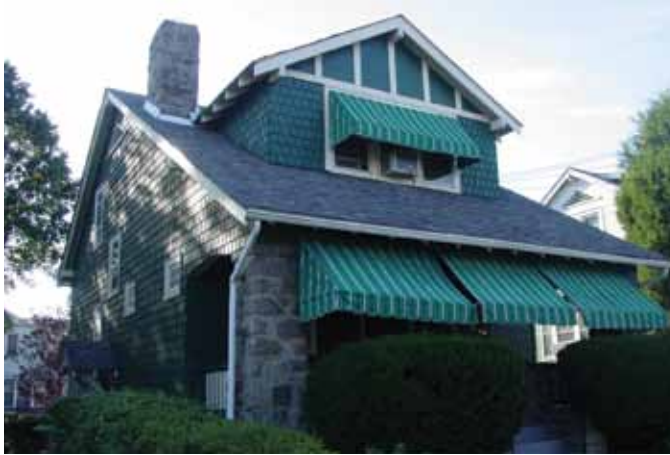
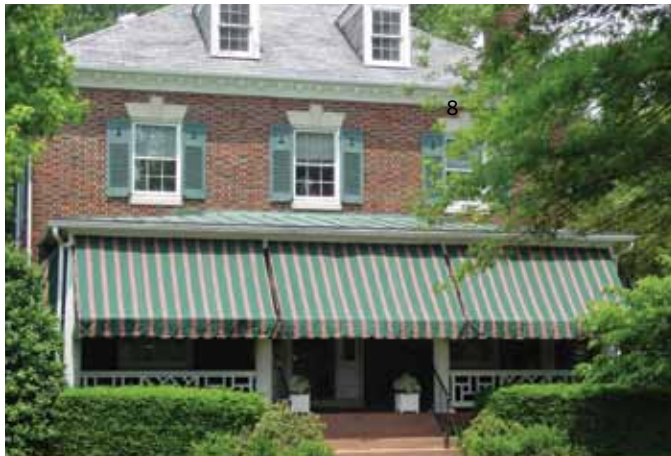
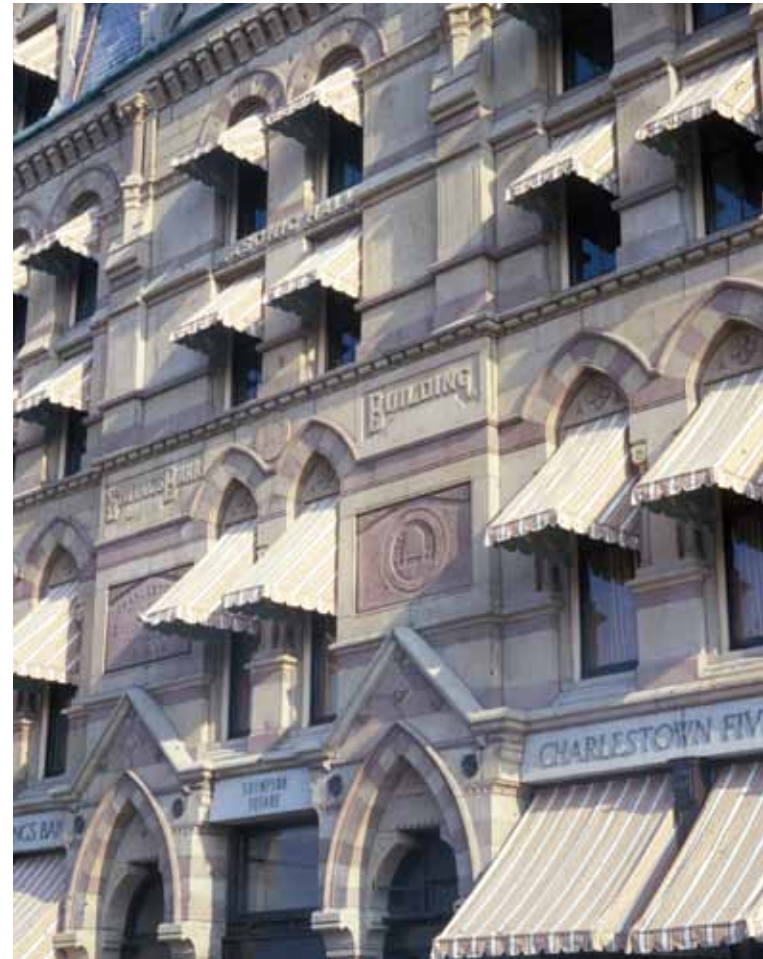
[7-9] Porches and canvas awnings provide shade and keep interiors cool in historic residential and commercial buildings.

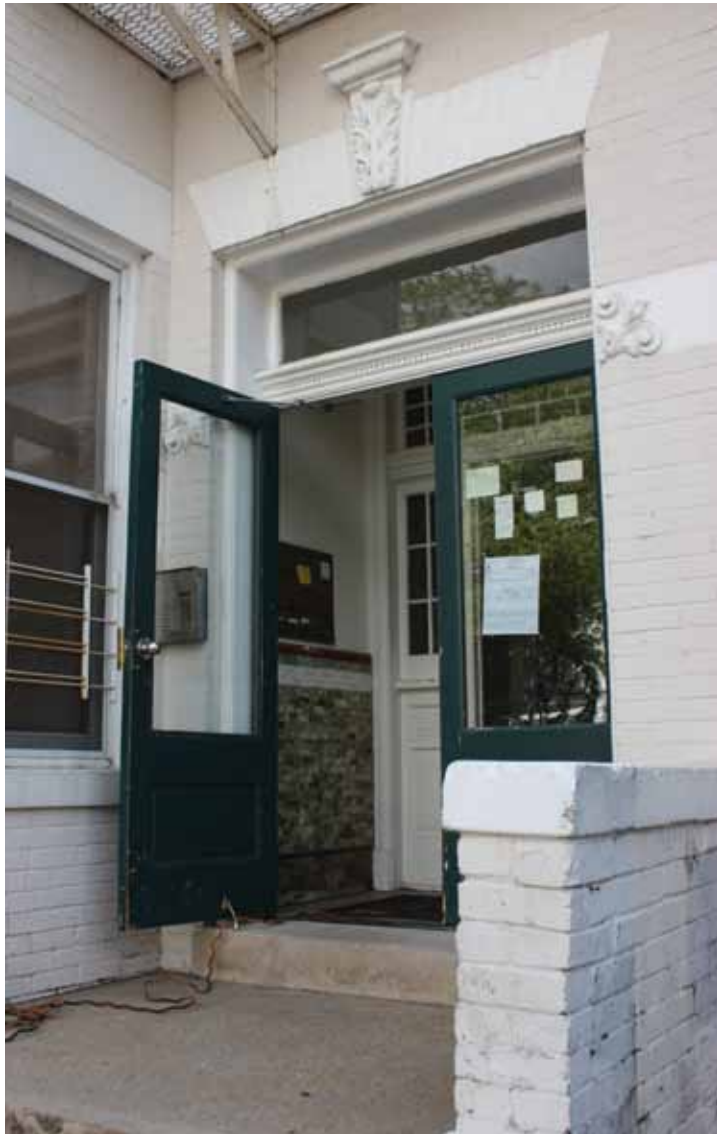
11

[11] A vestibule helps retain interior conditioned air in the living space in this historic row house.

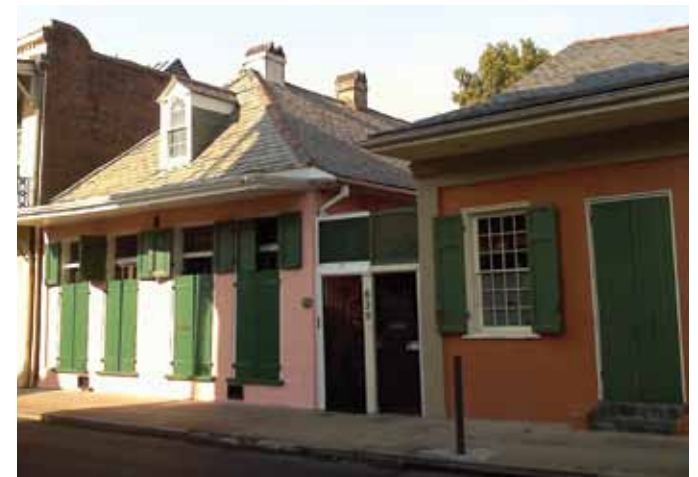
10

[10] Wood shutters provide natural light when open and keep interiors cool when closed in historic residential buildings.

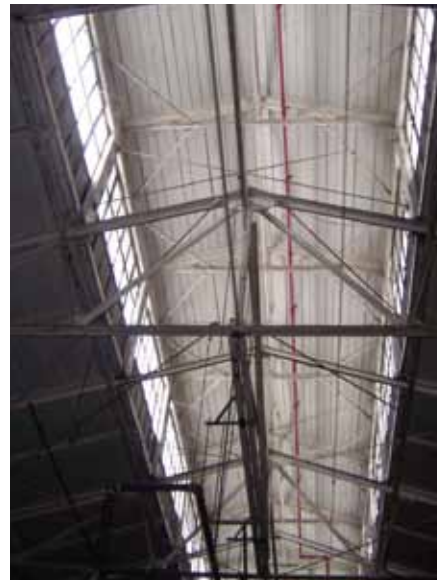
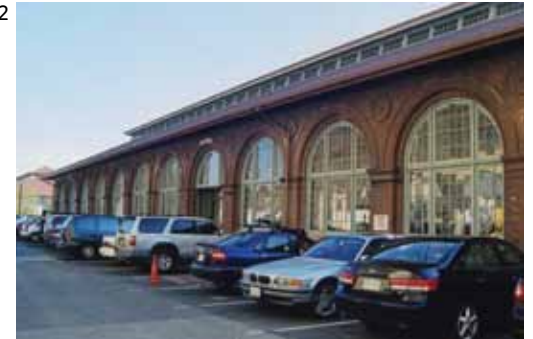
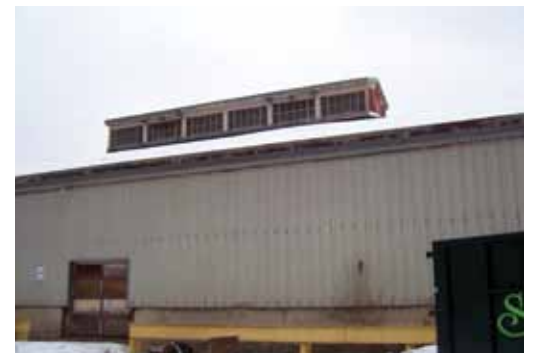
[12-14] Roof monitors provide natural light in historic industrial buildings

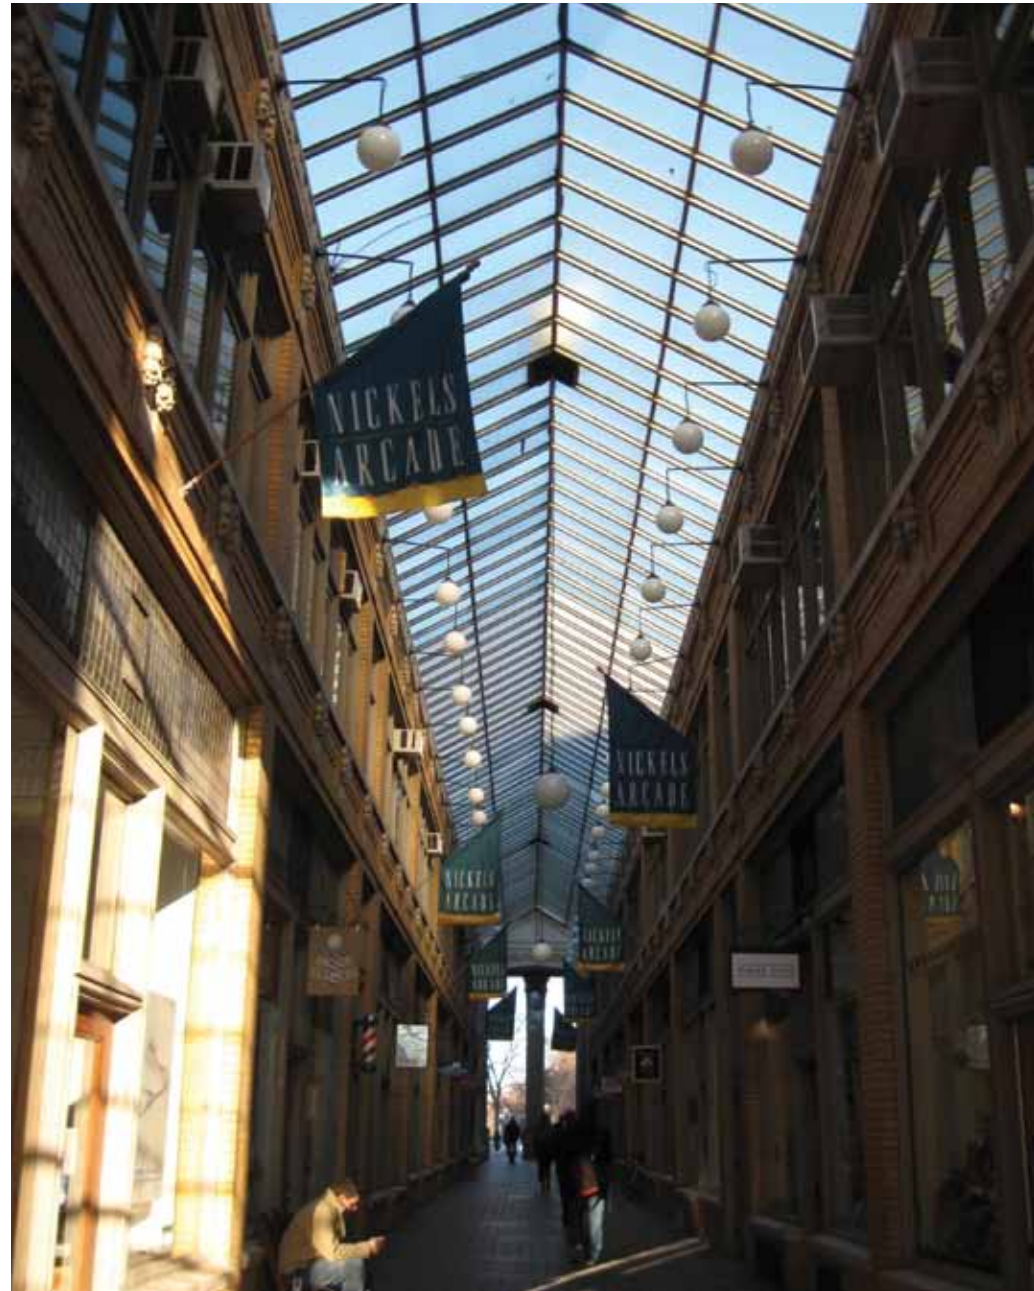
[15] Glass skylight illuminates historic shopping arcade.

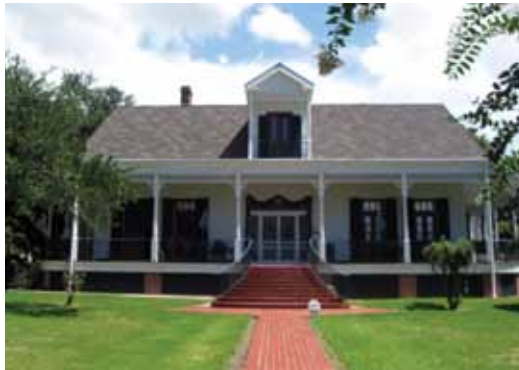
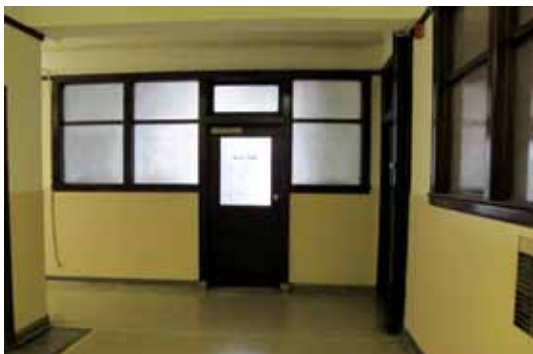
[16-18] Inherently sustainable features of historic buildings: Shutters and a deep porch keep the interior cool in a historic house in a warm climate (top); a skylight provides natural light to the interior of this mid-20th century house (center); partially glazed partitions and doors allow natural light into the corridor of a historic office building (bottom).

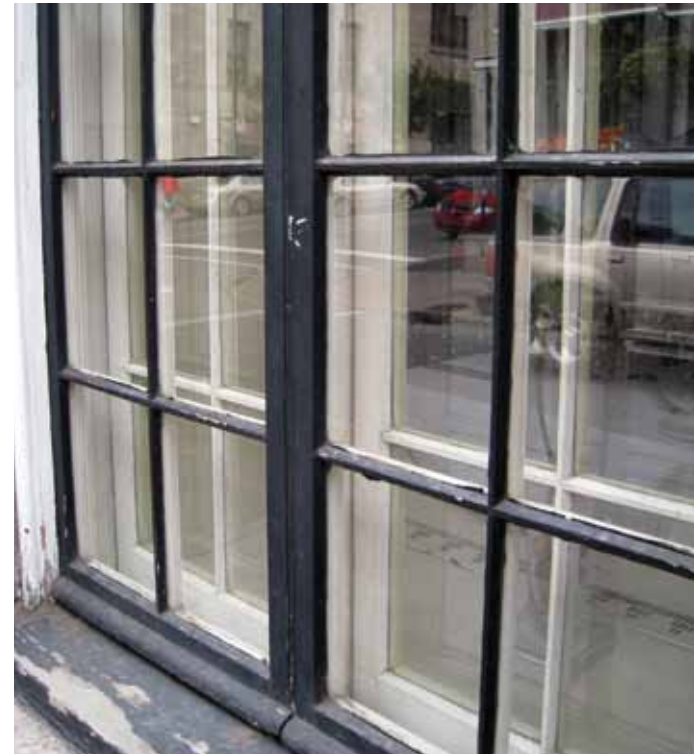
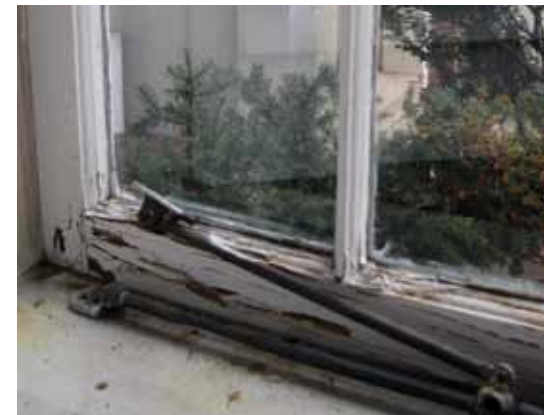
**Not Recommended:** [21-22] The peeling paint on an exterior window sill and on the interior of a window indicates that these features have not received regular maintenance. The broken casement window hardware also needs to be repaired to make the window operable.

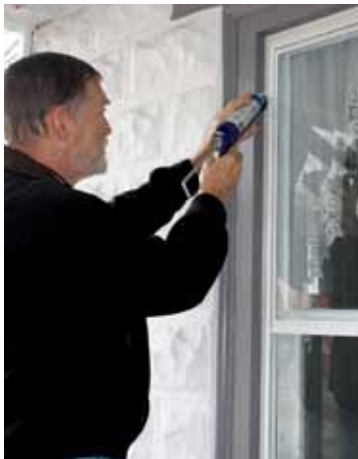
**Recommended:** [19] Caulking the gap between the aluminum storm window and wood window frame helps maximize thermal efficiency in this historic residence.

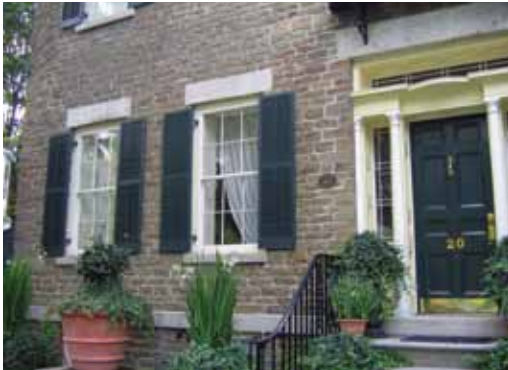
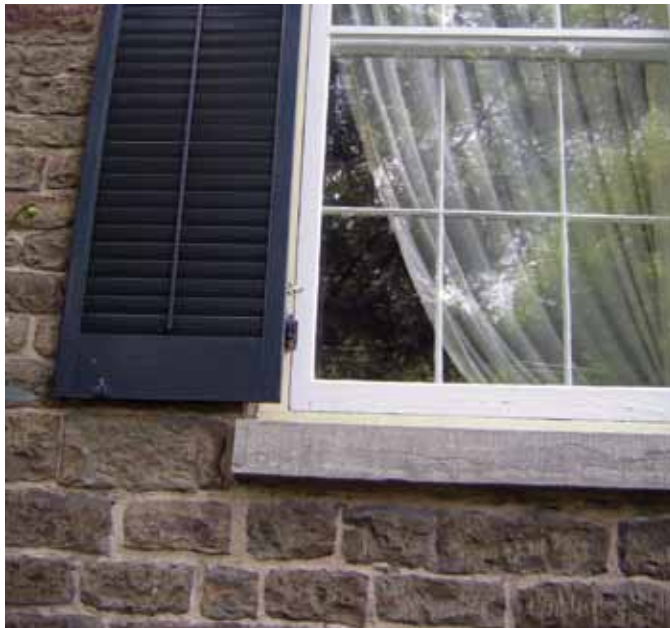
**Recommended:** [23-25] Historic exterior storm windows have been well maintained and continue to perform as intended.

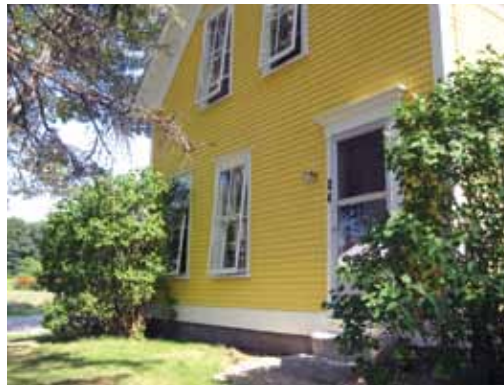
**Not Recommended:** [27] A broken sash cord can be repaired easily and does not justify replacement of the window.

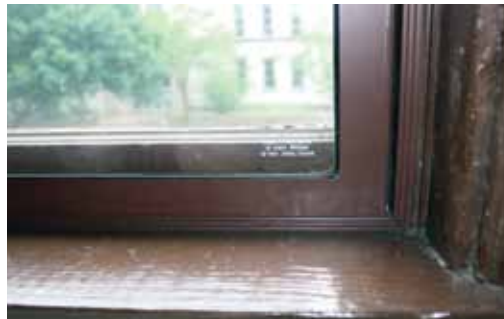
**Recommended:** [26] The new metal interior storm window was carefully matched to the exterior window as part of the rehabilitation of this historic armory building.

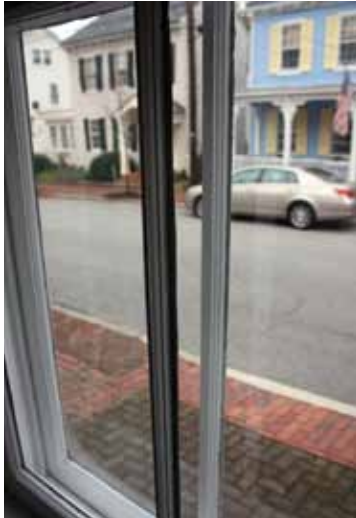
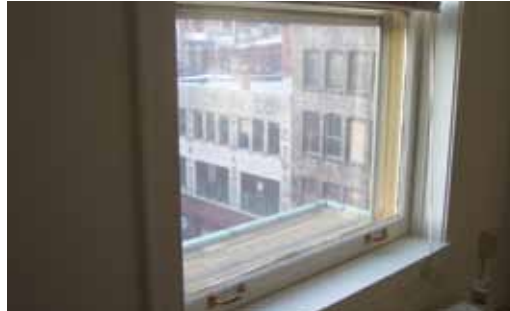
**Recommended:** [28-29]  
These exterior storm windows match the pane configuration of the historic interior windows in a residence and in a multi-story hotel building.

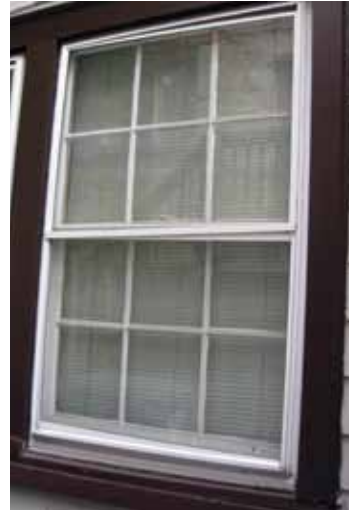
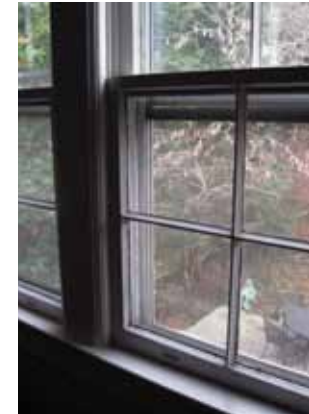
**Not Recommended:** [31-32]  
Ill-fitting exterior aluminum storm windows viewed from both inside and outside are clearly not energy efficient.

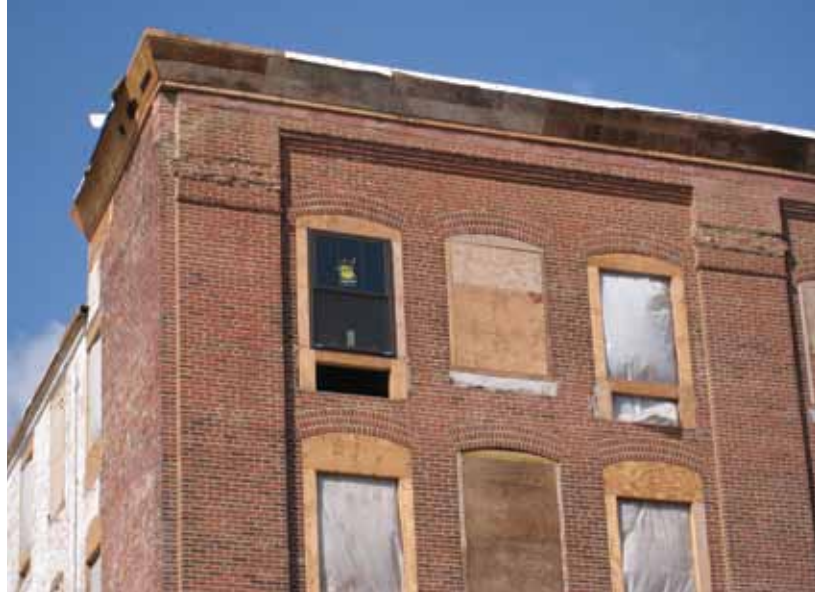
30

**Not Recommended:** [30] Not only have incompatible windows that do not fit the size and shape of the historic window openings been installed, but the original openings have also been shortened to install through-the-wall HVAC units.

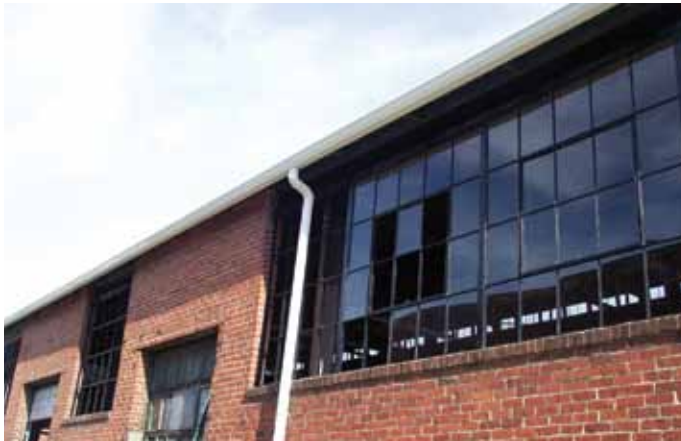
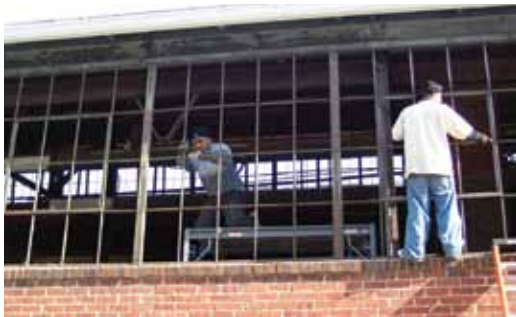
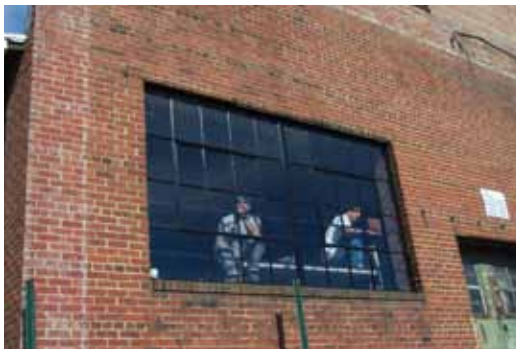
**Recommended:** [33-35] Original metal windows were appropriately repaired as part of the rehabilitation of this historic industrial building.

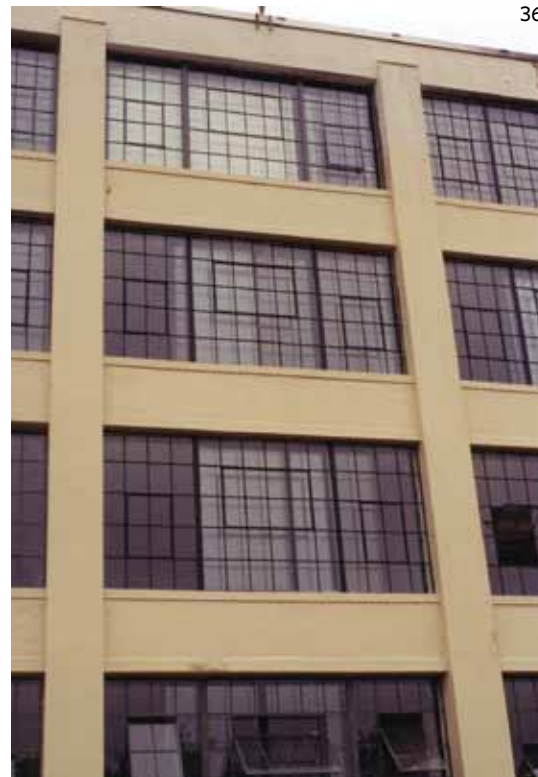
**Recommended:** [36-38] Original metal windows were retained and made operable during the rehabilitation of this historic mill complex. Installing patio slider doors as interior storm windows was a creative and successful solution to improve the energy efficiency of the existing windows.

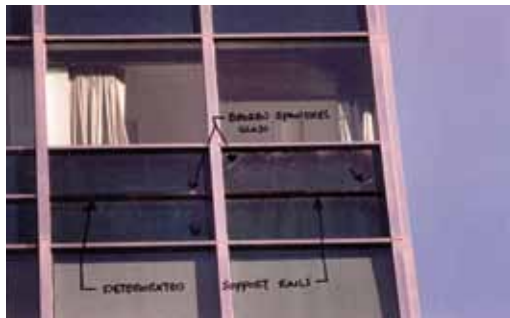
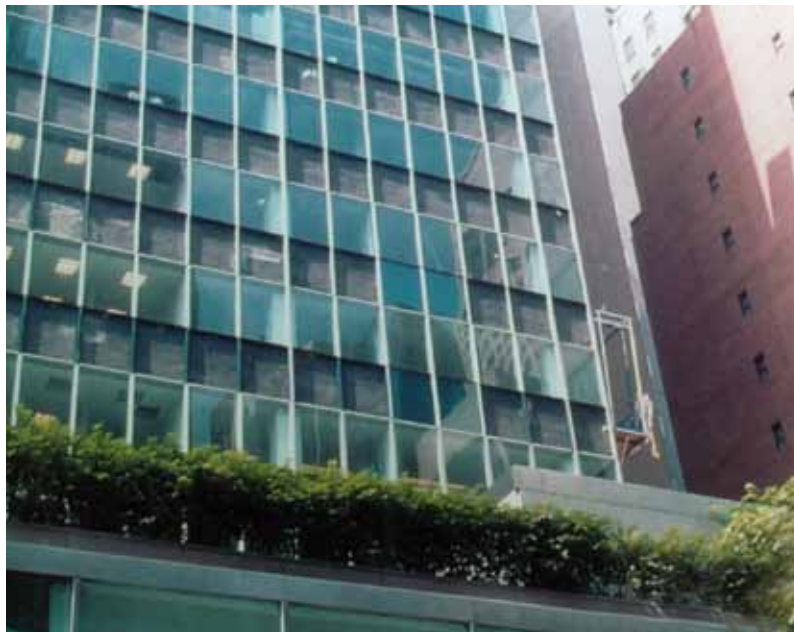
**Recommended:** [39-40]  
The original windows, which were deteriorated beyond repair, featured a dark tint. They were replaced with a slightly lighter-tinted glazing to improve daylighting in this mid-century modern office building.

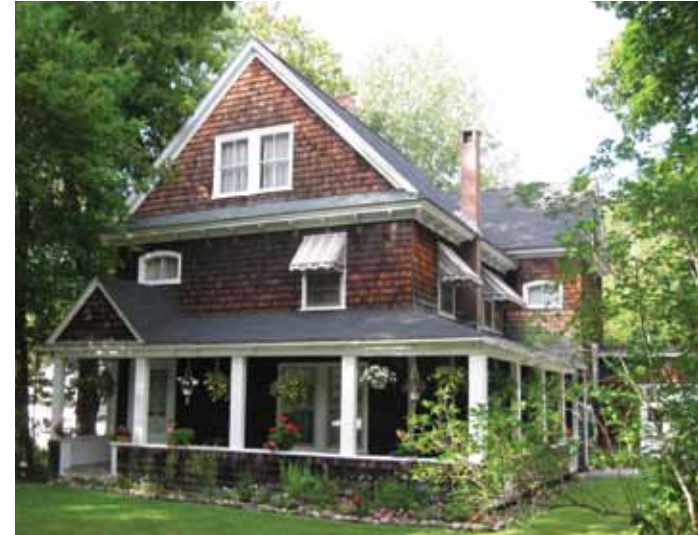
41

**Recommended:** [41] Traditional canvas awnings should be retained when they exist on historic buildings.

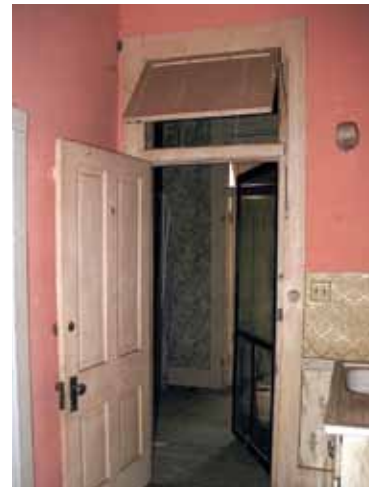
**Recommended:** [42] Transoms and screen doors are distinctive and practical features that provided cross ventilation in this historic hotel.

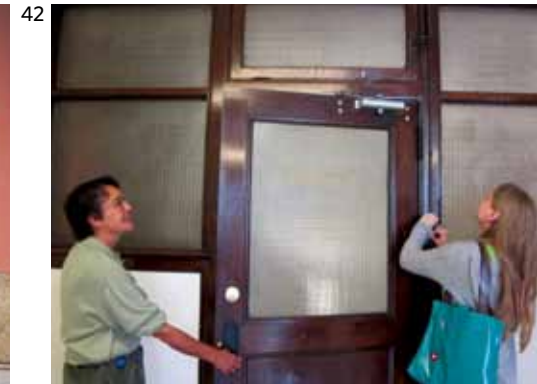
43

**Recommended:** [43] The wall and door glazing ensures that the corridor receives natural daylight and the operable transom helps air to circulate in this historic office building.

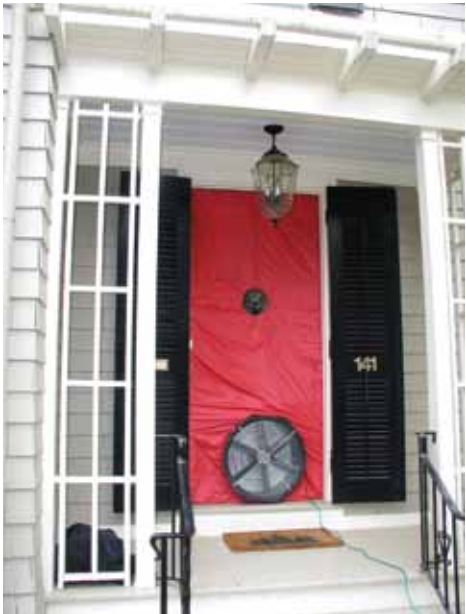
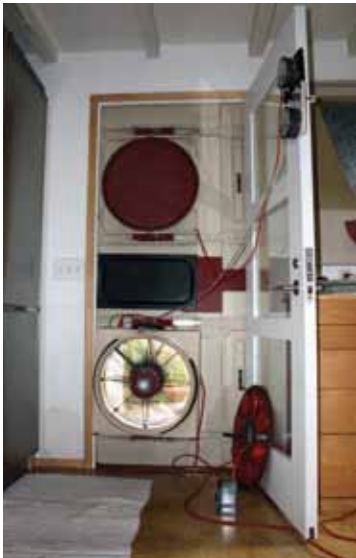
**Recommended:**  
[44-45] A blower door test is a useful tool to help identify air infiltration in a historic building before undertaking weatherization or retrofit treatments.  
*Top Photo: Robert J. Cagnetta, Heritage Restoration, Inc.*

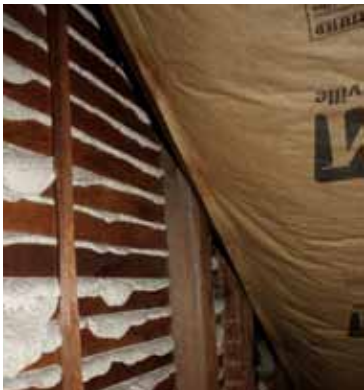
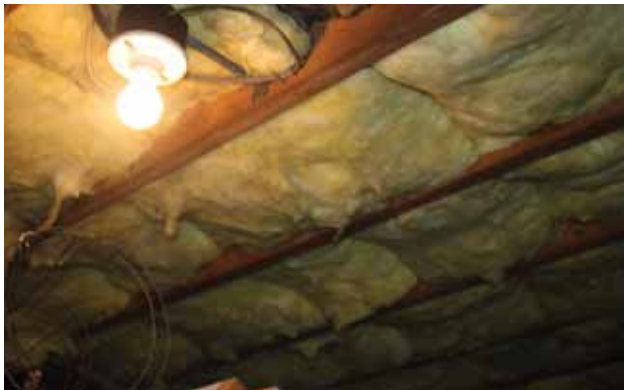
**Recommended:** [47-48] Insulation should be installed first in unfinished areas such as attics, crawl spaces and basements of residential buildings.

| RECOMMENDED | NOT RECOMMENDED |
|---|---|
| Insulating unfinished spaces, such as attics, basements and crawl spaces, first. | Insulating a finished space, which requires removing historic plaster and trim, before insulating unfinished spaces. |

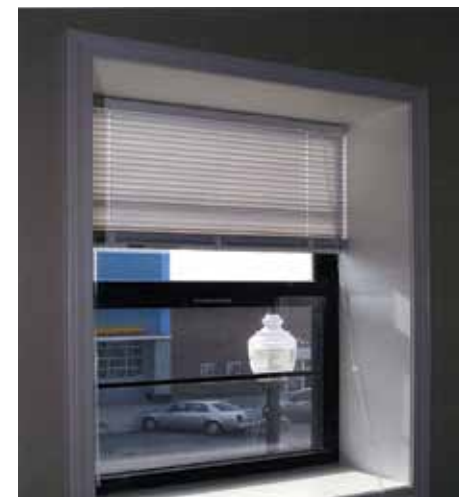
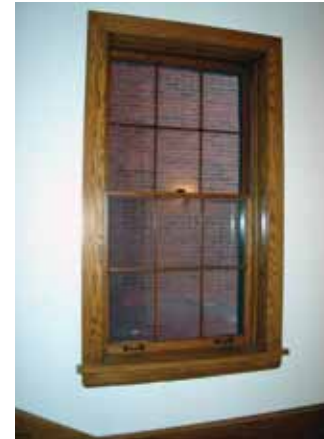
[50-51] When wall insulation was installed here the walls were furred out, which created deep, historically inappropriate window recesses. The repairable historic trim was also not reinstalled.

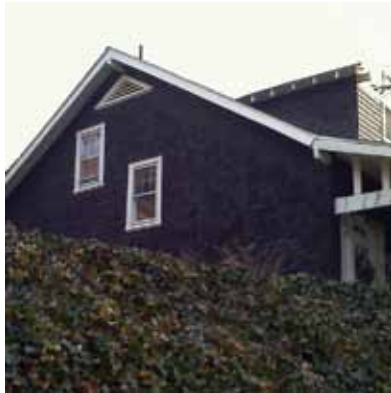
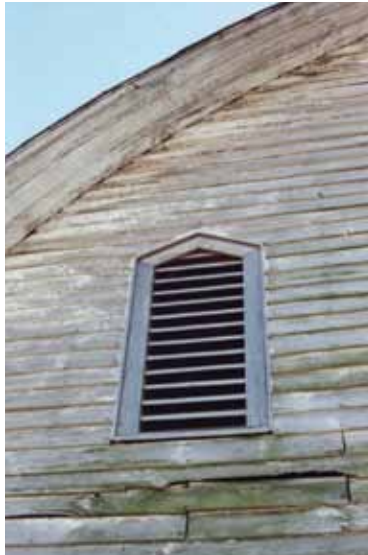
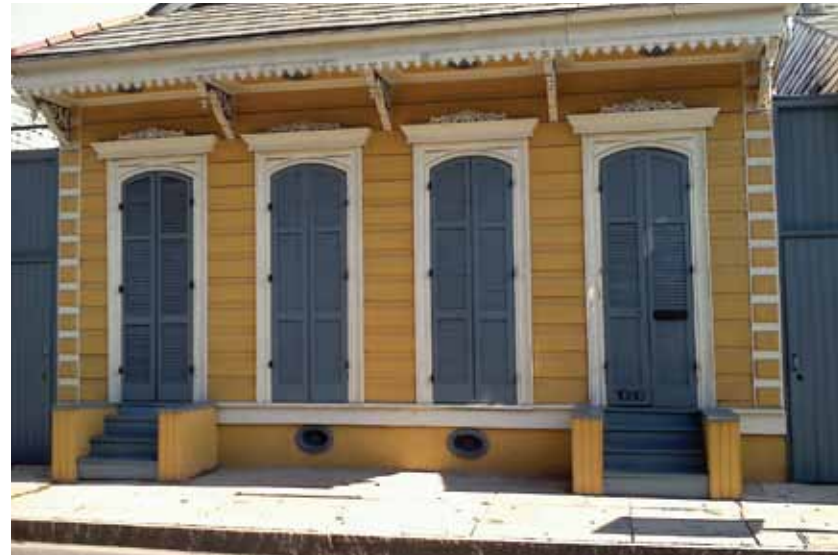
**Recommended:** [55-57]  
Wood vents in the gable ends of a historic house and a barn and cast-iron oval vents in a masonry foundation traditionally helped air circulate.

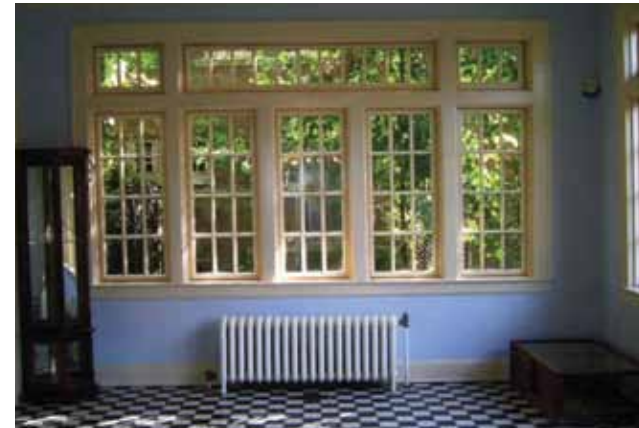
60

**Recommended:** [60] Original radiators that are still functional and efficient were retained in the rehabilitation of this historic house.

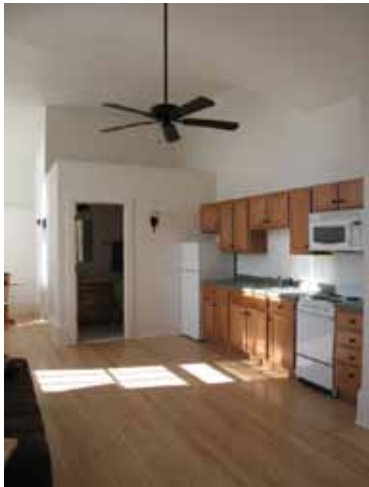
**Recommended:** [58] Ceiling fans enhance the efficiency of HVAC systems in historic buildings.

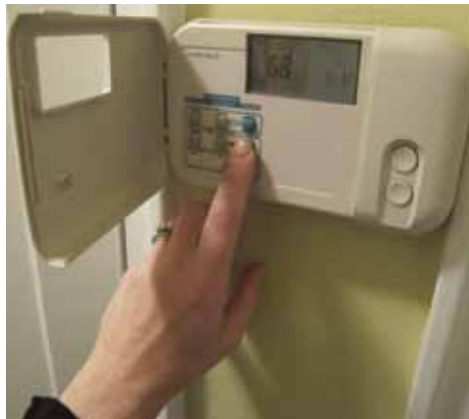
**Recommended:** [59] Installing a programmable thermostat can help existing systems to operate more efficiently.

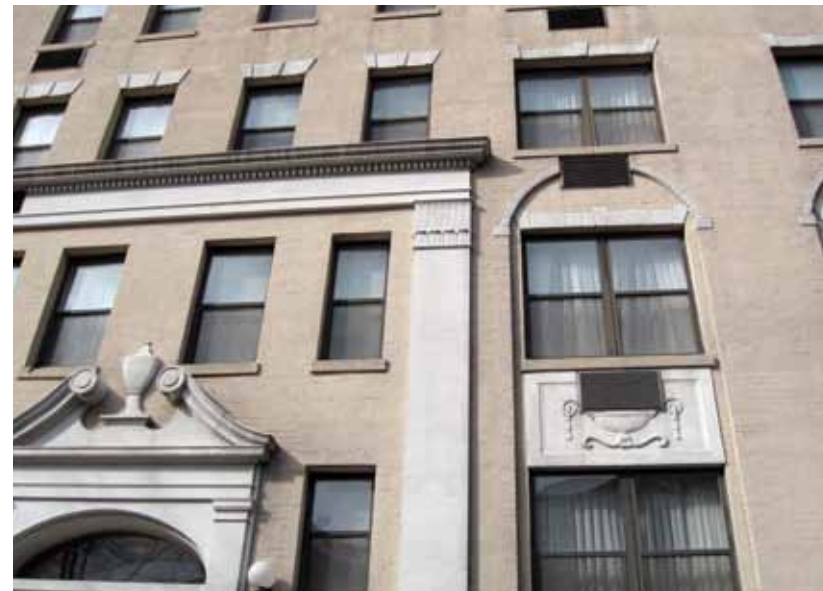
61

**Not Recommended:** [61] The cuts made in the brick and the decorative stone trim to install through-the-wall air conditioners have not only destroyed building material, but have also negatively impacted the character of this historic apartment building.

| Retaining or installing high efficiency, ductless air conditioners when appropriate, which may be a more sensitive approach than installing a new, ducted, central air-conditioning system that may damage historic building material. | Installing through-the-wall air conditioners, which damages historic material and negatively impacts the building's historic character. |

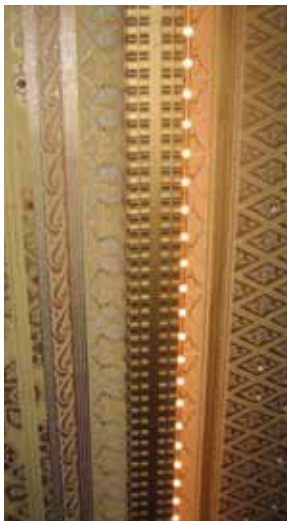
64

[64] The ductwork has been left unpainted which is compatible with this historic industrial interior.

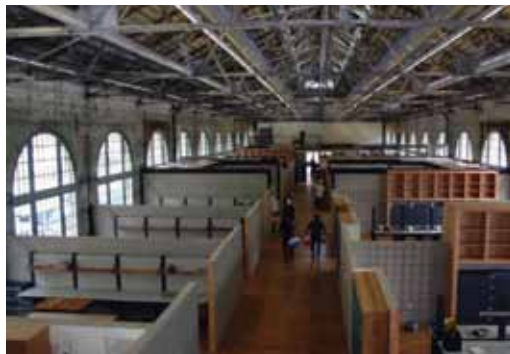
[65] To avoid damaging the metal ceiling, the ductwork was left exposed and it was painted to minimize its impact, thus preserving the historic character of this former bank.

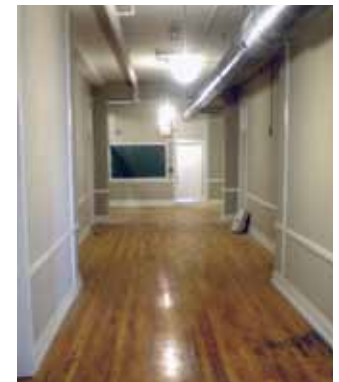
66

**Not Recommended:** [66] Interior ductwork has been inappropriately left exposed and unpainted here in this traditionally-finished school entrance hall.

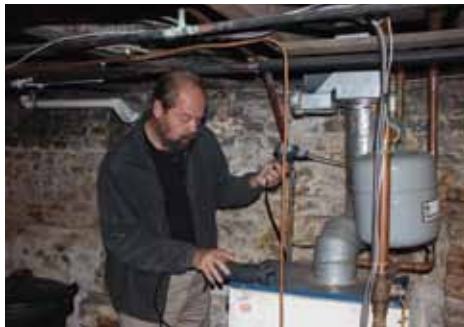
67

**Recommended:**[67] A professional energy auditor analyzes the performance of an existing furnace to ensure it is operating efficiently.

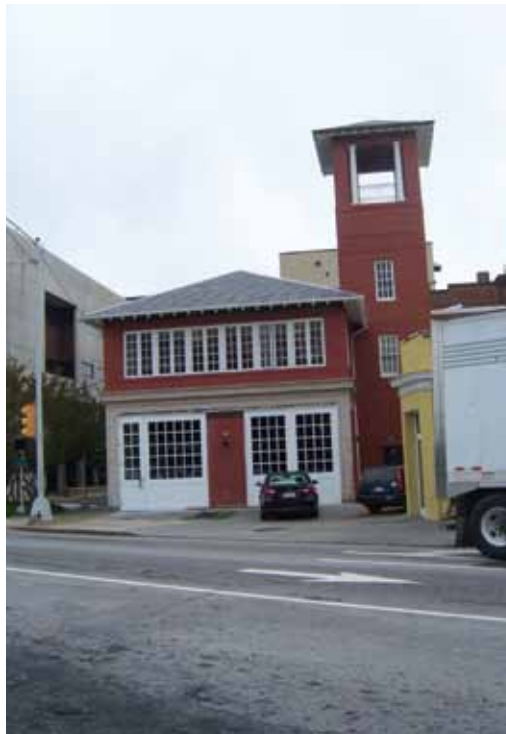
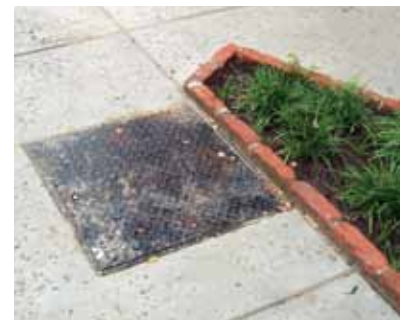
[68-69] A geothermal system, evidenced by a panel in the sidewalk, was installed on the site of this historic firehouse during rehabilitation.

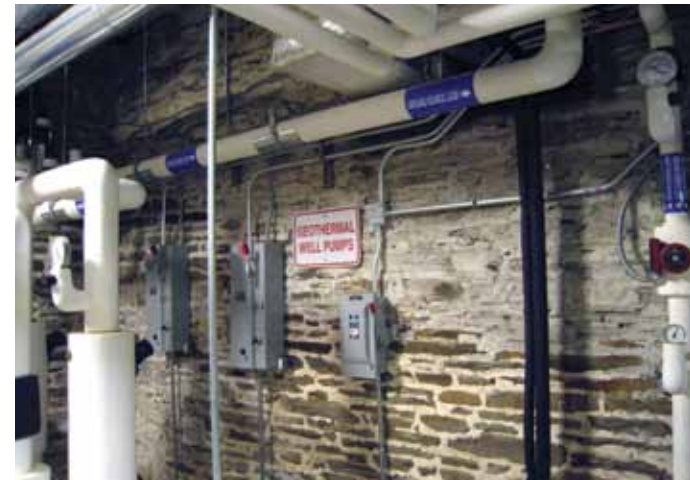
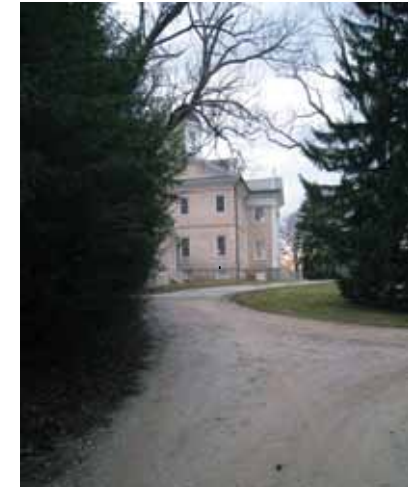
**Recommended:** [70-71]  
A geothermal system was installed on the property of this historic mansion, but only after an archeological investigation was conducted of the grounds.

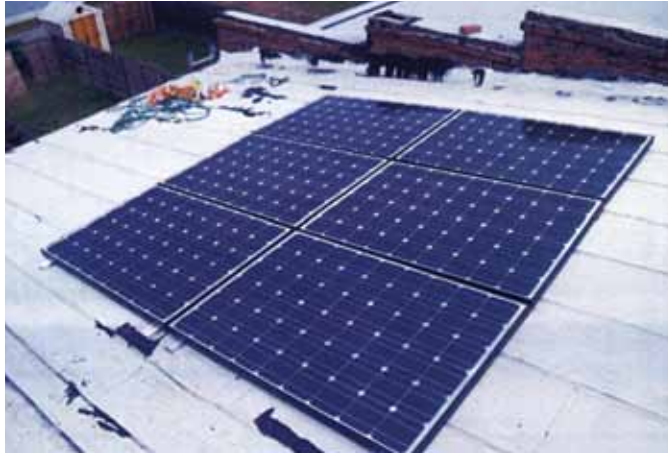
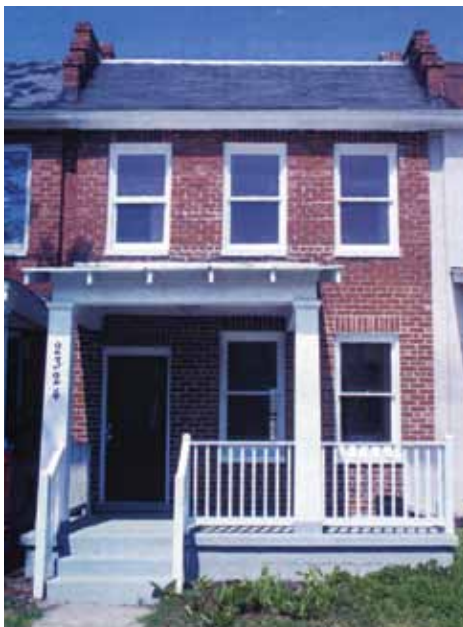
**Recommended:** [72-73] Solar panels were installed appropriately on the rear portion of the roof on this historic row house that are not visible from the primary elevation.

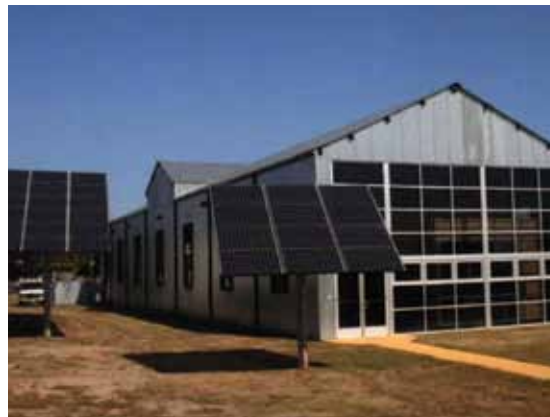
74

**Recommended:** [74] Free-standing solar panels have been installed here that are visible but appropriately located at the rear of the property and compatible with the character of this industrial site.

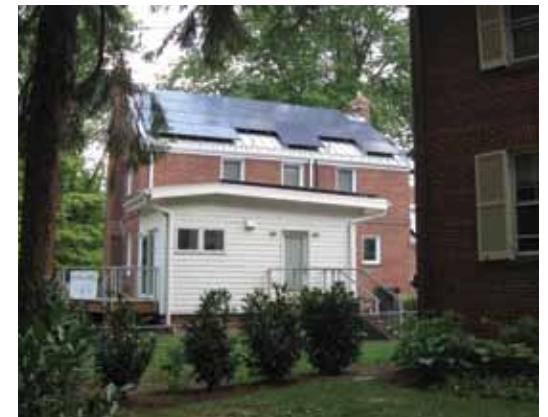
75

**Not Recommended:** [75] Solar roof panels have been installed at the rear, but because the house is situated on a corner, they are highly visible and negatively impact the character of the historic property.

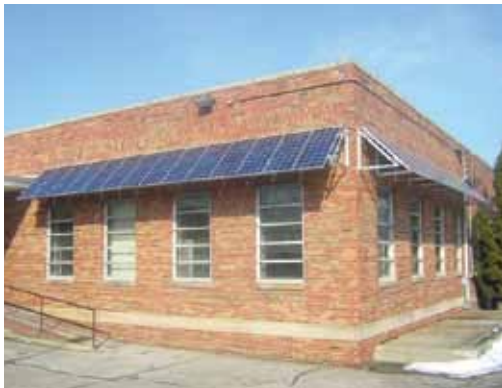
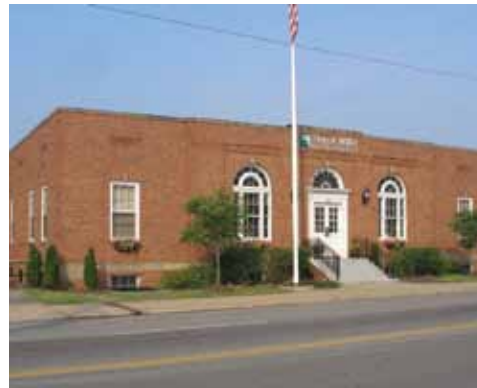
**Recommended:** [76-77] Solar panels, which also serve as awnings, were installed in secondary locations on the side and rear of this historic post office and cannot be seen from the front of the building. [78] Solar panels placed horizontally on the roof of this historic building are not visible from below.

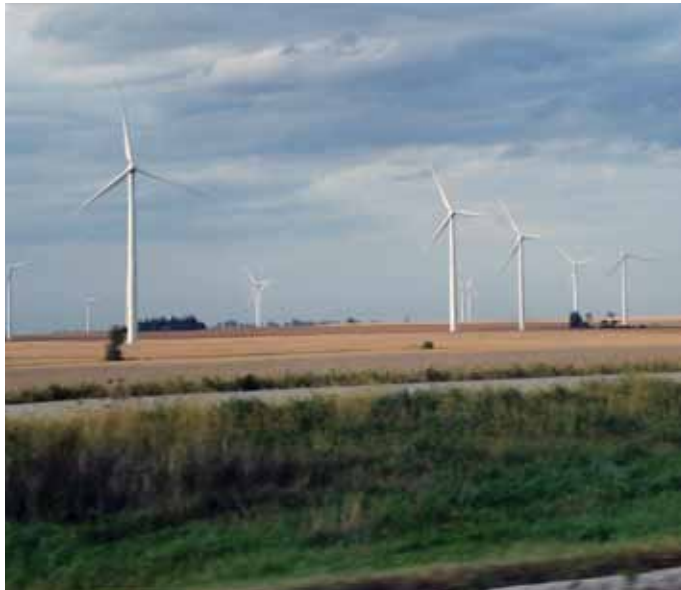
80

**Recommended:** [80] It is often best to install wind-powered equipment in off-site, rural locations to avoid negatively impacting a historic building and its site.

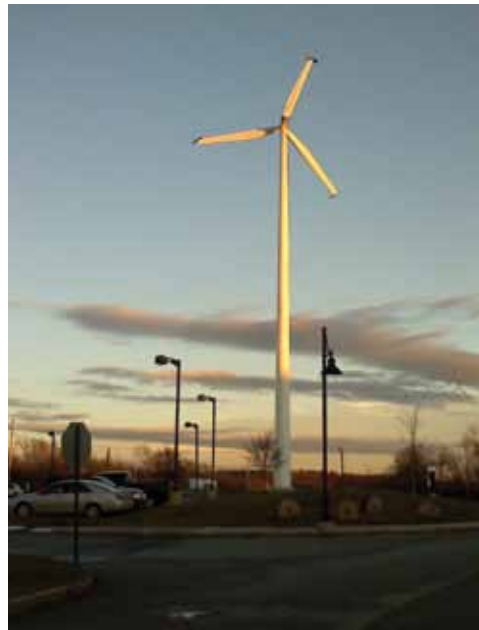
81

[81] This wind turbine is located in a large parking lot next to a historic manufacturing complex and it is compatible with the character of the industrial site.
