## **AGENDA**

Historic Preservation Commission  
Tuesday August 11, 6:00 PM

Northglenn Historic Preservation Commission  
June 9, 2026  
Minutes

The applicant, Travis Glaser, property owner of 9840 Palmer Ln, is requesting Alteration Certificate to remove an enclosed carport with associated room addition, build an addition to the original structure, as well as renovating the original portion of property through window and roofing replacement as shown in Exhibit B. The property owner is proposing two phases to the project. Phase 1 removes all the non-original parts and non-permitted areas of the house. (Note: An unpermitted and dilapidated shed attached to the northern section of the house has already been removed). Phase 2 includes the building of the new addition to include a garage, master bedroom and bathroom in the rear of the property, window and roof replacement.

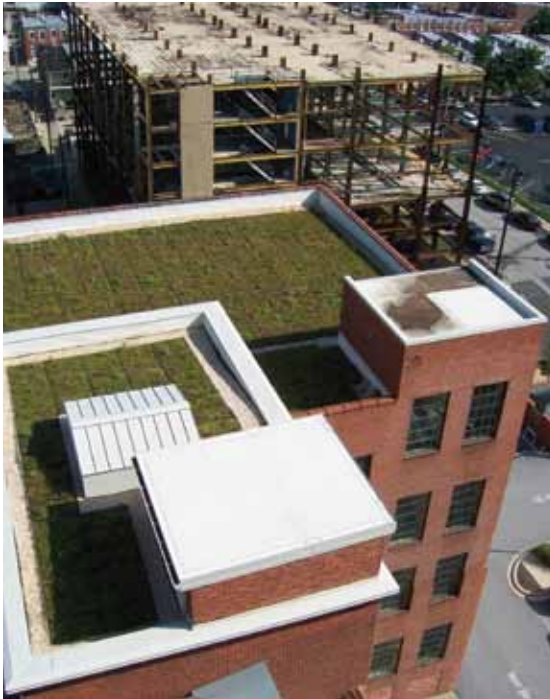
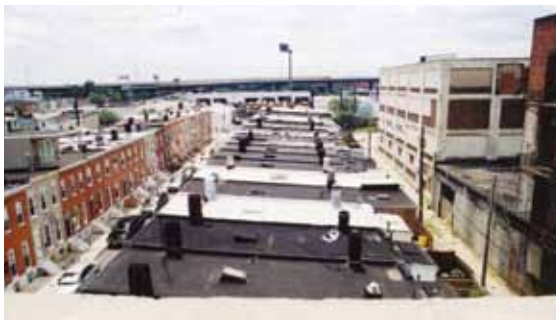
**Recommended:** [85-86] A cool or green roof is best installed on a flat roof where it cannot be seen from the public right of way and will not negatively impact the character of the historic building.

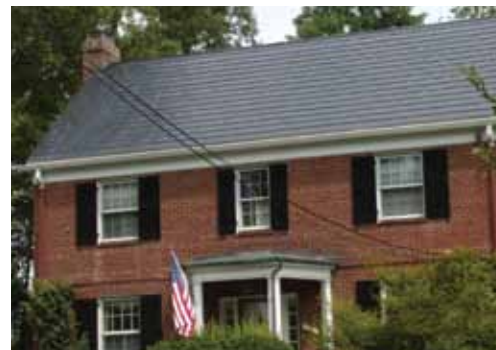
87

**Not Recommended:** [87] Historic roofing materials in good condition should be retained rather than replaced with another material perceived as more sustainable, such as, in this case, solar roofing shingles.

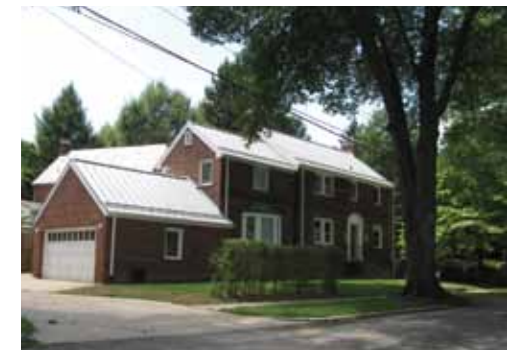
88

**Not Recommended:** [88] This new, cool white metal roof is not an appropriate material or color for this historic mid-20th century house.

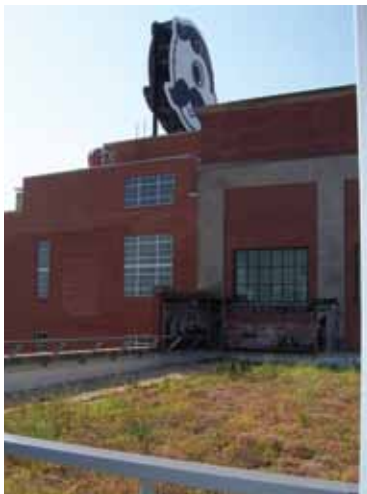
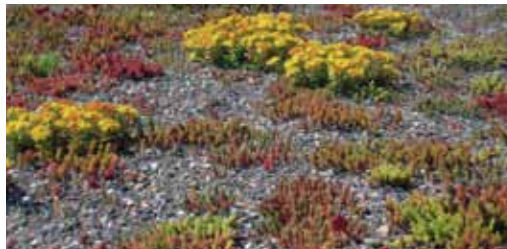
**Recommended:** [89-92] Low-scale and sustainable native plants are appropriate for these roof gardens on historic buildings.

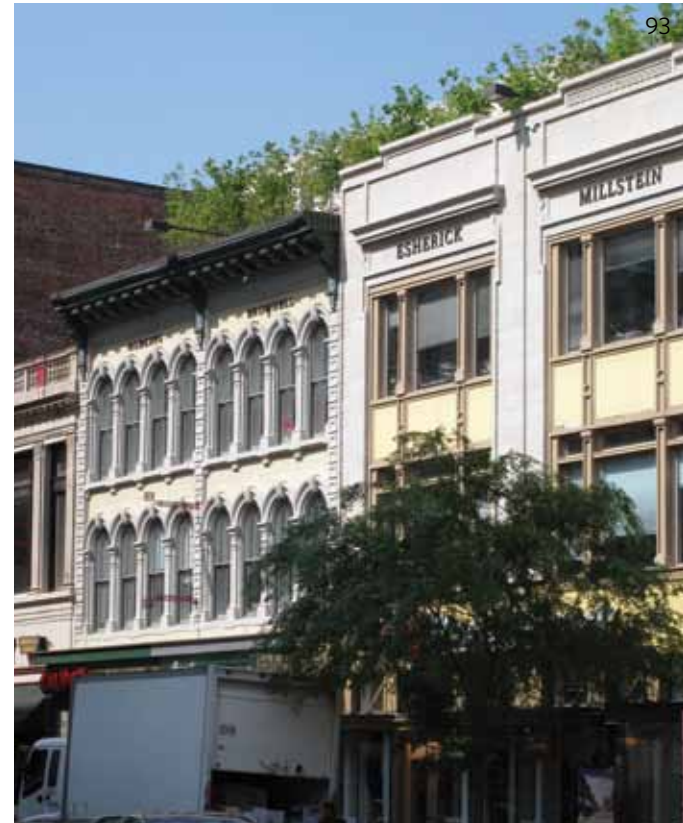
**Not Recommended:** [93] The vegetation on these green roofs has grown too tall and negatively impacts the character of these historic commercial buildings.

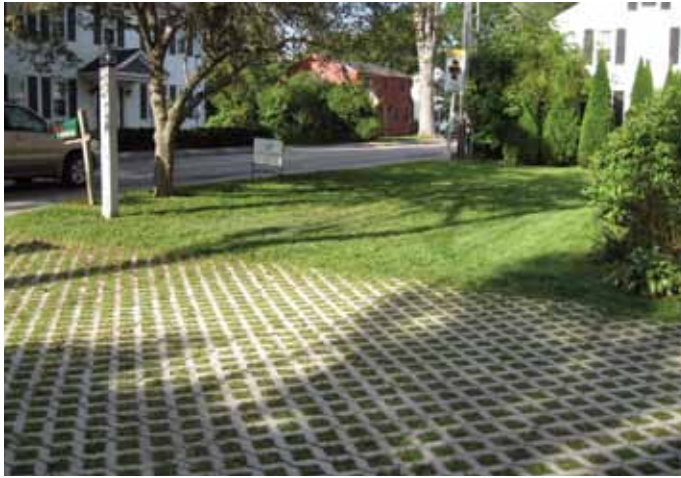
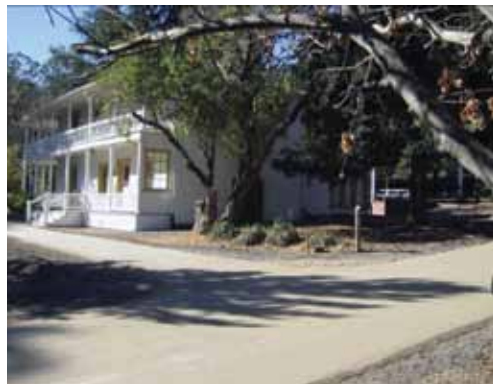
**Recommended:** [94-95] Permeable pavers were used at this historic residential property for a driveway and parking (above) and a hard-packed, construction aggregate provides environmentally-friendly paths for visitors at this historic site (below).

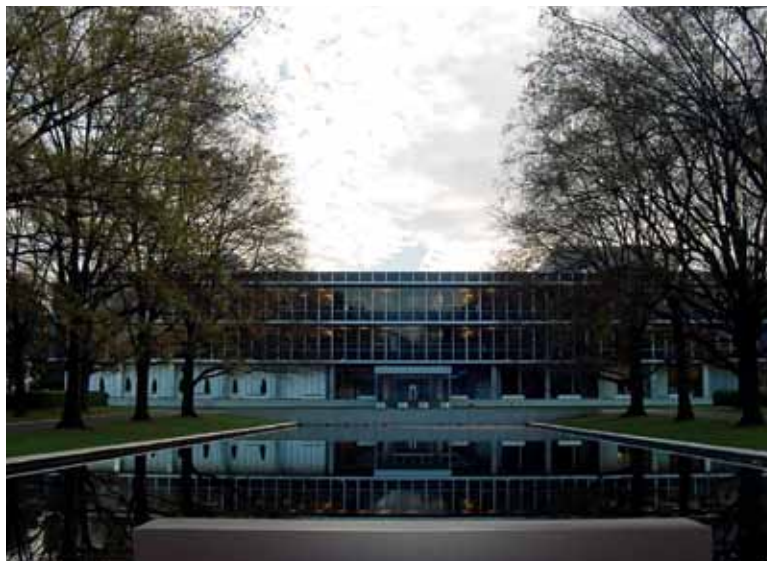
96

[96] Mature trees and a water feature contribute to the sustainability of this mid-twentieth century property.

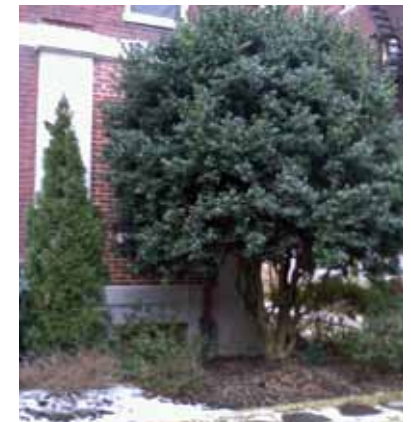
97

**Not Recommended:** [97] This tree, which was planted too close to the building, has caused the masonry wall to retain moisture that damaged the mortar and required that the brick be repointed in this area.

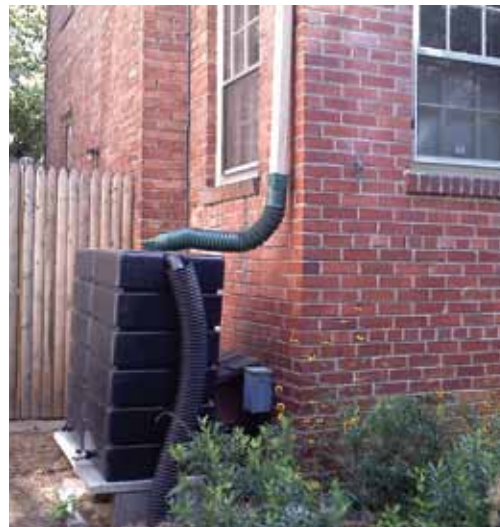
**Recommended:** [98-100] Rain gardens and rain-water collection tanks are features that may be added to a historic property to improve storm-water management and increase on-site water use.

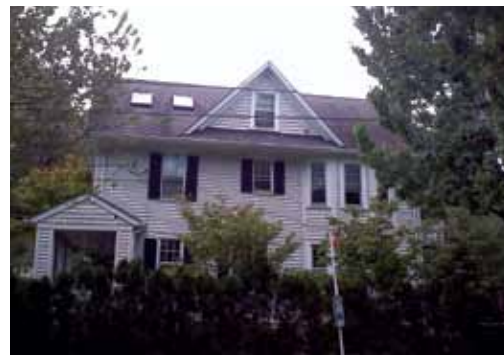
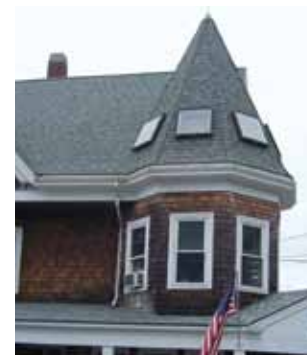
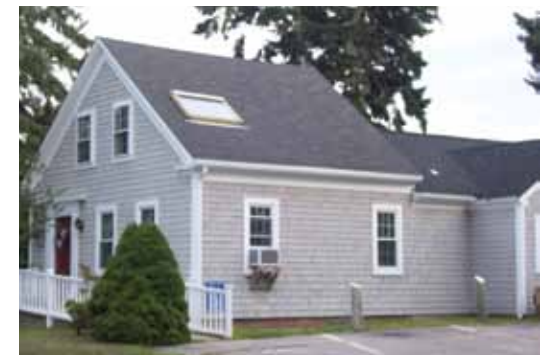
**Not Recommended:** [104-106]  
Skylights added on a primary roof elevation negatively impact the character of these historic houses.

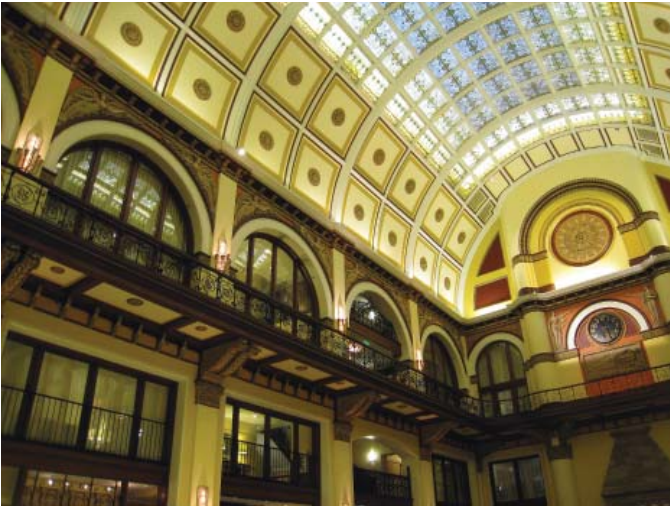
*Fig. 1. A decorative, stained glass skylight allows natural daylight into the interior.*

Operable windows, interior courtyards, clerestories, skylights, rooftop ventilators, cupolas, and other features that provide natural ventilation and light can reduce energy consumption. Whenever these devices can be used to provide natural ventilation and light, they save energy by reducing the need to use mechanical systems and interior artificial lighting.

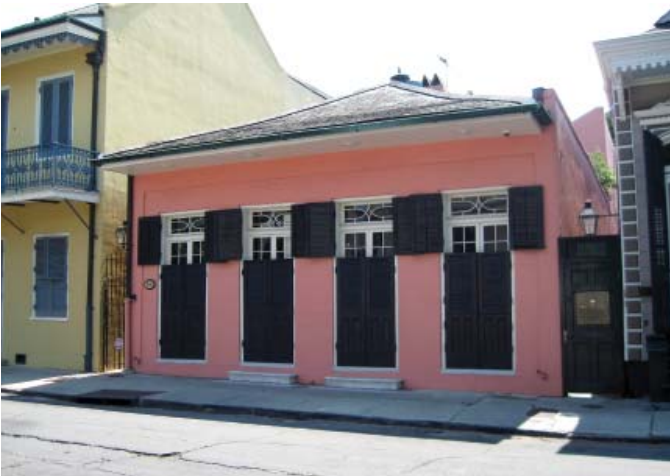
*Fig. 2. Upper and lower shutters control daylight and provide privacy.*

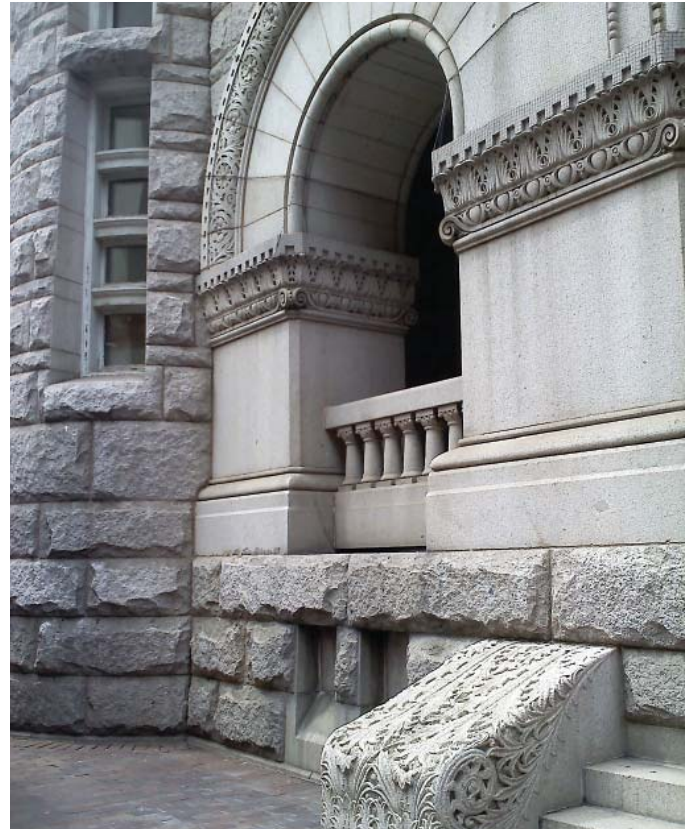
*Fig. 3. Stone walls with substantial mass have high thermal inertia.*

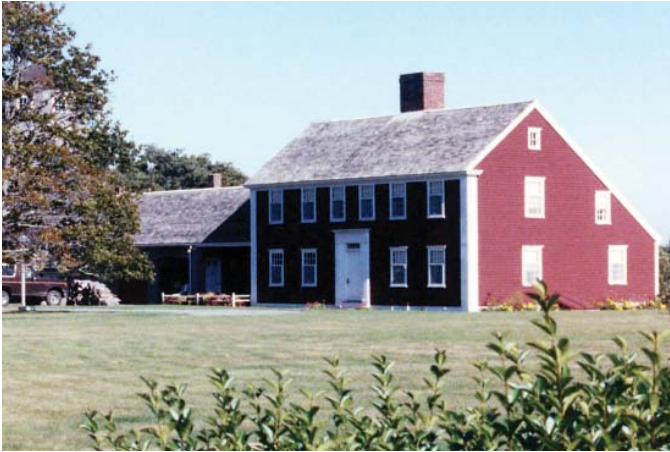
*Fig. 4. A typical New England saltbox features a steeply sloping roof to shed snow and a floor plan organized around a central chimney to conserve heat.*

influenced by the conditions of the local climate. Wide overhangs that sometimes extend to create porches minimize the heat gain from the sun in warmer climates, while steep, sloping roofs with minimal or no overhang prevail in colder climates to allow for shedding snow and increasing beneficial solar heat gain through the windows. Materials and color also influence the thermal performance of roofs. Metal and light colored roofs, for example, reflect sunlight and thereby reduce the heat gain from solar radiation.

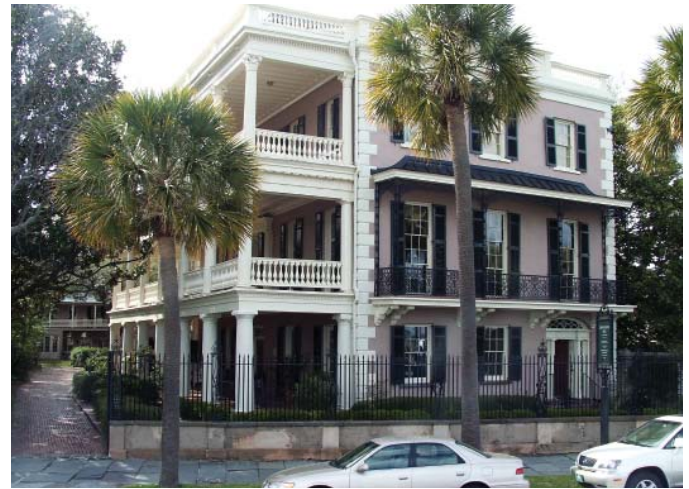
*Fig. 5. The side porches of this house in Charleston, SC, shade the large windows and provide outdoor living spaces that take advantage of sea breezes.*

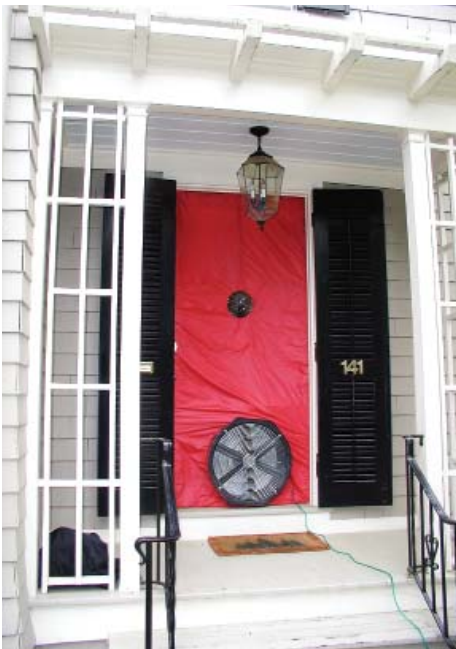
Fig. 6. (left) A blower door is used to depressurize a building by exhausting air at a rate that allows pressure gages and tracer smoke to measure the amount and location of air leakage. Photo: Robert Cagnetta, Heritage Restoration, Inc.

Tools such as a blower door test or infrared thermography are useful to identify specific areas of infiltration, lack of insulation and thermal bridging. Mechanical depressurization along with infrared thermography is extremely useful in identifying locations of air leakage and heat loss followed by the use of tracer smoke to isolate specific air leaks. These tests are often challenging to perform on buildings and must be undertaken by experienced professionals to avoid

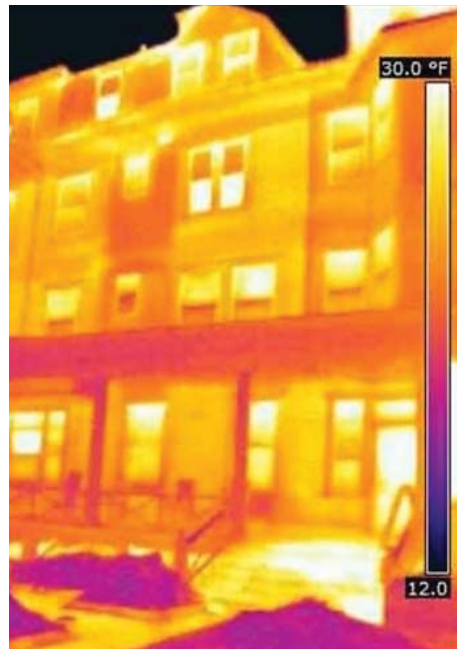
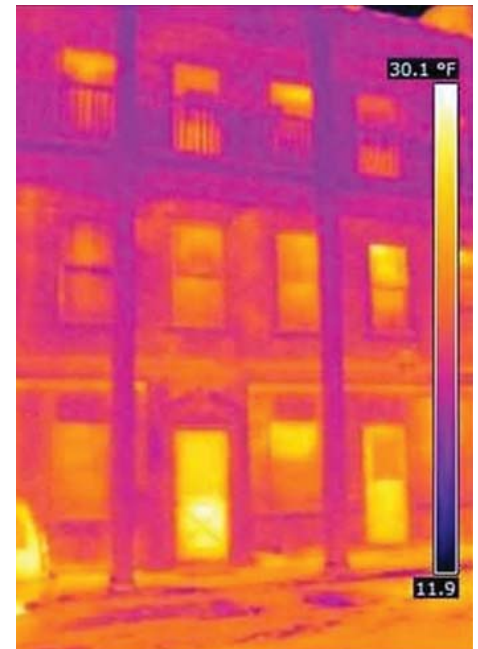
Fig. 7. (center and right) The left thermal image shows the walls of this building before insulating. After insulation was added, the cooler and, thus darker exterior walls evidence how much the heat loss has been reduced. Photos: EYP Architecture & Engineering.

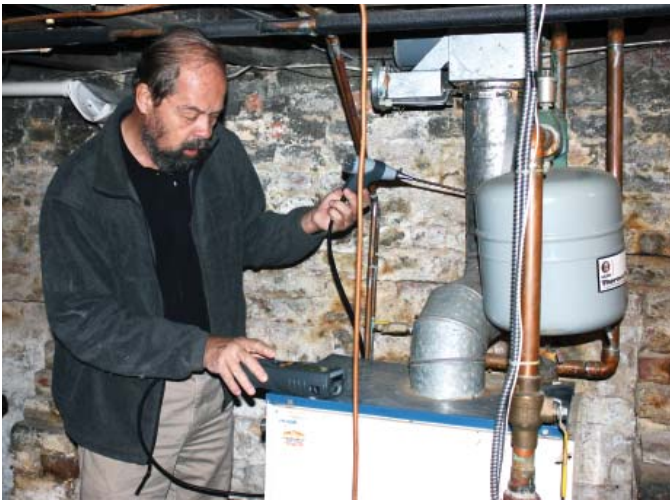
Fig. 9. An energy auditor tests the efficiency of a boiler.

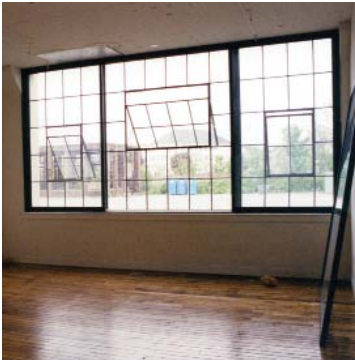
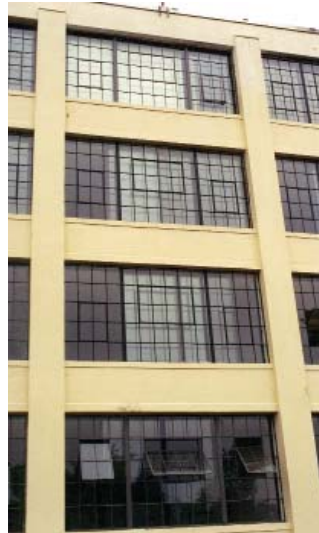
*Fig. 15. Original steel windows were retained and made operable during the rehabilitation of this historic mill complex. Insulated sliding windows were added on the interior to improve energy efficiency.*

For large, steel industrial windows, the addition of interior, insulated sliding glass windows that align with the primary vertical mullions has proven to be a successful treatment that allows the primary window to remain operable.

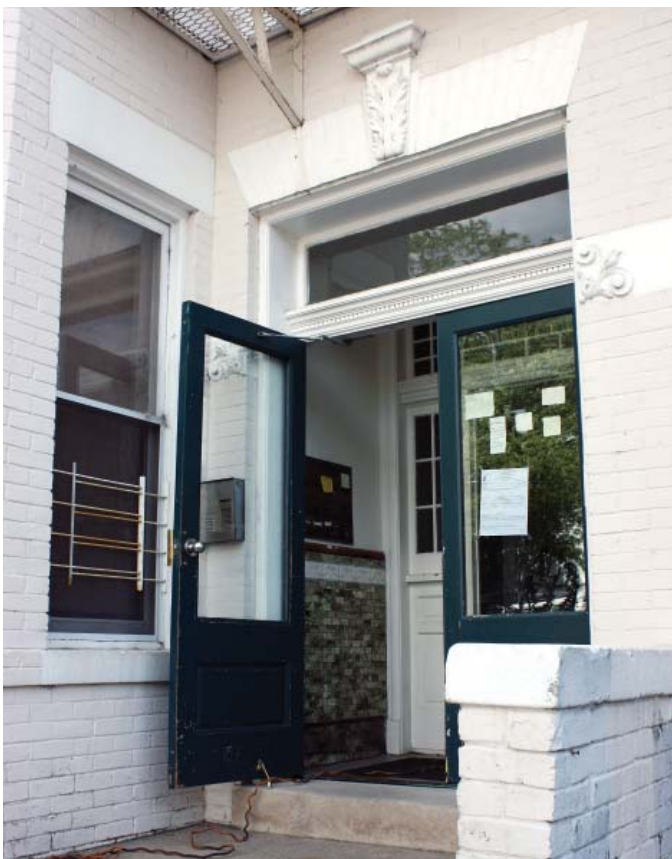
Fig. 16. Historic vestibules retain conditioned air in the living spaces.

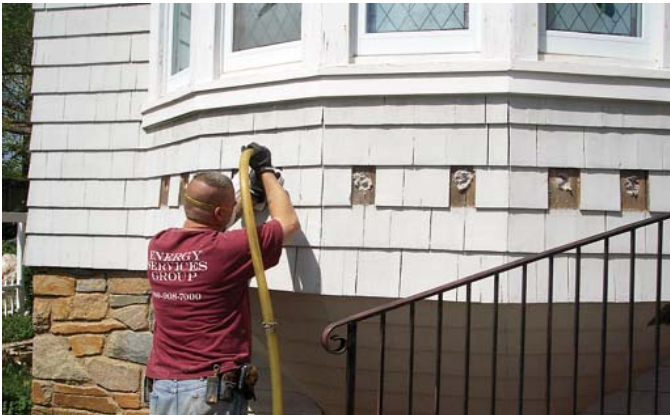
Fig. 18. Dense-packed cellulose insulation is being blown in through holes drilled in the sheathing. Once the operation has been completed, the shingles will be reinstalled. Photo: Edward Minch.

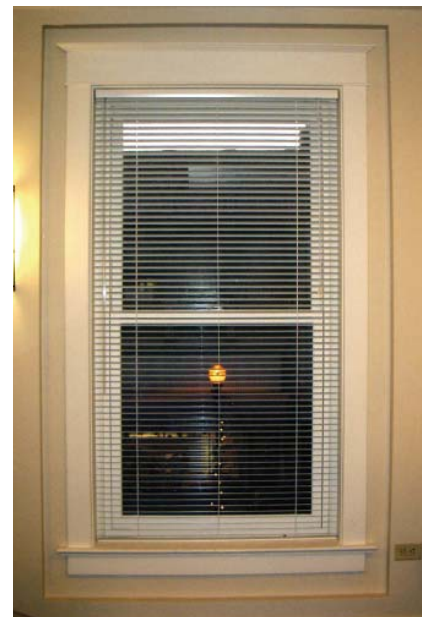
Fig. 20. The walls have been furred out inappropriately around the historic window trim creating an appearance the interior never had historically.

*Insulation Installed on Either Side of the Wall:* Batt, rigid foam board, and spray foam insulation are commonly added to the interior face of walls in existing buildings by furring-out the walls to accommodate the additional thickness. However, this often requires the destruction or alteration of important architectural features, such as cornices, base boards, and window trim, and the removal or covering of plaster or other historic wall finishes. Insulation installed in this manner is only recommended in buildings where interior spaces and features lack architectural distinction or have lost significance due to previous alterations.

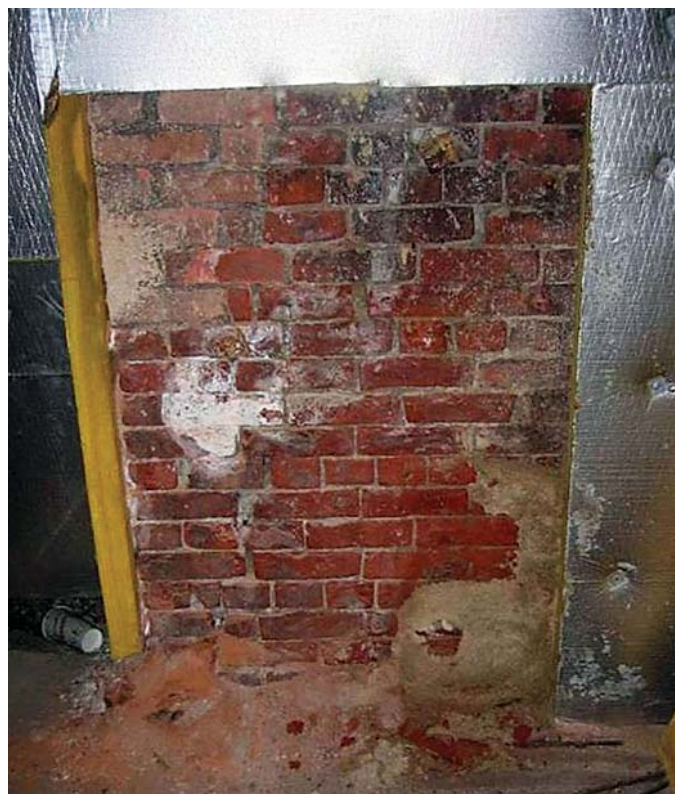
Fig. 21. The interior face of a brick masonry wall shows damage that resulted from the installation of a vapor retardant (foil facing) and thermal insulation. Photo: Simpson Gumpertz & Heger.

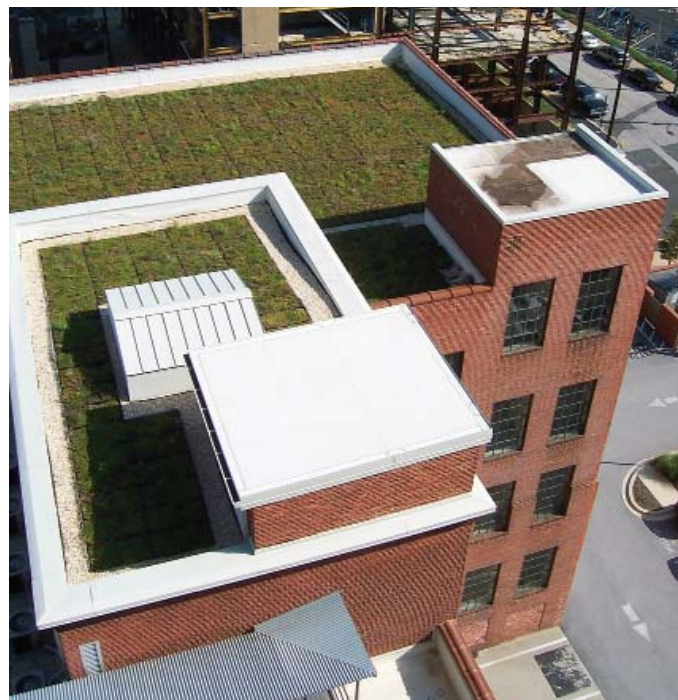
*Fig. 22. Installation of both cool and green roofs in an urban environment.*

A green roof consists of a thin layer of vegetation planted over a waterproofing system or in trays installed on top of an existing flat or slightly sloped roof. Green roofs are primarily beneficial in urban contexts to reduce the heat island effect in cities and to control storm water run-off. A green roof also reduces the cooling load of the building and helps cool the surrounding urban environment, filters air, collects and filters storm water, and can provide urban amenities, including vegetable gardens, for building occupants. The impact of increased

structural loads, added moisture, and potential for leaks must be considered before installing a green roof. A green roof is compatible on a historic building only if the plantings are not visible above the roofline as seen from below.

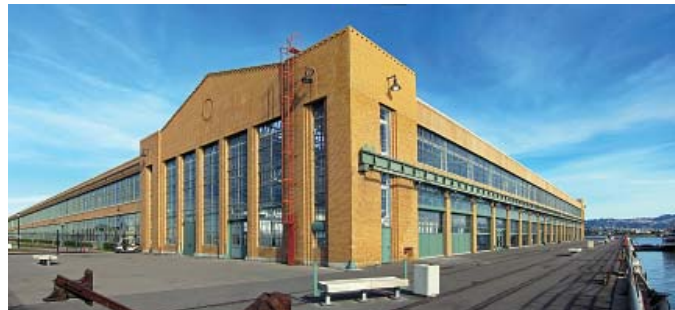
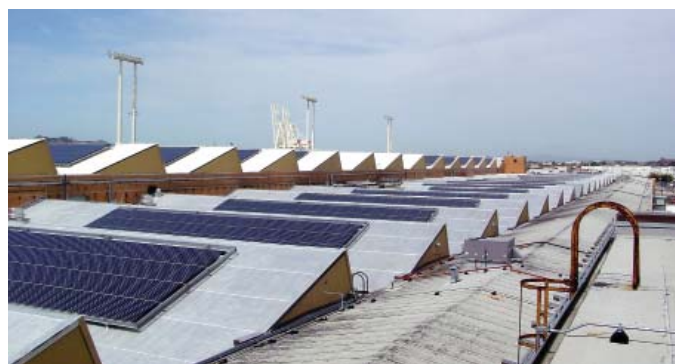
Fig. 23. Solar collectors installed in a compatible manner on low sloping sawtooth monitors. Top Photo: Neil Mishalov, Berkeley, CA.

Solar collectors used to heat water can be relatively simple. More complex solar collectors heat a fluid or air that is then pumped through the system to heat or cool interior spaces. Photovoltaic panels (PV) transform solar radiation into electricity. The greatest potential for the use of PV panels in historic buildings is on buildings with large flat roofs, high parapets, or roof configurations that allow solar panels to be installed without being prominently visible. The feasibility of installing solar devices in small commercial and residential buildings will depend on installation costs, conventional energy rates, and available incentives, all of

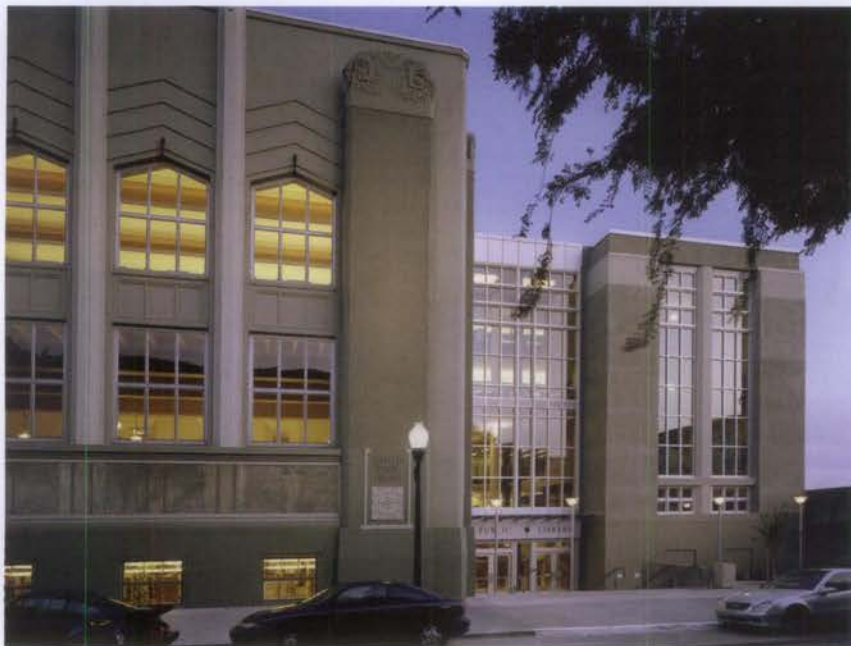
Figure 1. The addition to the right with its connecting hyphen is compatible with the Collegiate Gothic-style library. The addition is set back from the front of the library and uses the same materials and a simplified design that references, but does not copy, the historic building. Photo: David Wakely Photography.

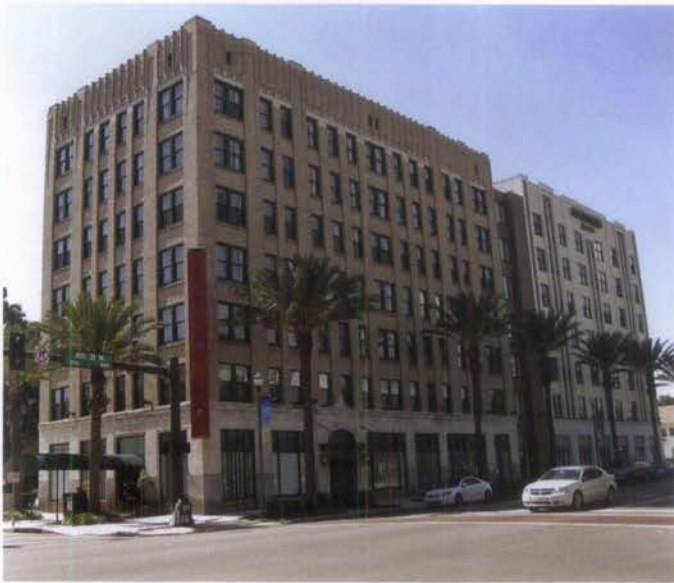
Figure 2. The new section on the right is appropriately scaled and reflects the design of the historic Art Deco-style hotel. The apparent separation created by the recessed connector also enables the addition to be viewed as an individual building.

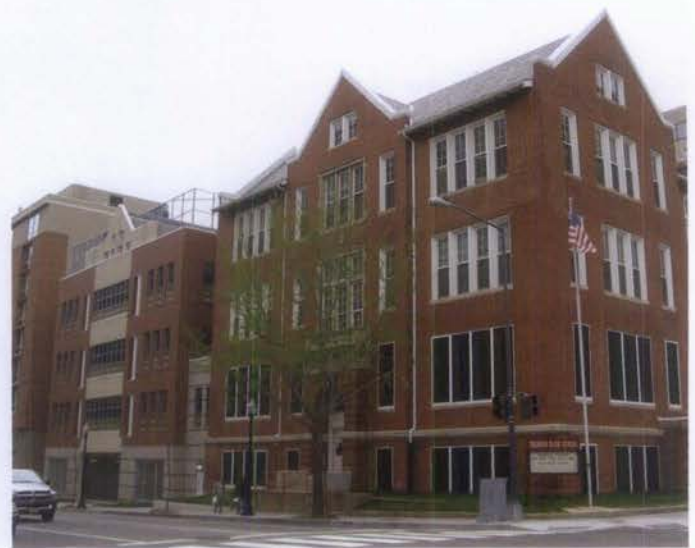
Figure 3. The red and buff-colored parking addition with a rooftop playground is compatible with the early-20th century school as well as with the neighborhood in which it also serves as infill in the urban setting.

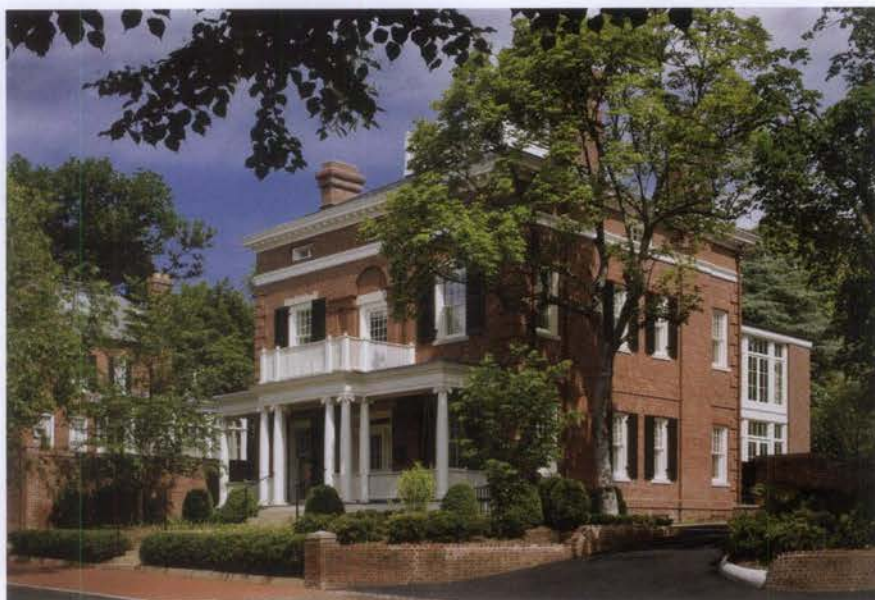
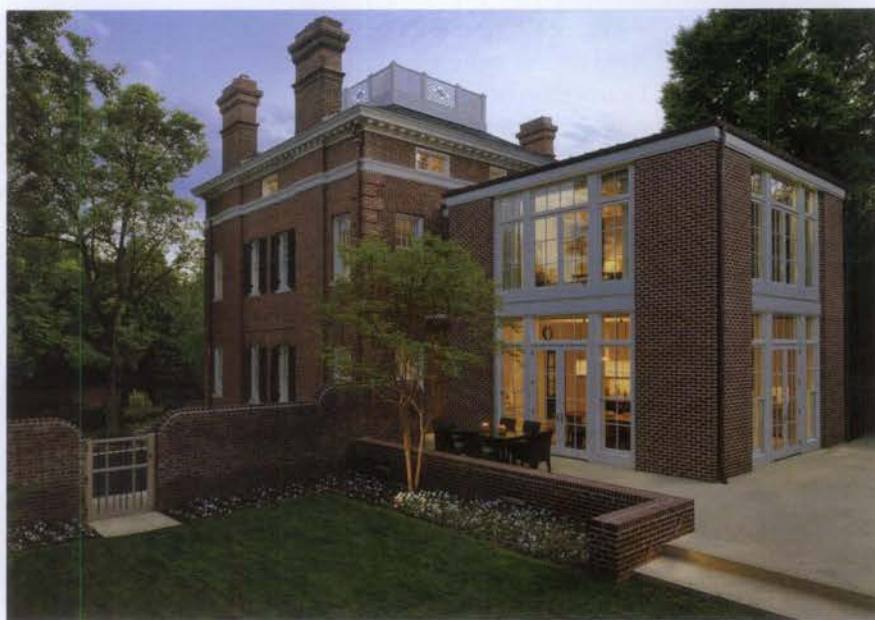
*Figure 4. This glass and brick structure is a harmonious addition set back and connected to the rear of the Colonial Revival-style brick house. Cunningham/Quill Architects. Photos: © Maxwell MacKenzie.*

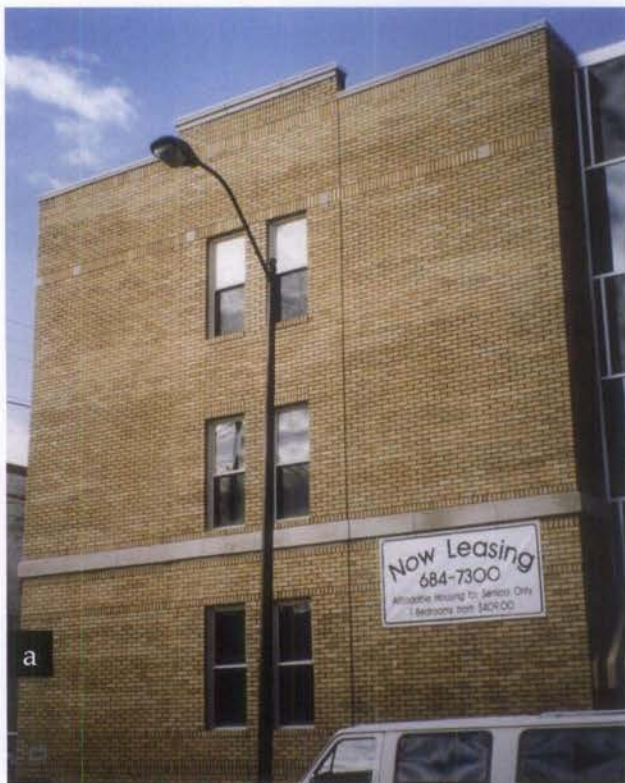
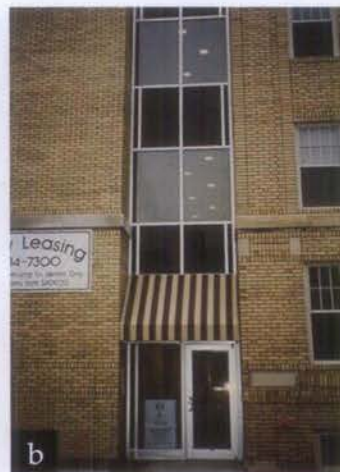
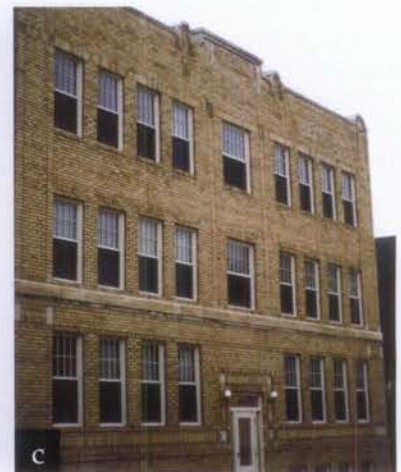
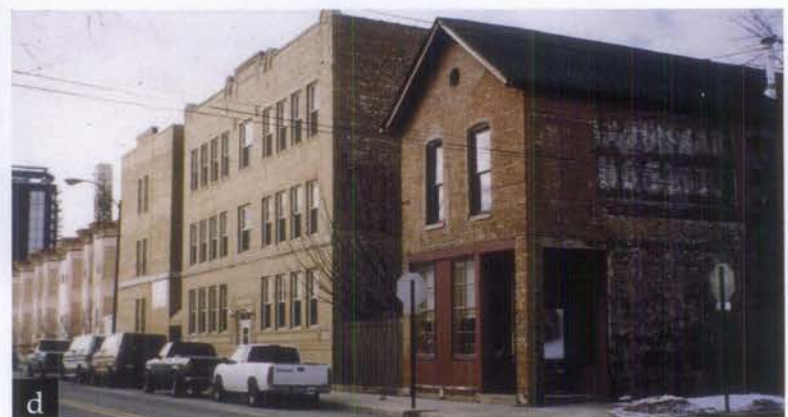
Figure 5. This addition (a) is constructed of matching brick and attached by a recessed connector (b) to the 1914 apartment building (c). The design is compatible and the addition is smaller and subordinate to the historic building (d).

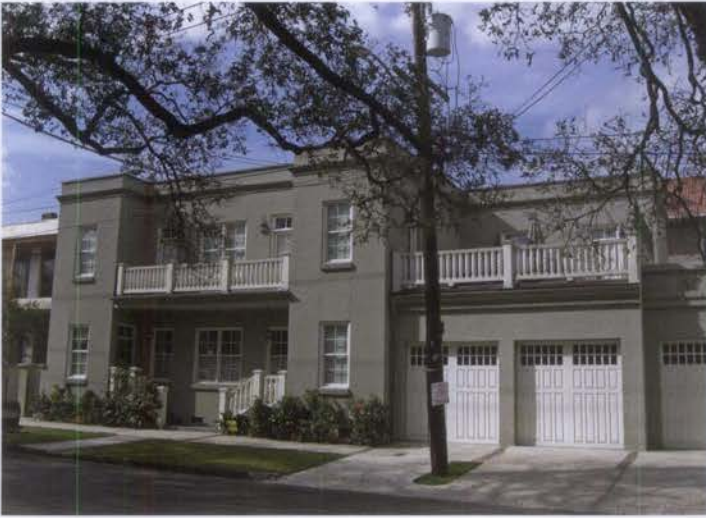
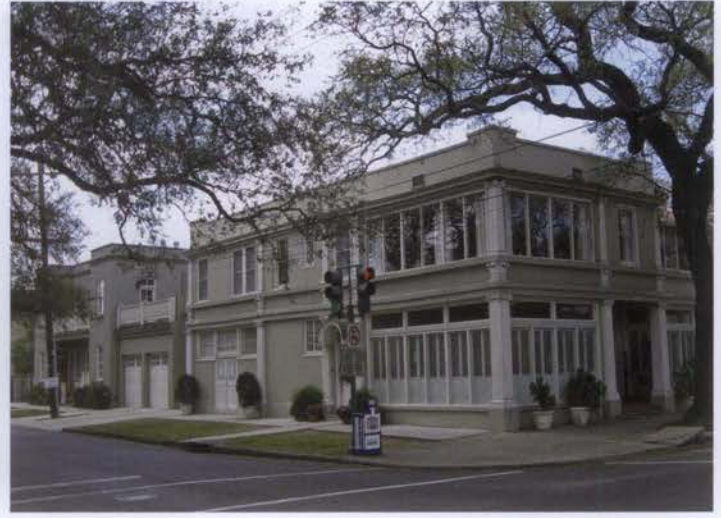
Figure 6. A new addition (left) is connected to the garage which separates it from the main block of the c. 1910 former florist shop (right). The addition is traditional in style, yet sufficiently restrained in design to distinguish it from the historic building.

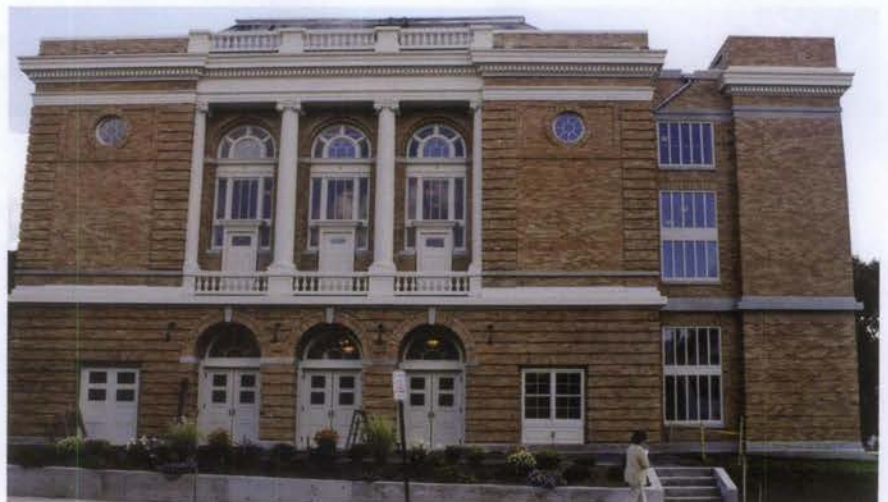
Figure 7. A vacant side lot was the only place a new stair tower could be built when this 1903 theater was rehabilitated as a performing arts center. Constructed with matching materials, the stair tower is set back with a recessed connector and, despite its prominent location, it is clearly subordinate and differentiated from the historic theater.

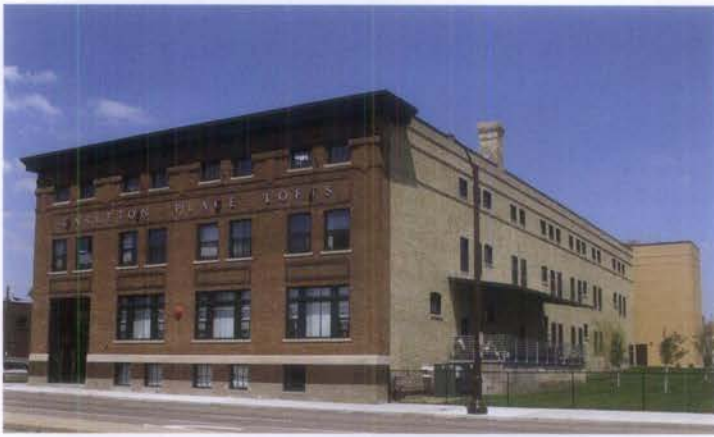
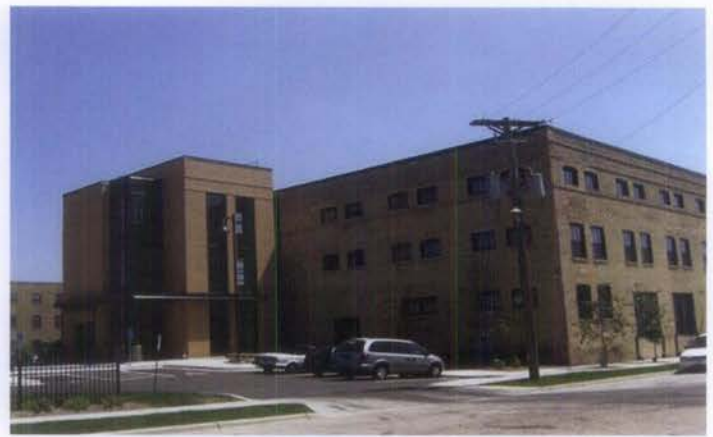
Figure 8. The rehabilitation of this large, early-20th century warehouse (left) into affordable artists' lofts included the addition of a compatible glass and brick elevator/stair tower at the back (right).

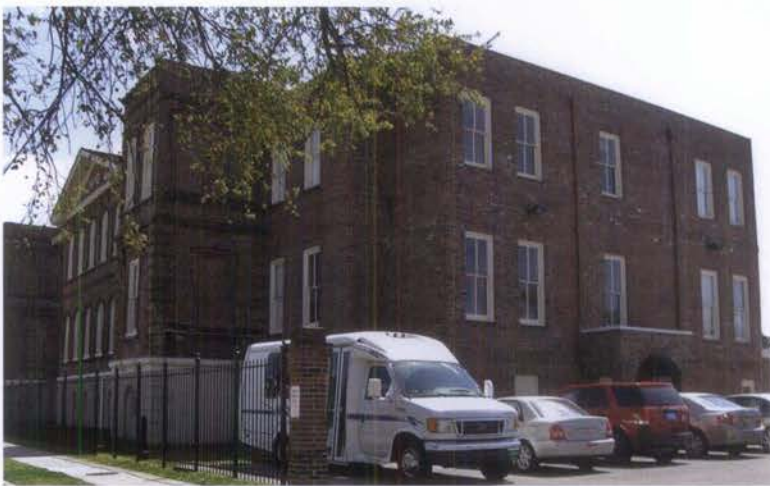
Figure 9. A simple, brick stair tower replaced two non-historic additions at the rear of this 1879 school building when it was rehabilitated as a women's and children's shelter. The addition is set back and it is not visible from the front of the school.

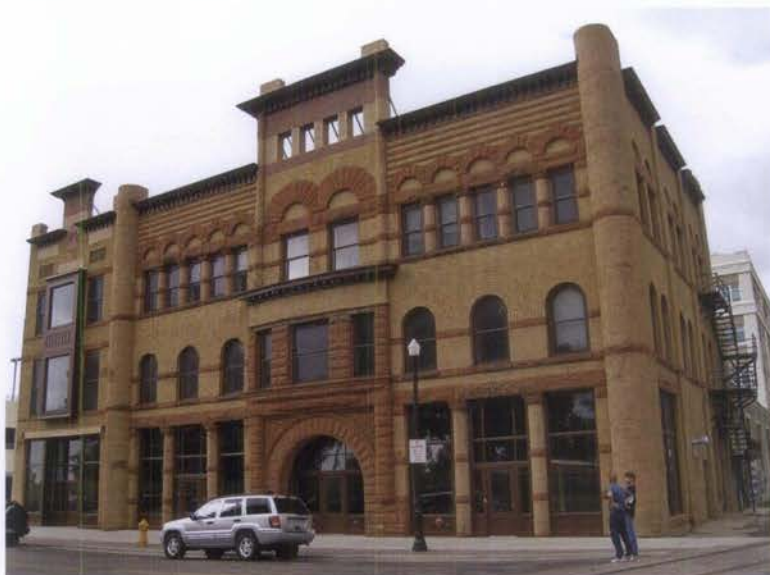
Figure 10. The small size and the use of matching materials ensures that the new addition on the left is compatible with the historic Romanesque Revival-style building.

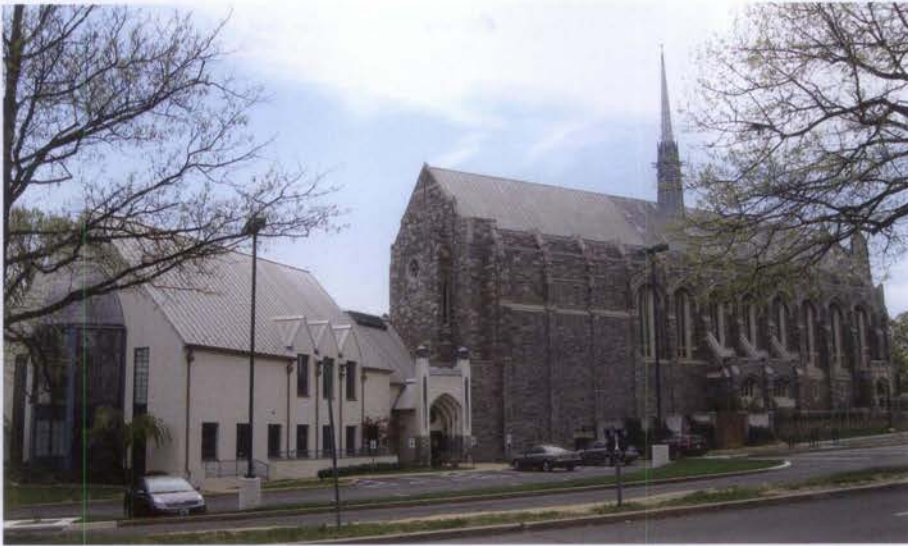
Figure 11. The addition to this early-20th century Gothic Revival-style church provides space for offices, a great hall for gatherings and an accessible entrance (left). The stucco finish, metal roof, narrow gables and the Gothic-arched entrance complement the architecture of the historic church. Placing the addition in back where the ground slopes away ensures that it is subordinate and minimizes its impact on the church (below).

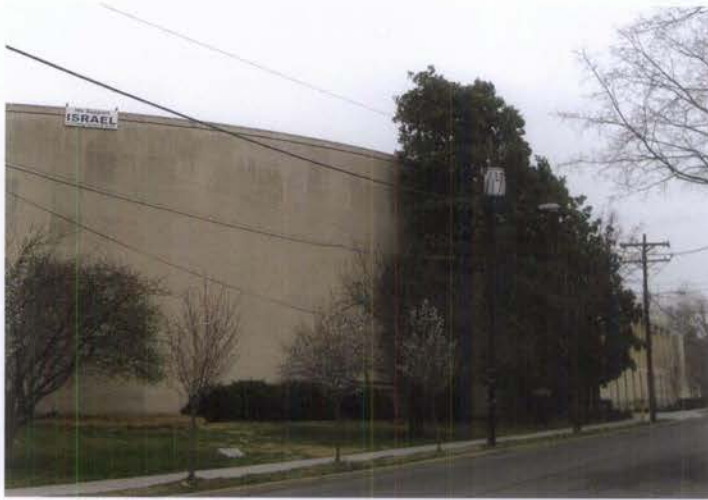
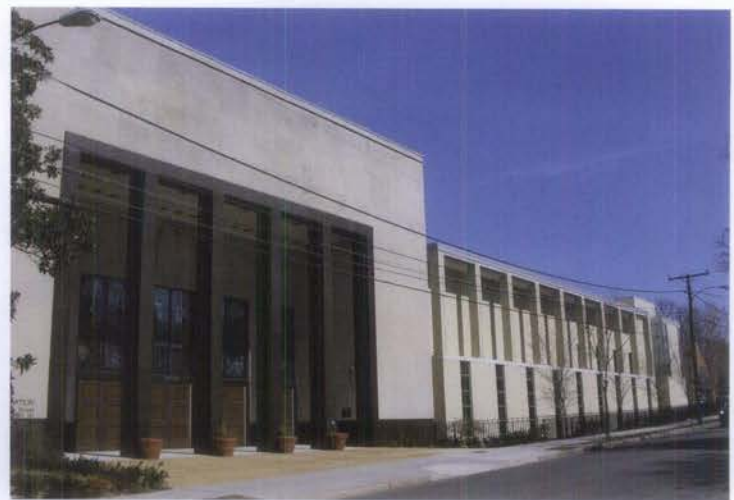
Figure 12. This 1954 synagogue (left) is accessed through a monumental entrance to the right. The new education wing (far right) added to it features the same vertical elements and color and, even though it is quite large, its smaller scale and height ensure that it is secondary to the historic resource.

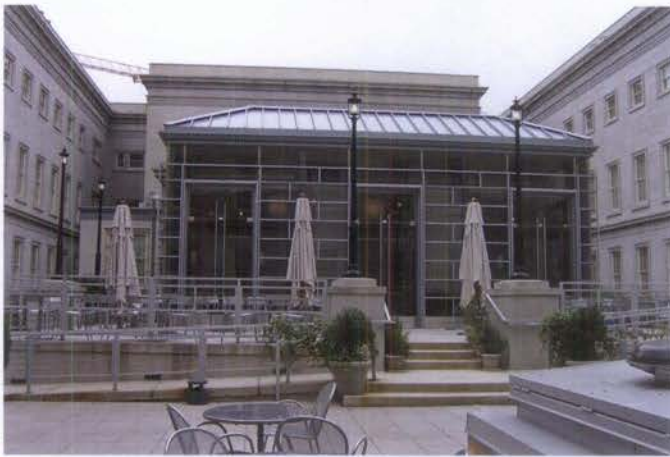
Figure 13. A glass and metal structure was constructed in the courtyard as a restaurant when this 1839 building was converted to a hotel. Although such an addition might not be appropriate in a more public location, it is compatible here in the courtyard of this historic building.

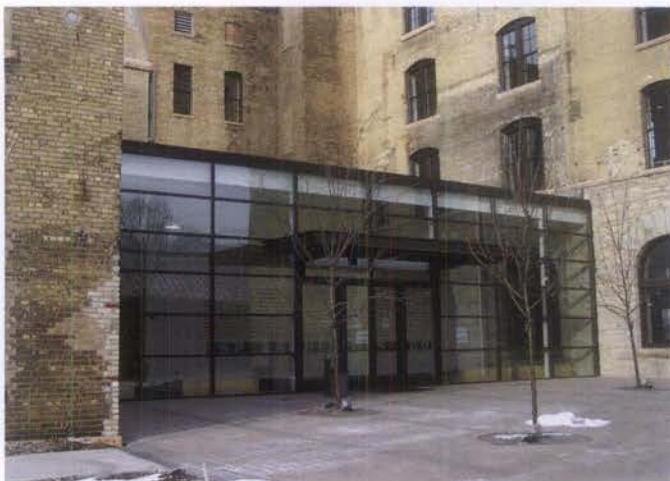
Figure 14. This glass addition was erected at the back of an 1895 former brewery during rehabilitation to provide another entrance. The addition is compatible with the plain character of this secondary elevation.

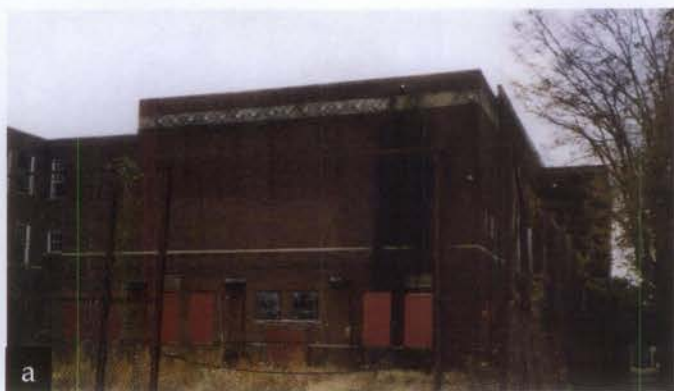
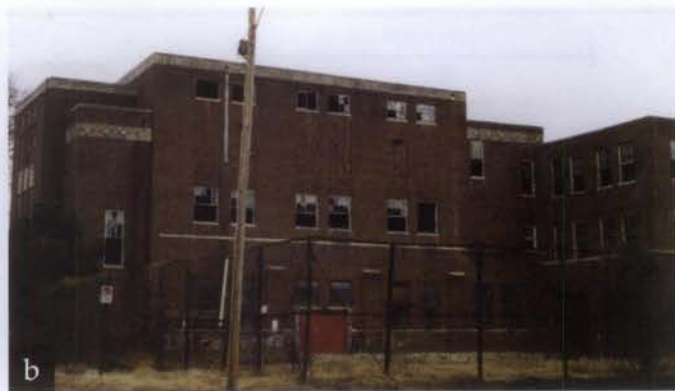
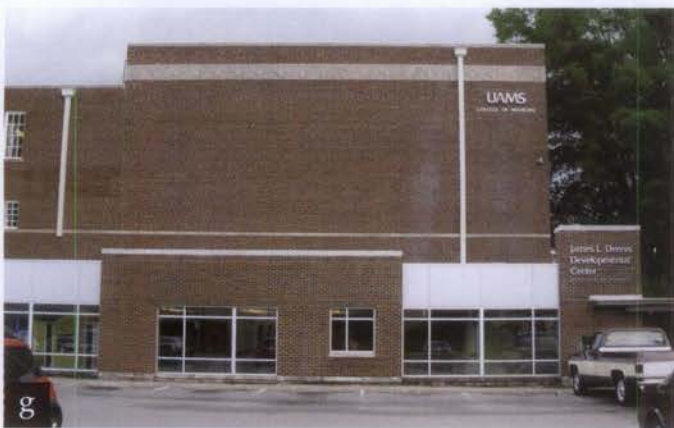
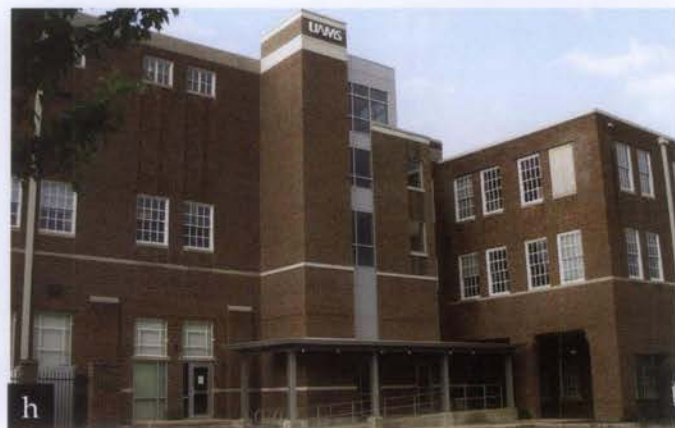
Figure 15. The rehabilitation of a c. 1930 high school auditorium for a clinic and offices proposed two additions: a one-story entrance and reception area on this elevation (a); and a four-story elevator and stair tower on another side (b). The gabled entrance (c) first proposed was not compatible with the flat-roofed auditorium and the design of the proposed stair tower (d) was also incompatible and overwhelmed the historic building. The designs were revised (e-f) resulting in new additions that meet the Standards (g-h).

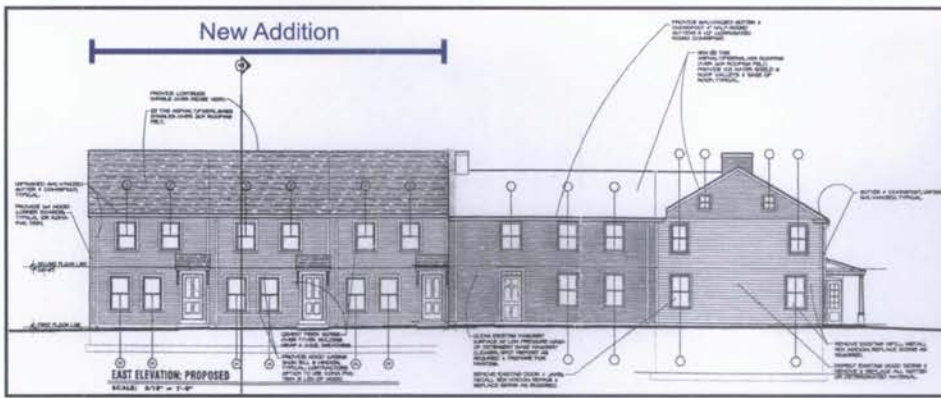
Figure 16. The proposal to add three row houses to the rear ell of this early-19th century residential property doubles its size and does not meet the Standards..

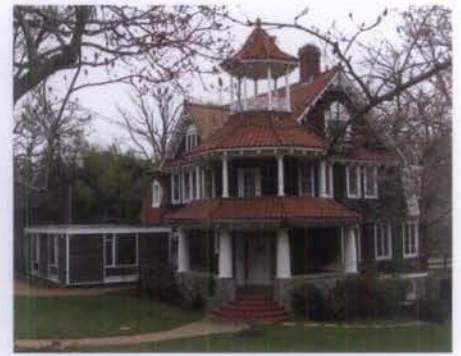
Figure 17. The small addition on the left is starkly different and it is not compatible with the eclectic, late-19th century house.
