## **AGENDA**

Historic Preservation Commission  
Tuesday August 11, 6:00 PM

Northglenn Historic Preservation Commission  
June 9, 2026  
Minutes

The applicant, Travis Glaser, property owner of 9840 Palmer Ln, is requesting Alteration Certificate to remove an enclosed carport with associated room addition, build an addition to the original structure, as well as renovating the original portion of property through window and roofing replacement as shown in Exhibit B. The property owner is proposing two phases to the project. Phase 1 removes all the non-original parts and non-permitted areas of the house. (Note: An unpermitted and dilapidated shed attached to the northern section of the house has already been removed). Phase 2 includes the building of the new addition to include a garage, master bedroom and bathroom in the rear of the property, window and roof replacement.

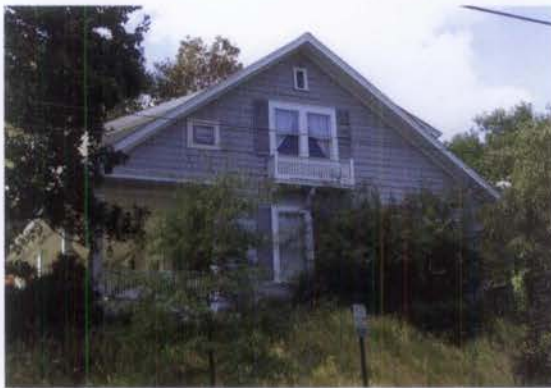
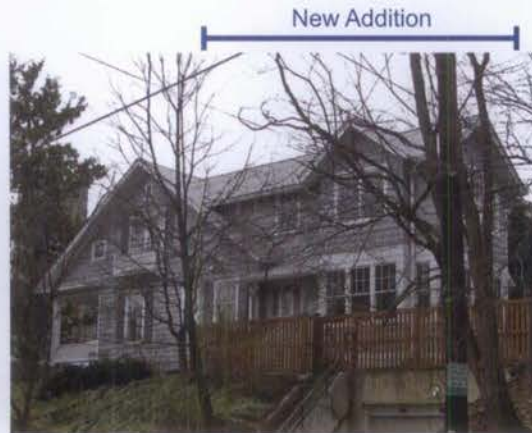
Figure 18. The expansion of a one- and one-half story historic bungalow (left) with a large two-story rear addition (right) has greatly altered and obscured its distinctive shape and form.

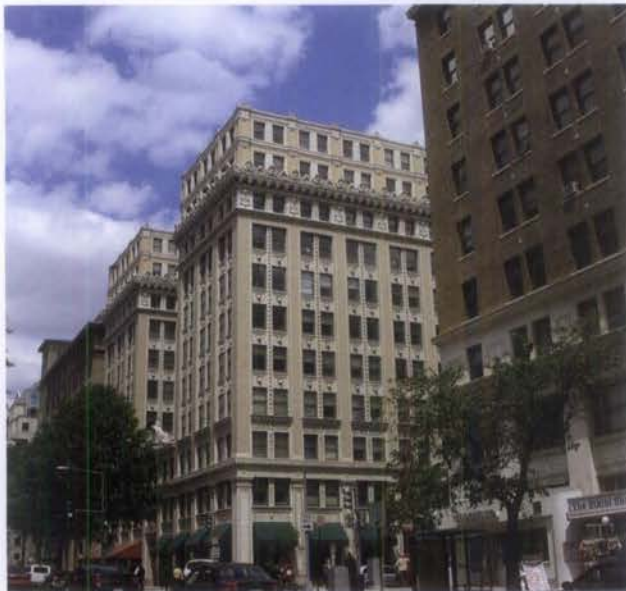
Figure 19. The upper two floors of this early-20th century office building were part of the original design, but were not built. During rehabilitation, the two stories were finally constructed. This treatment does not meet the Standards because the addition has given the building an appearance it never had historically.

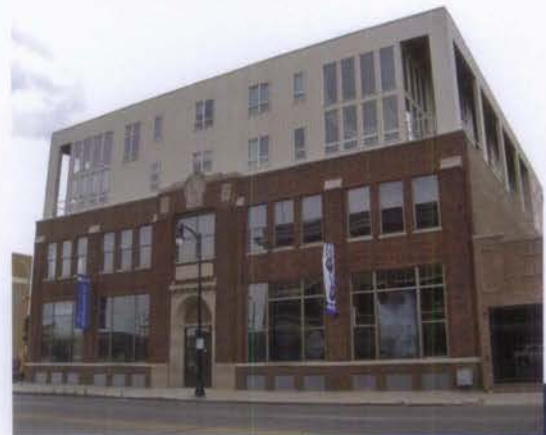
Figure 20. The height, as well as the design, of these two-story rooftop additions overwhelms the two-story and the one-story, low-rise historic buildings.

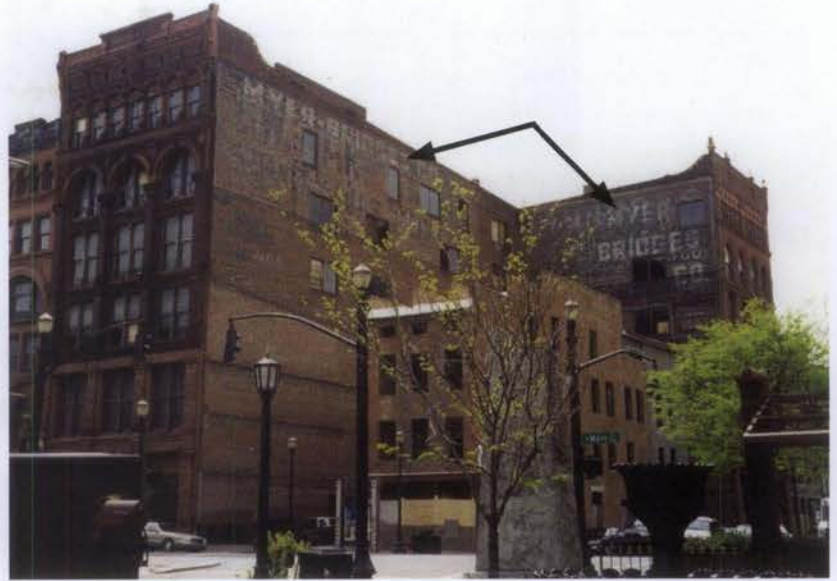
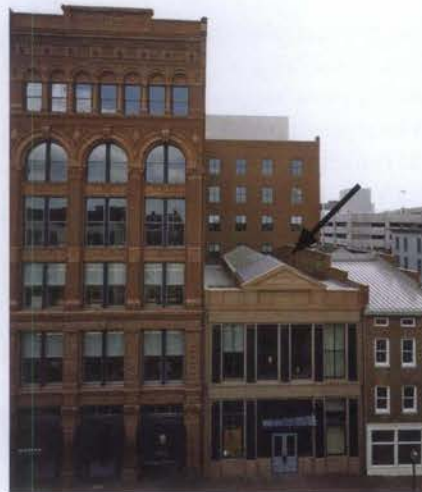
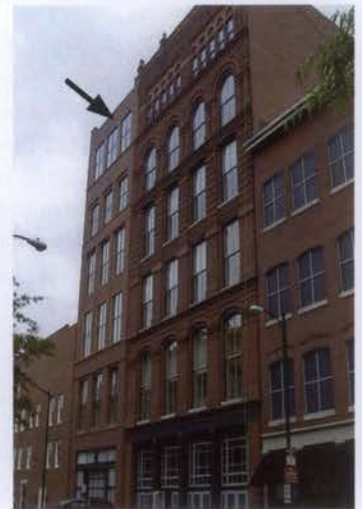
*Figure 21. Both wings of this historic L-shaped building (top), which fronts on two city streets, adjoined vacant lots. A two-story addition was constructed on one lot (above, left) and a six-story addition was built on the other (above, right). Like the historic building, which has two different facades, the compatible new additions are also different and appear to be separate structures rather than part of the historic building.*

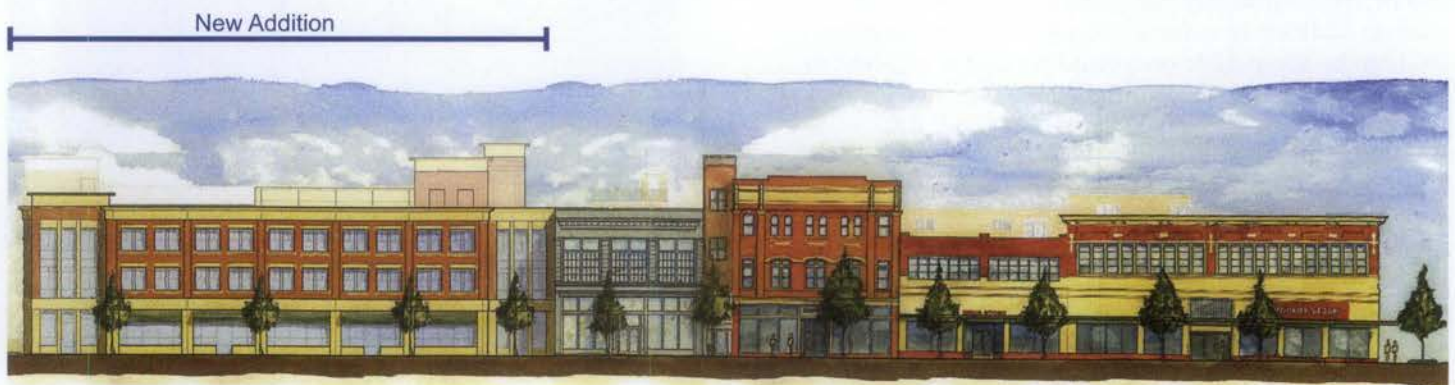
*Figure 22. The proposed new addition is compatible with the historic buildings that remain on the block. Its design with multiple storefronts helps break up the mass.*

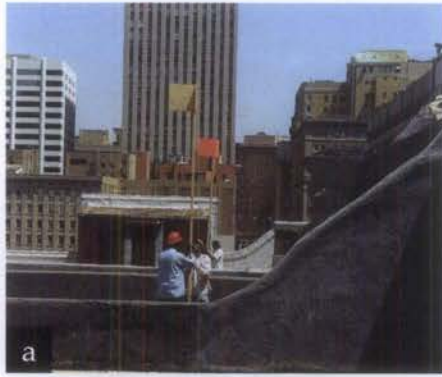
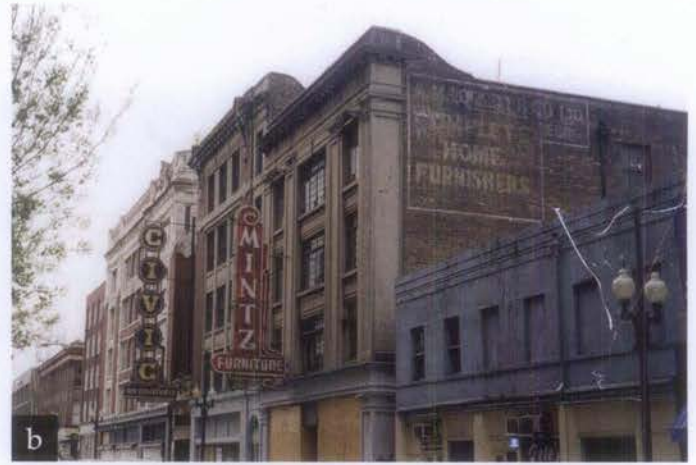
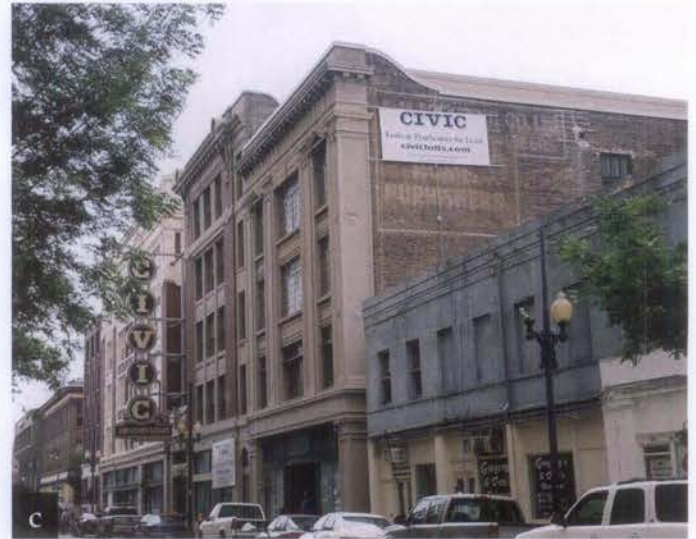
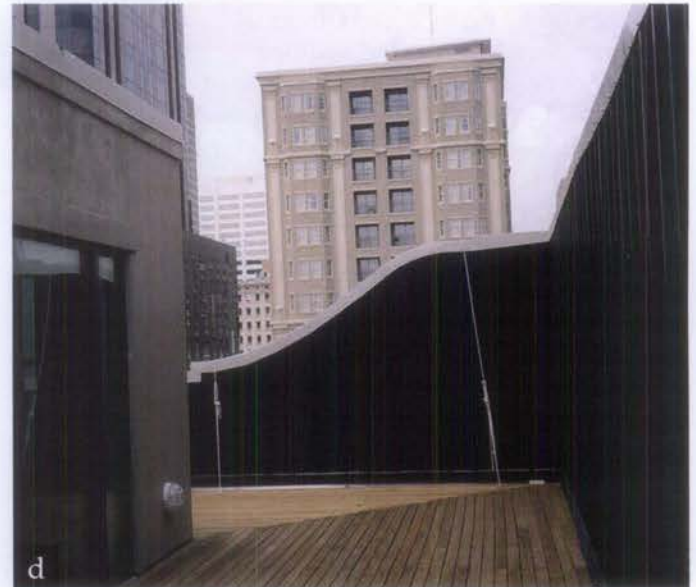
Figure 23. Colored flags marking the location of a proposed penthouse addition (a) were placed on the roof to help evaluate the impact and visibility of an addition planned for this historic furniture store (b). Based on this evaluation, the addition was constructed as proposed. It is minimally visible and compatible with the 1912 structure (c). The tall parapet wall conceals the addition from the street below (d).

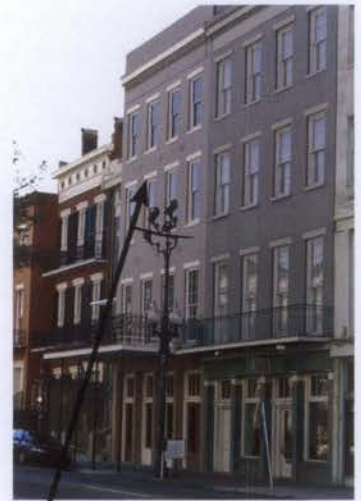
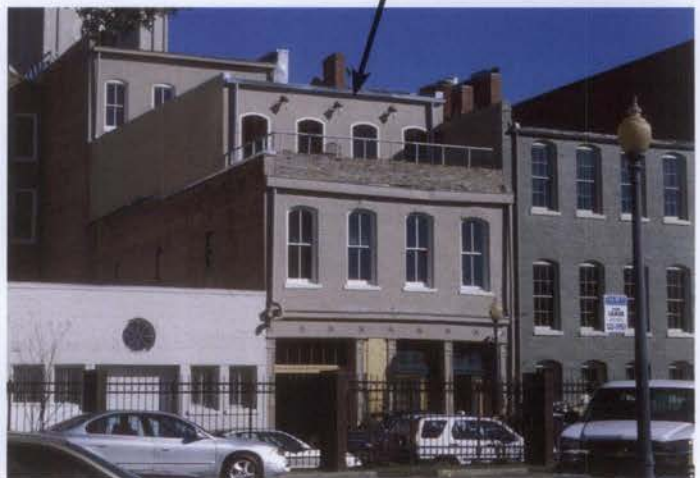
**Figure 26.** A rooftop addition would have negatively impacted the character of the primary facade (right) of this mid-19th century, four-story structure and the low-rise historic district. However, a third floor was successfully added on the two-story rear portion (below) of the same building with little impact to the building or the district because it blends in with the height of the adjacent building.

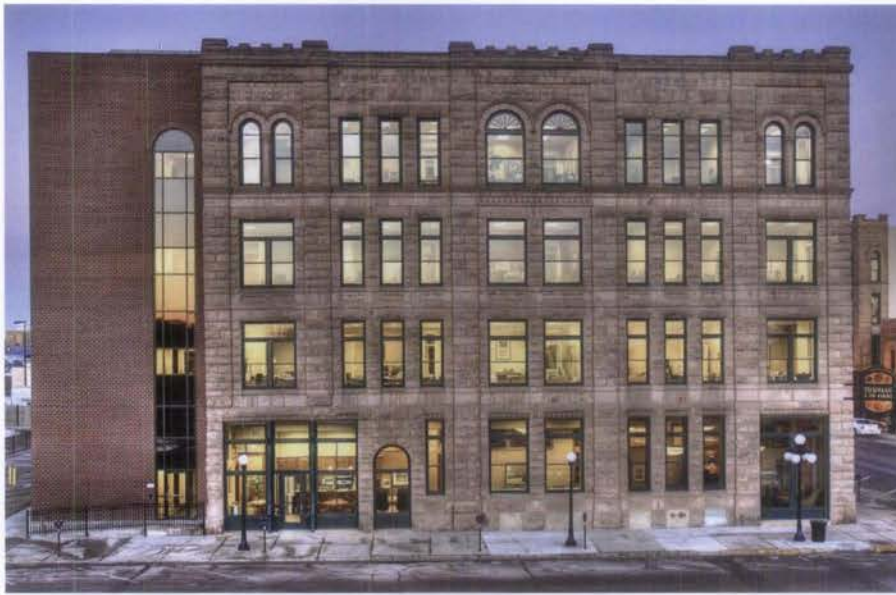
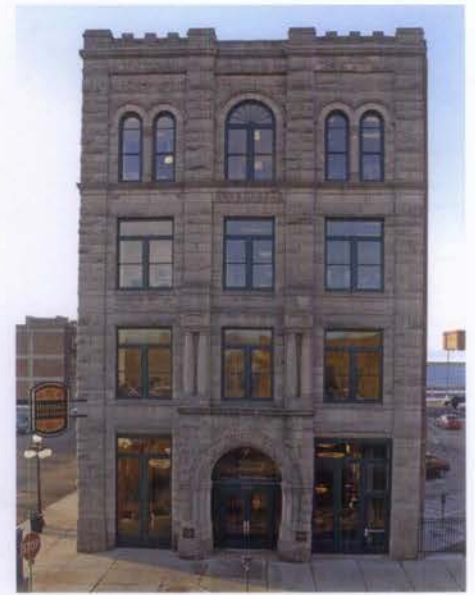
Figure 27. Although the new brick stair/elevator tower (left) is not visible from the front (right), it is on a prominent side elevation of this 1890 stone bank. The compatible addition is set back and does not compete with the historic building. Photos: Chadd Gossman, Aurora Photography, LLC.

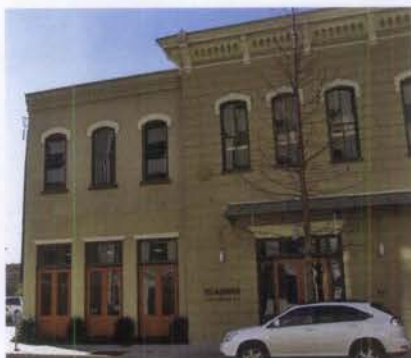
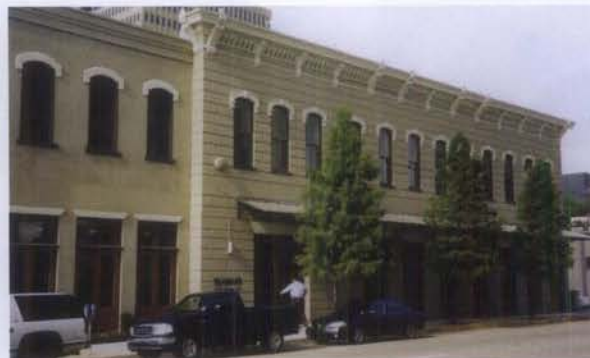
Figure 28. A small addition (left) was constructed when this 1880s train station was converted for office use. The paired doors with transoms and arched windows on the compatible addition reflect, but do not replicate, the historic building (right).

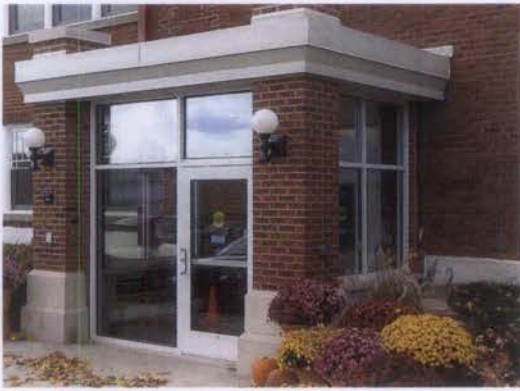
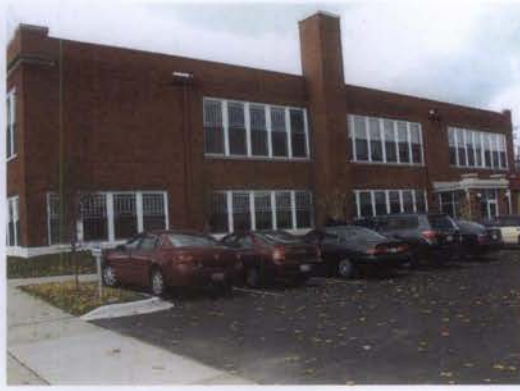
Figure 29. This simple glass and brick entrance (left) added to a secondary elevation of a 1920s school building (right) is compatible with the original structure.

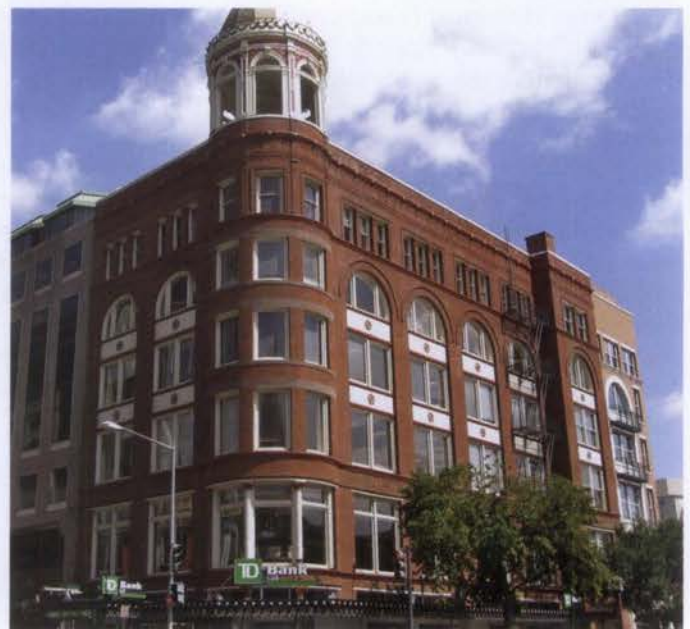
Figure 30. The small addition on the right of this late-19th century commercial structure is clearly secondary and compatible in size, materials and design with the historic building.

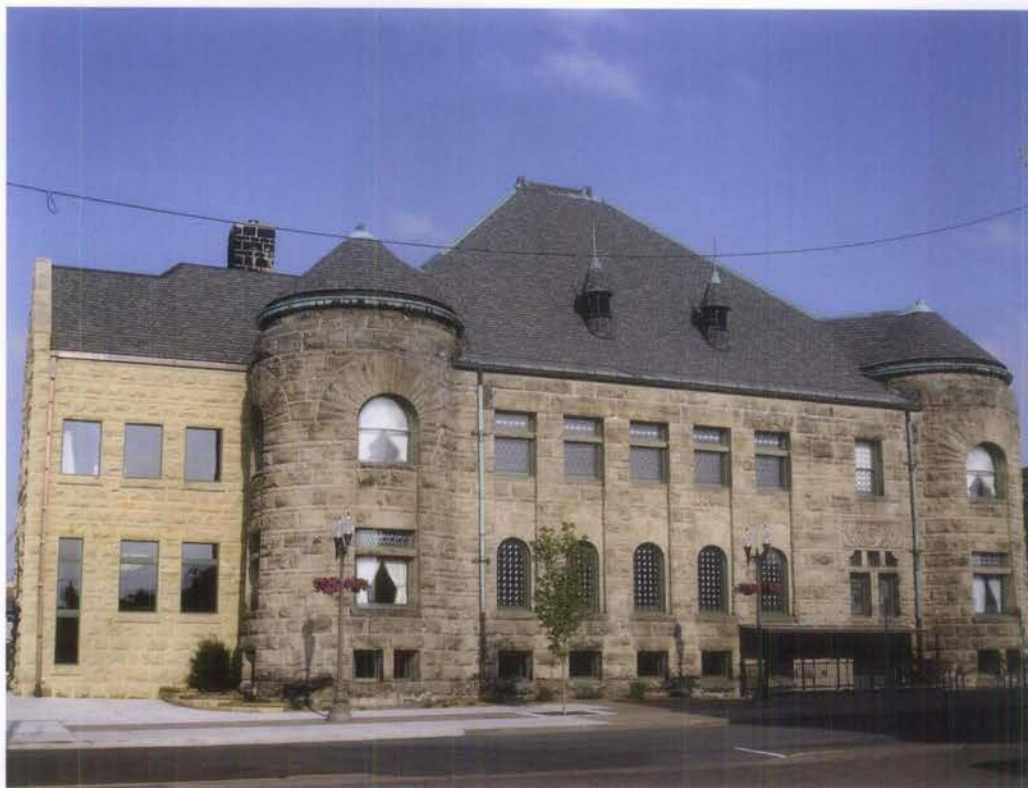
Figure 31. An elevator/stair tower was added at the back of this Richardsonian Romanesque-style theater when it was rehabilitated. Rough-cut stone and simple cut-out openings ensure that the addition is compatible and subordinate to the historic building. Photo: Chuck Liddy, AIA.

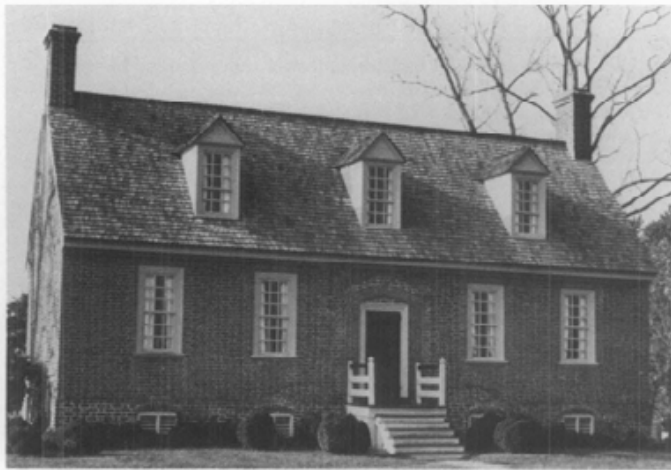
1. The Rolfe-Warren House, a tidewater Virginia property, was restored to its 18th-century appearance in 1933. The handsplit and dressed wooden shingles are typical of the tidewater area with special features such as curved butts, projecting ridge comb and closed swept valleys at the dormer roof connections. Circa 1970 Photo: Association for the Preservation of Virginia Antiquities.

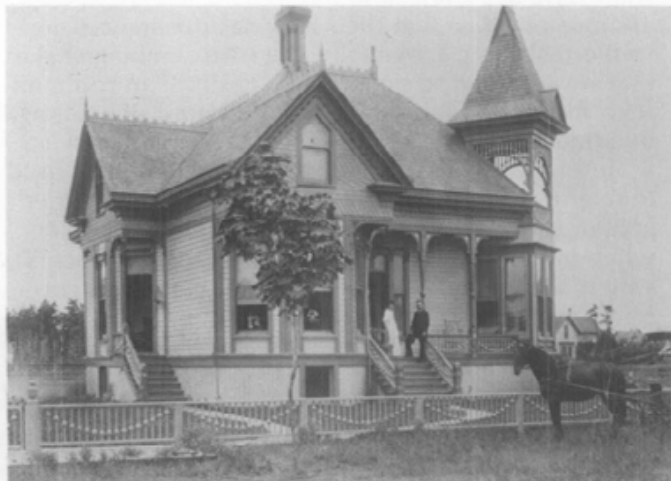
3. Readily available and inexpensive sawn shingles were used not only for roofs, but also for gables and wall surfaces. The circa 1891 Chambers House, Eugene, Oregon used straight sawn butts for the majority of the roof and hexagonal butts for the lower portion of the corner tower. Decorative shingles in the gable ends and an attractive wooden roof cresting feature were also used. Photo: Lane County Historical Society.

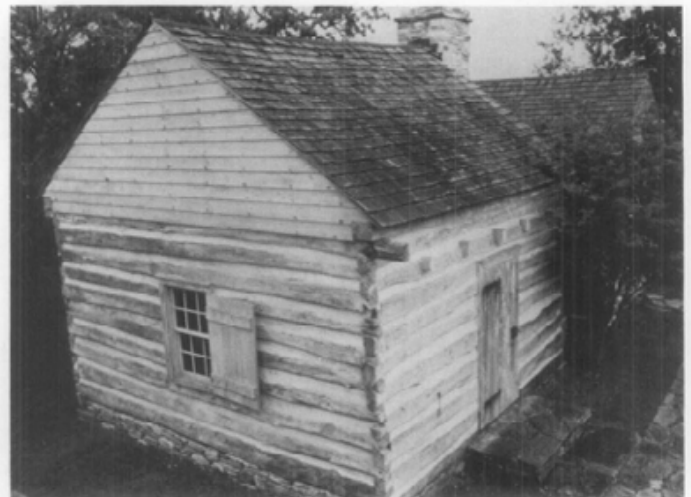
2. Handsplit and dressed shingles were also used on less elaborate buildings as seen in the restoration of the circa 1840 kitchen at the Winedale Inn, Texas. The uneven surfaces of the handsplit shingles were generally dressed or smoothed with a draw-knife to keep the rainwater from collecting in the wood grain and to ensure that the shingles lay flat on the sub-roof. Photo: Thomas Taylor.

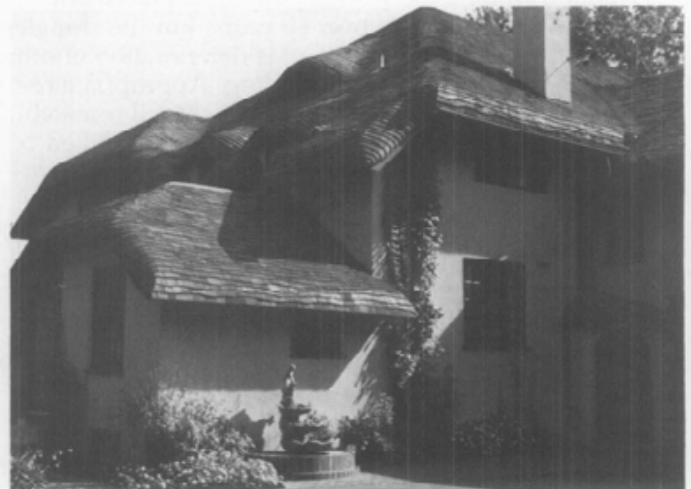
4. With the popularity of the revival of historic styles in the late 19th and early 20th centuries, a new technique was developed to imitate English thatch roofs. For the Tudor Revival cottages, steaming and curving of sawn shingles provided an undulating pattern to this picturesque roof shape. Photo: Courtesy of C.H. Roofing.

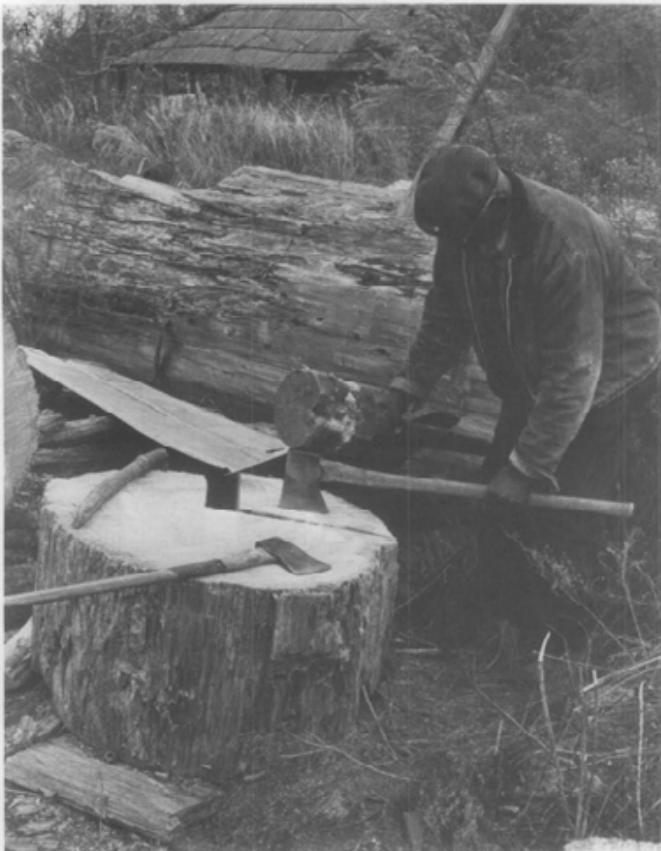
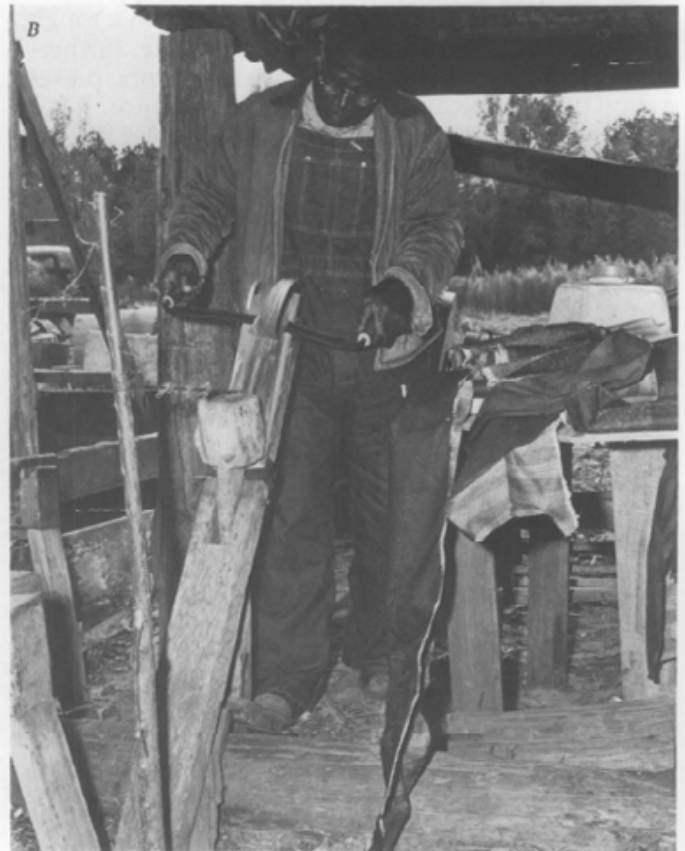
5. Custom Handsplit shingles are still made the traditional way with a mallet and froe or ax. For these cypress shingles, a "bolt" section of log (photo A) the length of the shingle has been sawn and is ready to be split into wedge-shaped segments. Handsplit shingles are fabricated with the ax or froe cutting the wood along the grain and separating, or riving, the shingle away from the remaining wedge. The rough surfaces are dressed on a shavinghorse using a draw-knife as shown above (photo B). Note the long wooden shingles covering the work shed in photo A. Photos: Al Honeycutt, North Carolina Division of Archives and History.

to dress or plane the shingles on a shavinghorse with a draw-knife or draw-shave (see illus. 5B) to make them fit evenly on the roof. This reworking was necessary to provide a tight-fitting roof over typically open shingle lath or sheathing boards. Dressing, or smoothing of shingles, was almost universal, no matter what wood was used or in what part of the country the building was located, except in those cases where a temporary or very utilitarian roof was needed.

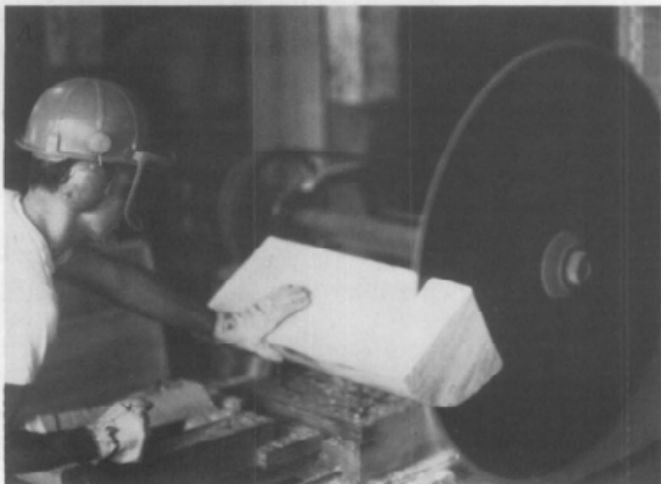
6. Modern machine-made shingles are sawn. Shown are: (photo A) Eastern White Pine quarter split shingle block on equalizer saw being trimmed to parallel the ends; and (photo B) the restored 19th-century shingle mill saw cutting tapered flitches or shingles. The thickness and taper can be precisely controlled. Photo: Steve Ruscio, The Shingle Mill.

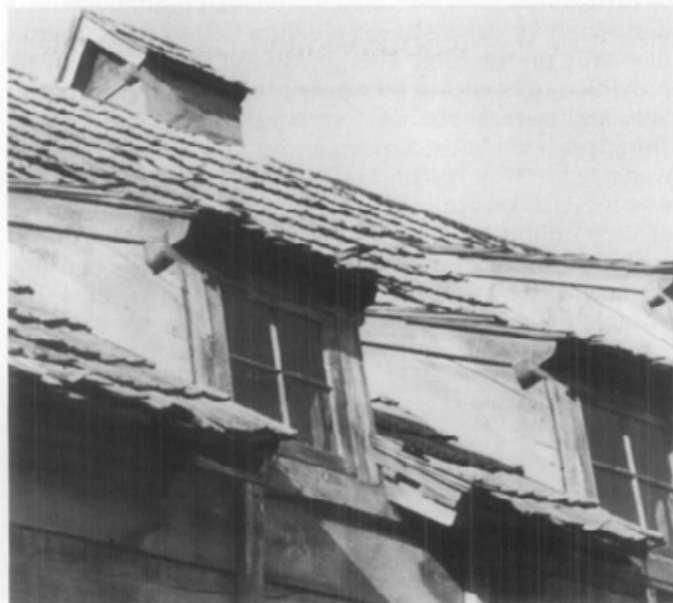
8. The long biaxially tapered handsplit shingles on the Ephrata Cloisters in Pennsylvania were overlapped both vertically and horizontally. The insert sketch shows channels under the shingles that provided ventilation and drainage of any trapped moisture. The aged appearance of these handsplit and dressed shingles belies their original smoothness. Replacement shingles should match the original, not the aged appearance. Photo: National Park Service; Sketch: Reed Engle.

Not all shingles were laid in evenly spaced, overlapping, horizontal rows. In various regions of the country, there were distinct installation patterns; for example, the biaxially-tapered long shingles occasionally found in areas settled by the Germans (see illus. 8). These long shingles were overlapped on the side as well as on top. This formed a ventilation channel under the shingles that aided drying. Because ventilation of the shingles can prolong their life, roofers paid attention to these details (see illus. 9).

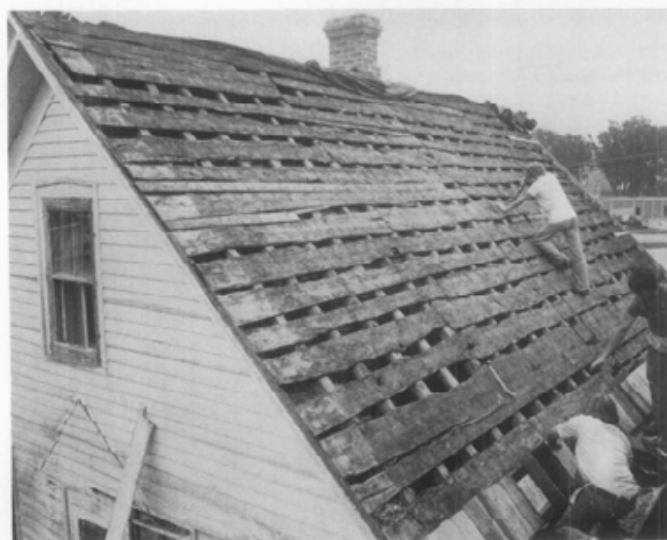
7. The reshingling of the circa 1856 Stovewood House in Decorah, Iowa, revealed the original open sheathing boards and pole rafters. Sawn cedar shingles were used as a replacement for the historic cedar shingles seen still in place at the ridge. A new starter course is being laid at the eaves. Photo: Norwegian-American Museum, Decorah, Iowa.

In order to have a weathertight roof, it was important to have adequate coverage, proper spacing of shingles, and straight grain shingles. Many roofs were laid on open shingle lath or open sheathing boards (see illus. 7). Roofers typically laid three layers of shingles with approximately 1/3 of each shingle exposed to the weather. Spaces between shingles (1/8"–1/2" depending on wood type) allowed the shingles to expand when wet. It was important to stagger each overlapping shingle by a minimum of 1-1/2" to avoid a direct path for moisture to penetrate a joint. Doubling or tripling the starter course at the eave gave added protection to this exposed surface. In order for the roof to lay as flat as possible, the thickness, taper and surface of the shingles was relatively uniform; any unevenness on handsplit shingles had already been smoothed away with a drawknife. To keep shingles from curling or cupping, the shingle width was generally limited to less than 10".

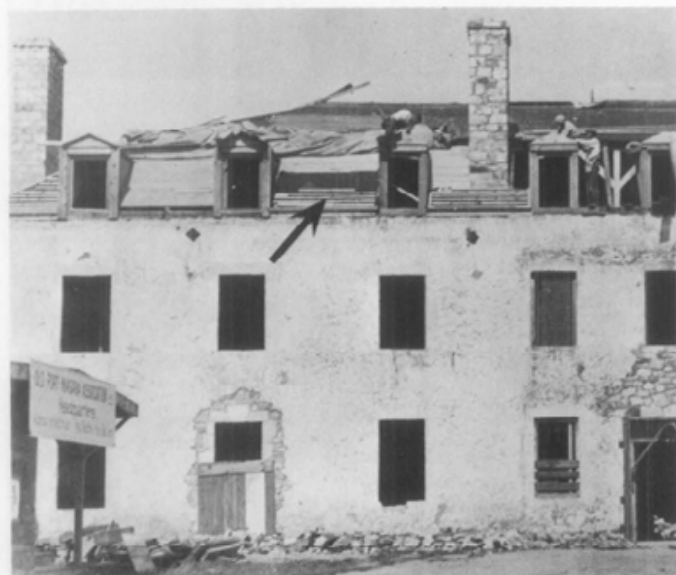
9. This 1927 view of the reshingling of the French Castle at Old Fort Niagara, N.Y., shows the wooden sleepers being laid (see arrow) over solid sheathing in order to raise the shingles up slightly to allow under-shingle ventilation. Note that the horizontal strips are not continuous to allow airflow and trapped moisture to drain away. This cedar roof has lasted for over 60 years in a harsh moist environment. Photo: Old Fort Niagara, Assoc. Inc.

**Beware of heavily insulated attic rafters.** Historically, the longest lasting shingle roofs were generally the ones with the best roof ventilation. Roofs with shingling set directly on solid sheathing and where there is insulation packed tightly between the wooden rafters without adequate ventilation run the risk of condensation-related moisture damage to wooden roofing components. This is particularly true for air-conditioned structures. For that reason, if insulation must be used, it is best to provide ventilation channels between the rafters and the roof decking, to avoid heavy felt building papers, to consider the use of vapor barriers, and perhaps to raise the shingles slightly by using "sleepers" over the roof deck. This practice was popular in the 1920s in what the industry called a "Hollywood" installation, and examples of roofs lasting 60 years are partly due to this under-shingle ventilation (refer to illus. 9).

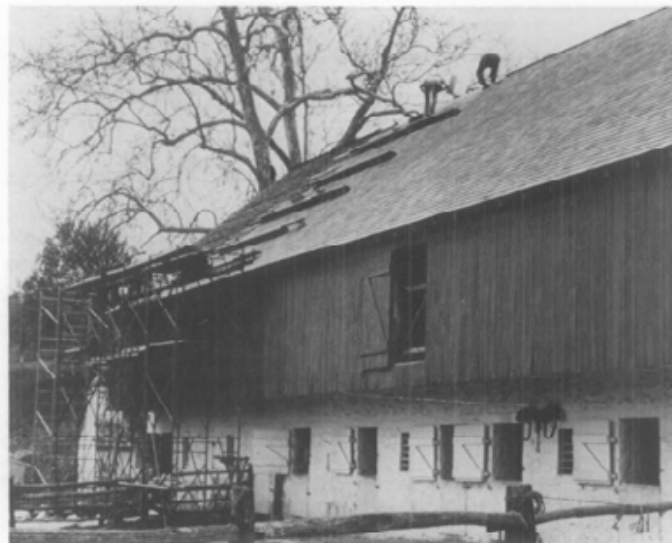
11. The replacement sawn red cedar shingles matched the deteriorated shingles exactly for this barn re-roofing. The old shingles, seen to the far left, were removed as the new shingles were installed. Even the horizontal coursing matched because the exposure length for both old and new shingles was the same. Photo: Williamsport Preservation Training Center.

mation regarding the early shingles used. Before specifying a replacement roof, it is important to *establish the original shingle material, configuration, detailing and installation* (see illus. 11). If the historic shingles are still in place, it is best to remove several to determine the size, shape, exposure length, and special features from the unweathered portions. If there are already replacement shingles on the roof, it may be necessary to verify through photographic or other research whether the shingles currently on the roof were an accurate replacement of the historic shingles.

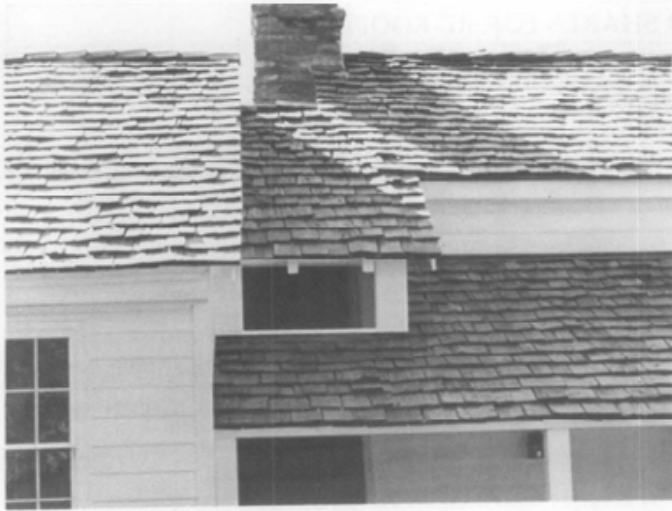
12. Inappropriately selected and installed wooden shingles can drastically alter the historic character of a building. This tavern historically was roofed with handsplit and dressed shingles of a relatively smooth appearance. In this case, a commercially available shake was used to effect a "rustic" appearance. Photo: National Park Service.

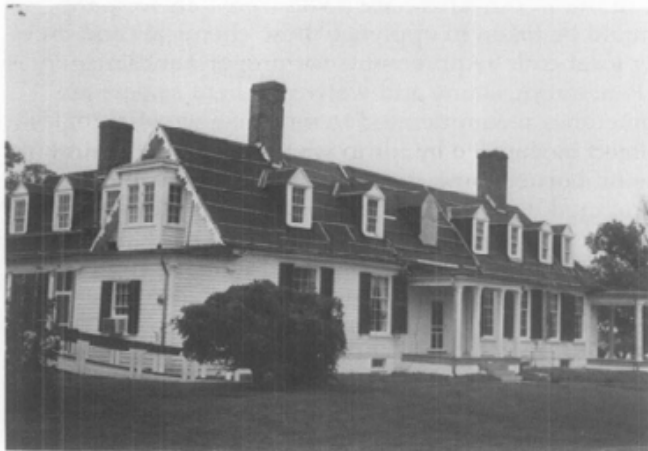
A. The later non-historic shingles were removed from Appomattox Manor (circa 1840 with later additions) and roofing paper was installed for temporary protection during the re-shingling.

14. Original 19th-century handsplit and dressed wooden shingles 18" long, 3"-4" wide, and 5/8" thick were found in place on the Appomattox Manor at Hopewell, Virginia. The butts were curved and evidence of a red stain remained. The specifications and details were researched so that the appearance of the historic shingles and installation patterns could be matched in the re-shingling project. Photos: John Ingle.

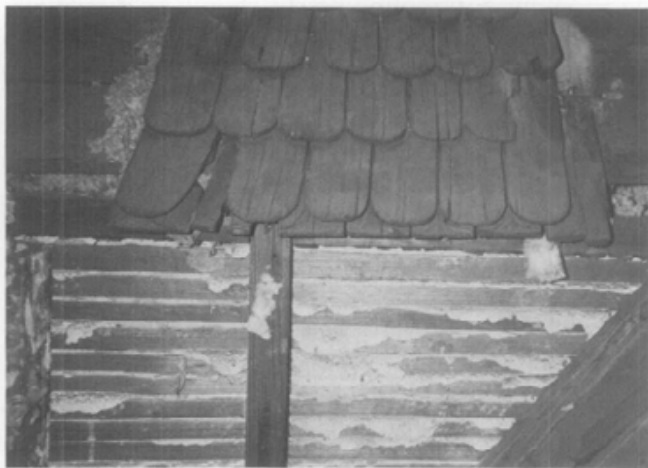
B. These weathered historic 19th-century handsplit and dressed shingles were found in place under a later altered roof. Note the straight butt eave shingles under the curved butts of the historic dormer shingles.

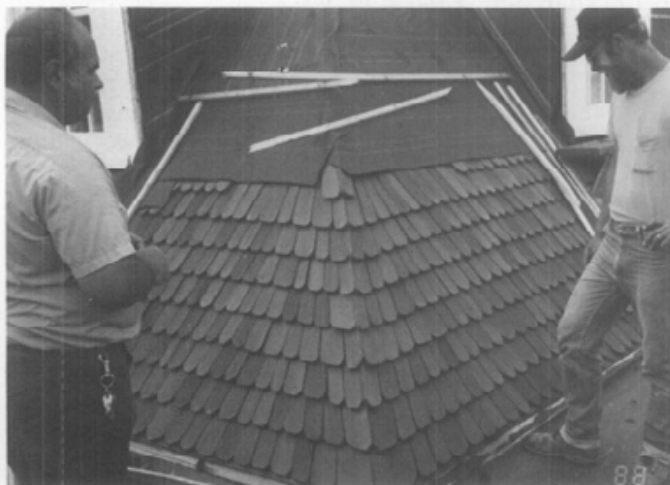
D. The fanned hips (seen here), swept valleys, and projecting ridge combs were installed as part of the re-roofing project. Special features, when documented, should be reproduced when re-shingling historic roofs.

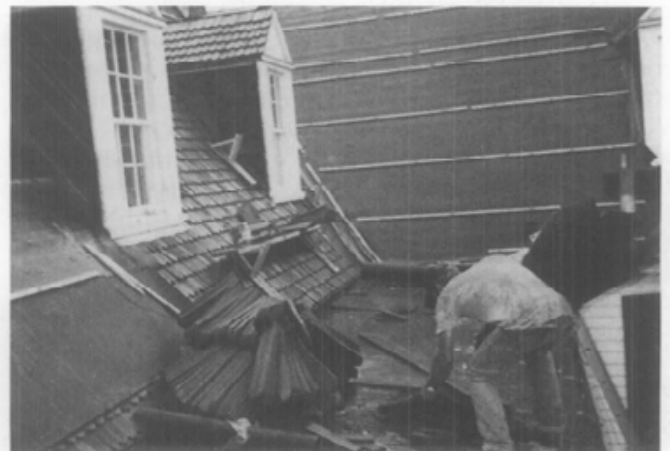
C. The replacement shingles (see specifications above), matched the historic shingles and were of such high quality that little hand dressing was needed at the site. The building paper, a temporary protection, was removed as the shingles were installed on the sheathing boards.

**Type of nails and flashing:** double hot dipped galvanized nails sized to penetrate sheathing totally; metal flashing to be 20 oz. lead-coated copper, or terne-coated stainless steel; additional flashing reinforcement to be aluminum foil type with fiber backing to use at hips, ridges, eaves, and valleys.

**Type of sheathing:** uninsulated attic, any deteriorated 3/4" sheathing boards, spaced 1/2"-3/4", to be replaced in kind.

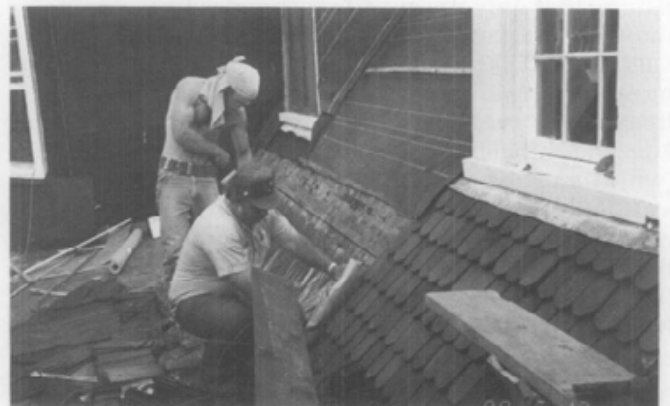
E. In order to achieve a "Class B" fire-rating, the shingles were dipped in fire-retardant chemicals and allowed to dry prior to installation. Iron oxide was added to this chemical dip to stain the shingles to match the historic red color. These coatings will need periodic reapplication.

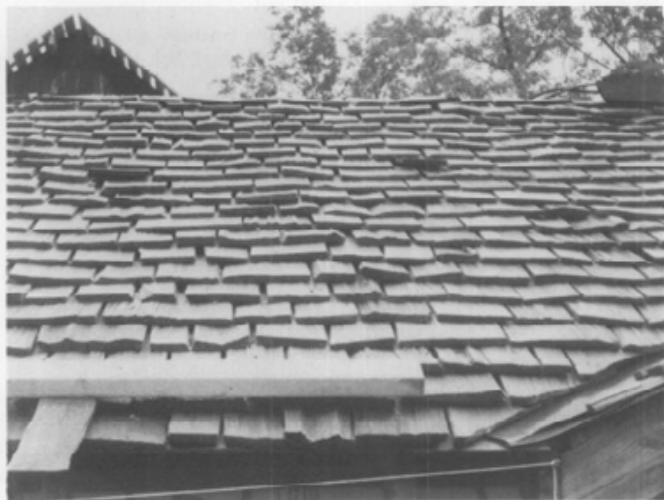
15. These commercially available roofing products with rustic split faces are not appropriate for historic preservation projects. In addition to the inaccurate appearance, the irregular surfaces and often wide spaces between shingles will allow wind-driven moisture to penetrate up and under them. The excessively wide boards will tend to cup, curl and crack. Moss, lichens and debris will have a tendency to collect on these irregular surfaces, further deteriorating the roofing. Photo: Sharon C. Park.

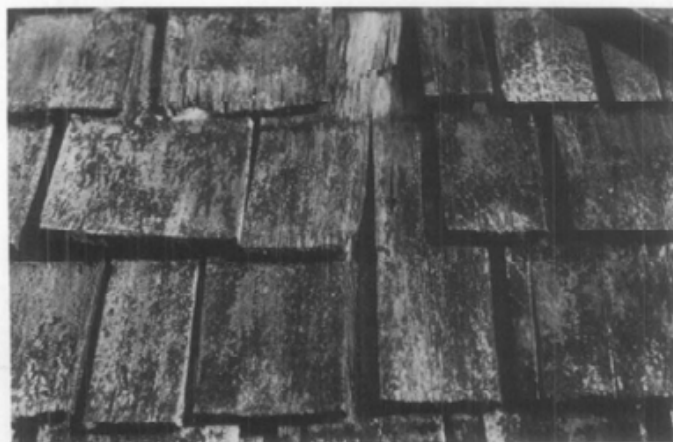
16. Routine maintenance is necessary to extend the life of the roof. On this roof, the shingles have not seriously eroded, but the presence of lichens and moss is becoming evident and there are a few cracked and missing shingles. The moss spores should be removed, missing shingles replaced, and small pieces of metal flashing slipped under cracked shingles to keep moisture from penetrating. Photo: Williamsport Preservation Training Center.

Periodic maintenance inspections of the roof may reveal loose or damaged shingles that can be selectively replaced before serious moisture damage occurs (see illus. 16). Keeping the wooden shingles in good condition and repairing the roof, flashing and guttering, as needed, can add years of life to the roof.

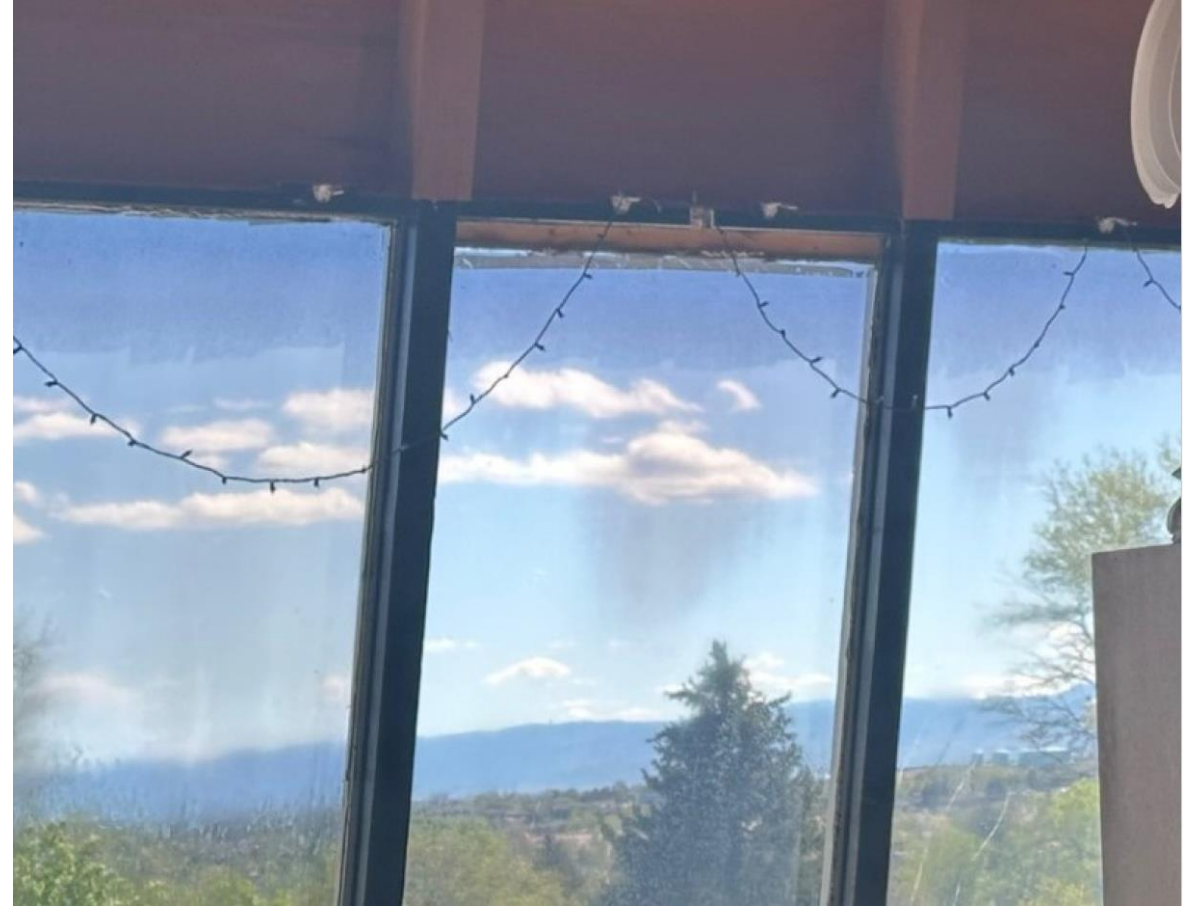
# ***EXISTING WINDOW CONDITION***

- **Not original**
- **Film on windows**
- **Improper Sizing**

Due to the age of the existing windows, many of the windows are broken or damaged beyond repair necessitating replacement. The applicant is seeking to replace the windows with energy-efficient windows that mirror the same dimensions and retain the character of the structure. Three of the windows will be redesigned to allow for egress. Staff is recommending the approval for safety and notes that overall dimensions will remain to minimize the visible change to the egress windows.

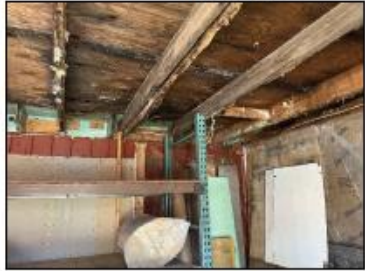
Window removed and fill in  
by others

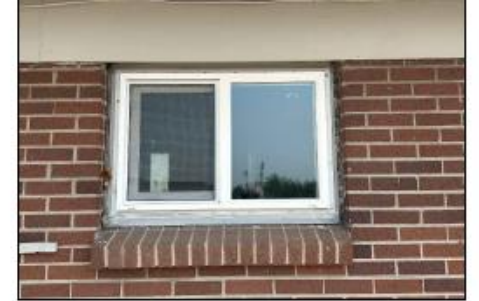
Window not original and does not fit opening

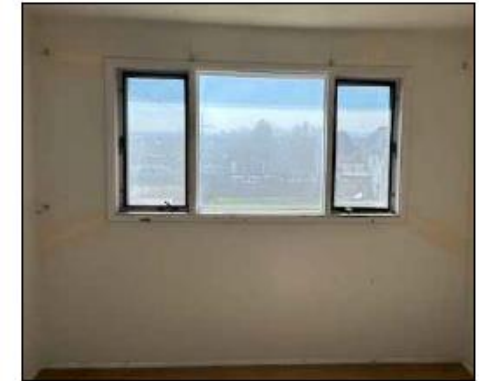
Bedroom Windows rusted and do not meet egress

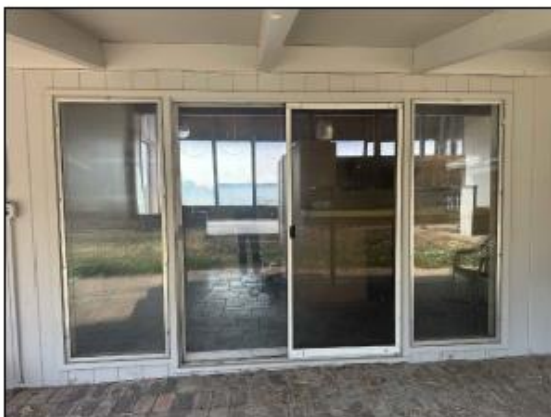
Sliding Glass door is not original the 2 side windows are but not tempered glass

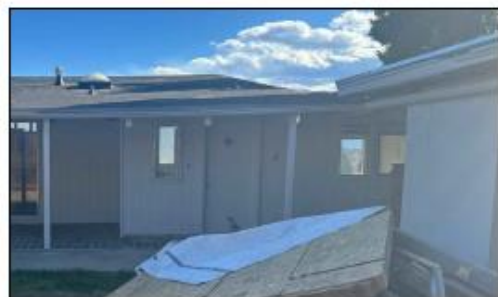
These doors and vestibule were not part of the original home.

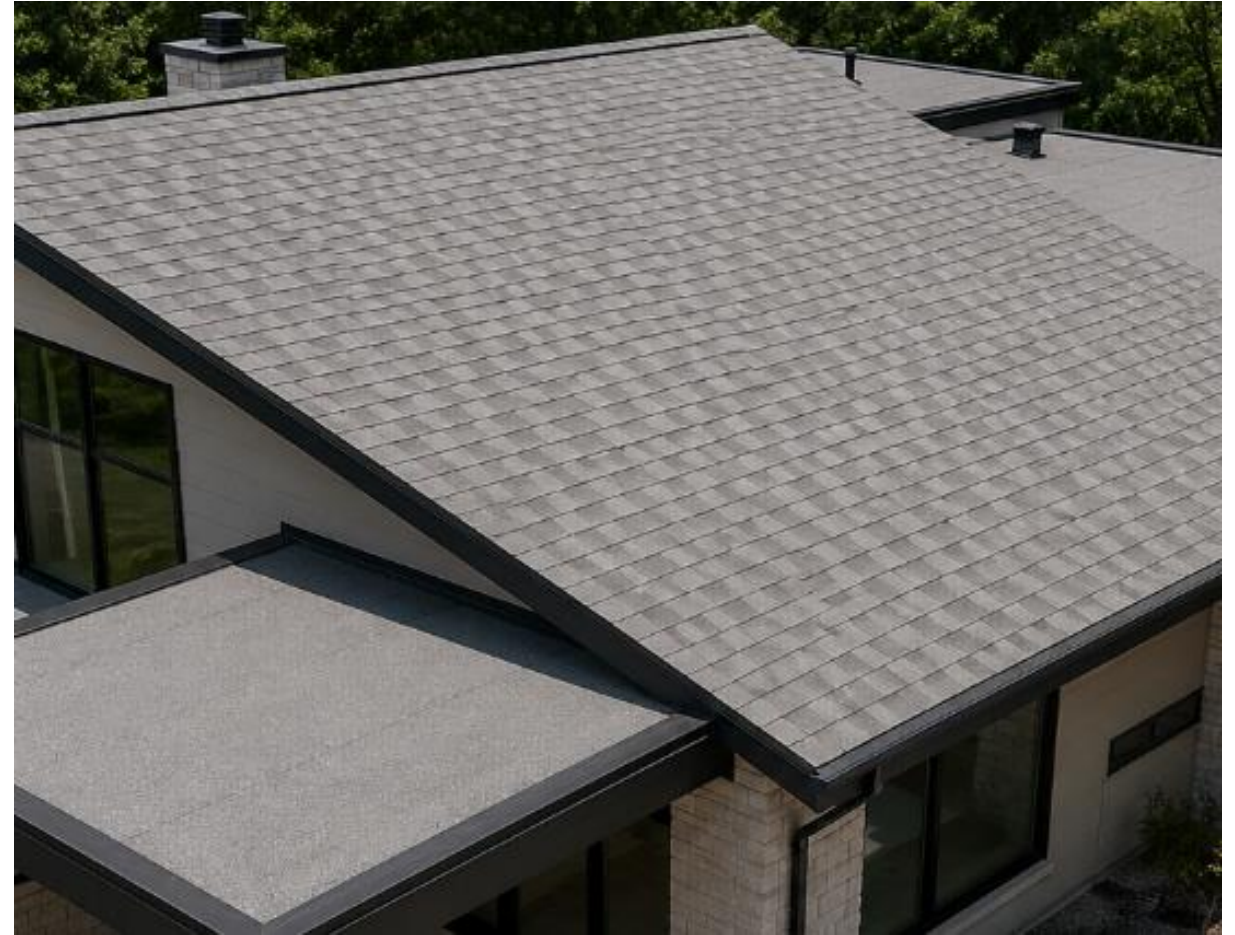
# ***PROPOSED ROOFING MATERIALS***

- **Light grey asphalt shingle on pitched areas**
- **Light grey modified bitumen torch down granulated material on flat areas**
- **Photo is for illustration purposes only**

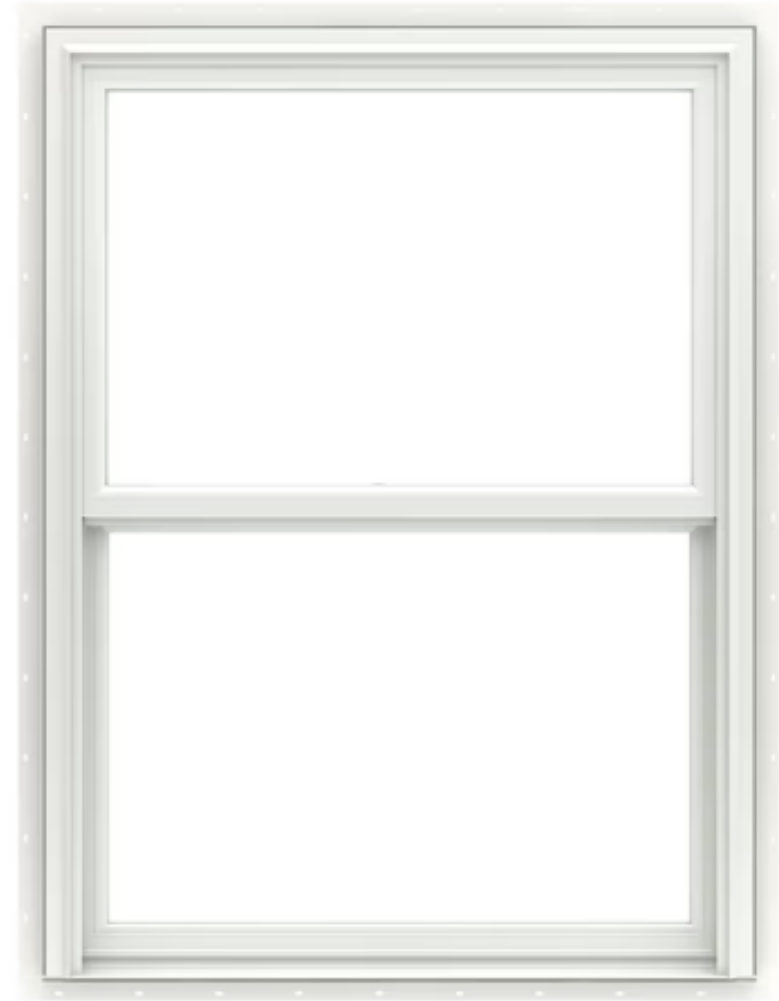
# ***PROPOSED WINDOWS***

- **Pella Impervia  
Fiberglass**
- **Paintable to match  
existing windows that  
are painted**
- **Visual appearance  
mimics original  
windows**

Except for the egress windows, all replacement windows will closely resemble the existing size, design, panes, muntin profile, color, and reflective qualities of the glass. The egress windows will maintain all attributes practical while allowing for safety measures for the occupants.
