**INDOOR AIR SAMPLING REPORT  
GETHSEMANE LUTHERAN CHURCH  
10675 WASHINGTON STREET  
NORTHGLENN, COLORADO**

February 7, 2013  
Project No. 500557003

Subject: Indoor Air Sampling Report  
Gethsemane Lutheran Church  
10675 North Washington Avenue  
Northglenn, Colorado

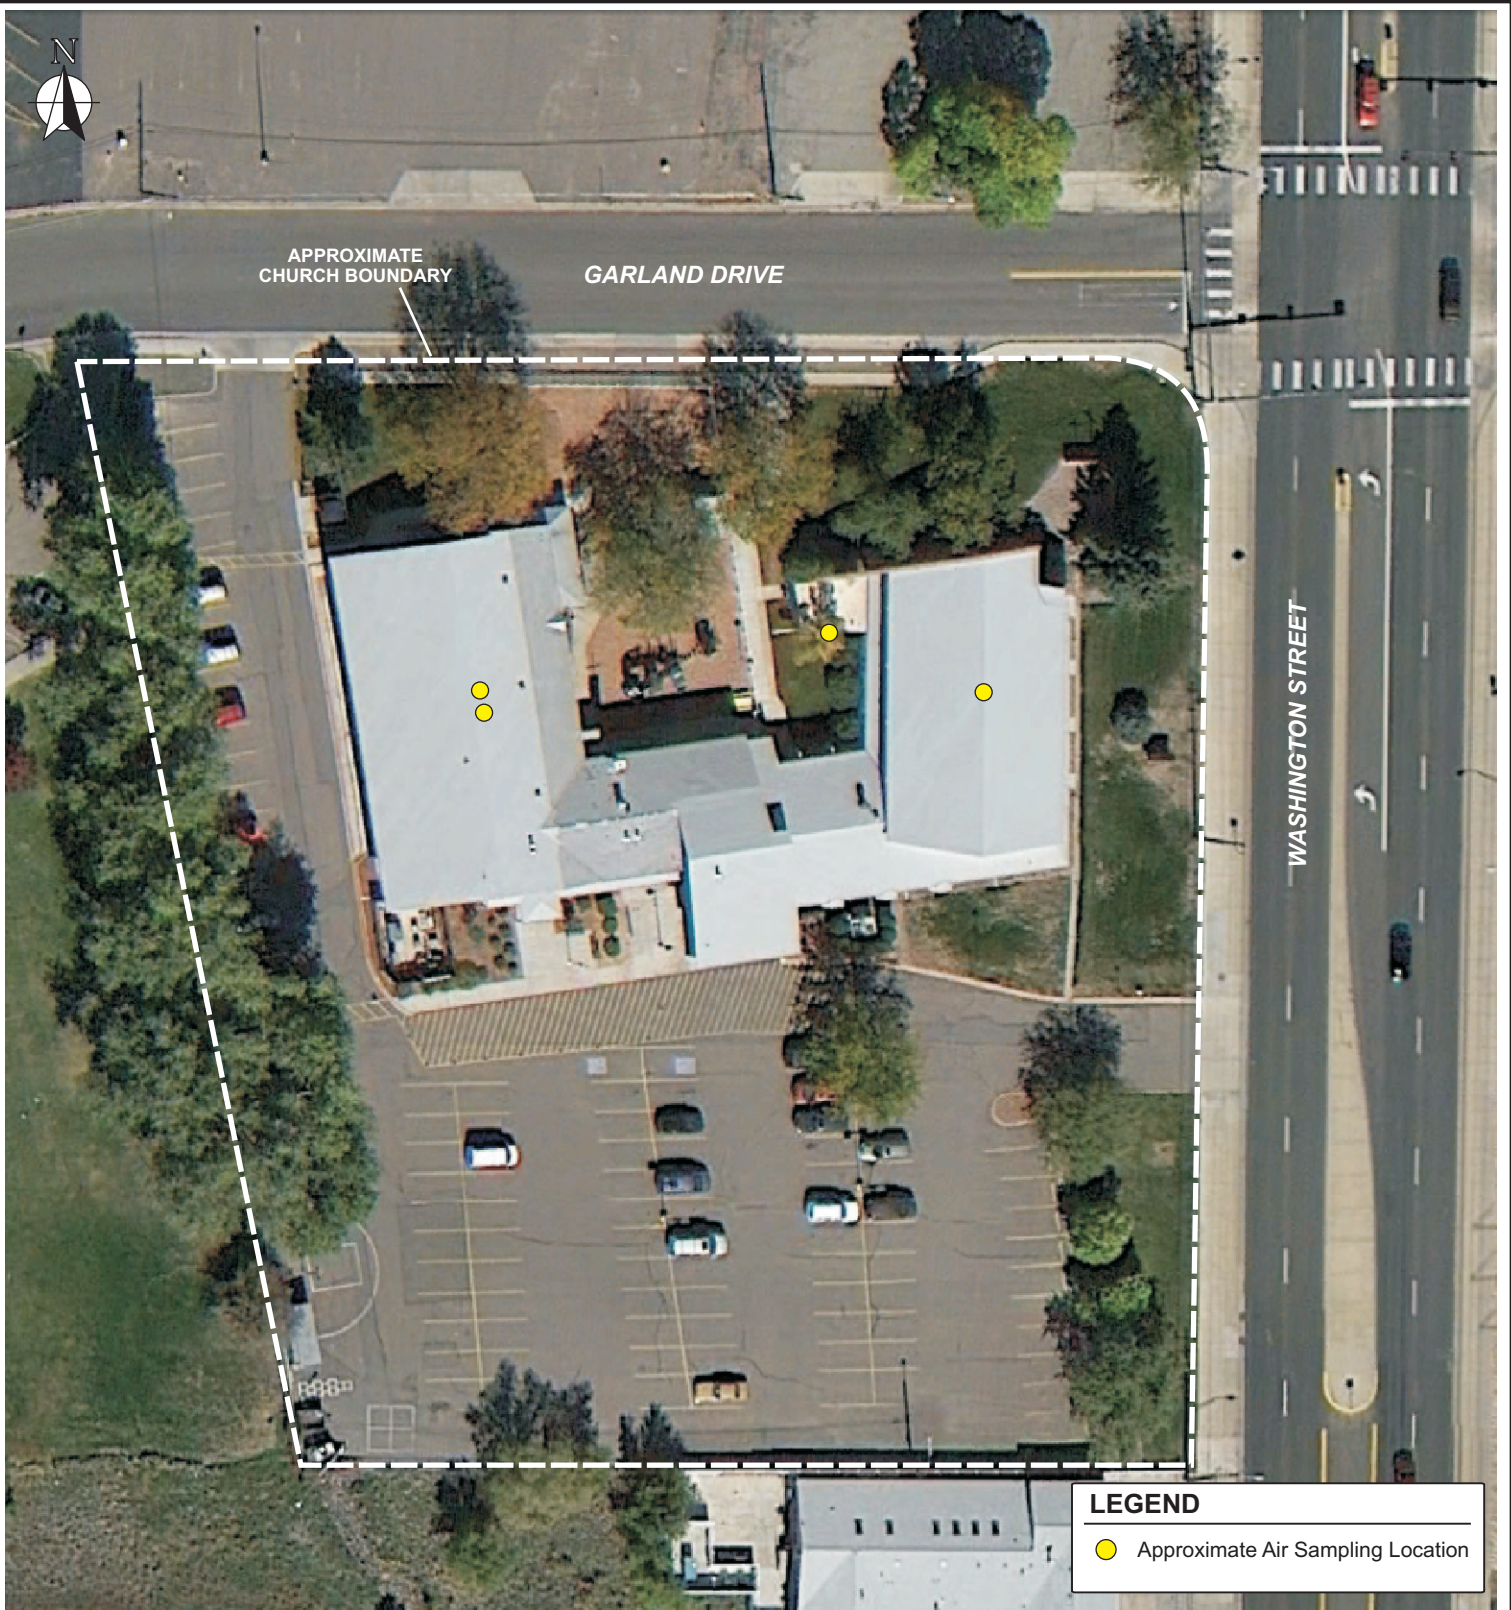
**AIR SAMPLING LOCATIONS**

Ninyo & Moore conducted indoor air sampling activities at the Church in January 2013. On January 18, 2013, four 6-liter Summa<sup>®</sup> canisters were placed in three different areas of the Church property to collect representative air quality samples in the building and outside the building. Sample SV-W-1 was collected in the lower-level classroom hallway in the west wing of the building. Sample SV-E-1 was collected in the fellowship hall, in the church basement in the east wing of the building. One Summa<sup>®</sup> canister sample, SV-O-1, was placed outside the building, in the front exterior courtyard, to represent outdoor ambient air in the vicinity. One Summa<sup>®</sup> canister, sample DUP-1, was placed in the west wing hallway adjacent to sample SV-W-1 as a duplicate sample, as part of the quality assurance procedures. The duplicate sample was submitted blind to the laboratory. The approximate locations of the Summa<sup>®</sup> canisters within the Church property are presented on **Figure 2**.
