## ADMINISTRATION MEMORANDUM 12-36

DATE:	December 17, 2012
TO:	Honorable Mayor Joyce Downing and City Council Members
FROM:	William A. Simmons, City Manager MAP Debbie Tuttle, Economic Development Manager & NURA Executive Director A
SUBJECT:	Northglenn Urban Renewal Authority Plan Recommendations CR-141 – Resolution Determining That Certain Real Property Consistutes a "Blighted Area" CR-142 – Resolution Approving a Substaintial Modification to Current Urban Renewal Plan CR-143 – Resolution Approving a New Urban Renewal Plan 2

## Northglenn Area Conditions Survey

The following report, the Northglenn Area Conditions Survey (the "Survey") was prepared for the Northglenn Urban Renewal Authority (NURA) and Northglenn City Council in July and August 2012. The purpose of this work was to analyze conditions within a defined Survey Area (also referred to here as "the Survey Area") located within the City of Northglenn, Colorado and Adams County, Colorado, in order to determine whether factors contributing to blight are present and whether it is, therefore, eligible as an urban renewal plan area under the provisions of the Colorado Urban Renewal Law.

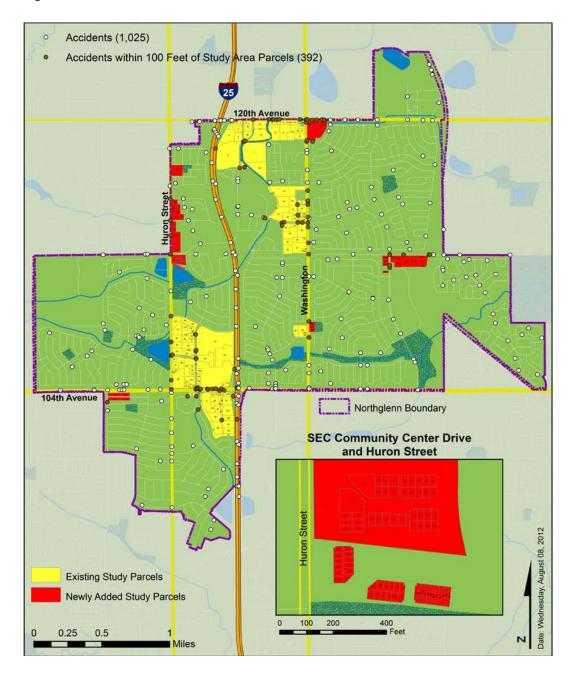
Figure 2: Vehicular Accidents

Along with a lack of internal streets is a lack of lighting (internal), sidewalks and parking areas making the property largely inaccessible and deficient in terms of improvements required for redevelopment. According to the Northglenn Police Department, "there are a high number of 911 based calls for service" associated with traffic accidents. (See **Figure 2** illustrating the location of vehicular accidents.)

The following sub-categories of factor (b) were found in the Survey Area:

- Vehicular access
- Internal circulation
- Driveway definitions and curb cuts
- Parking layout
- Traffic accident history

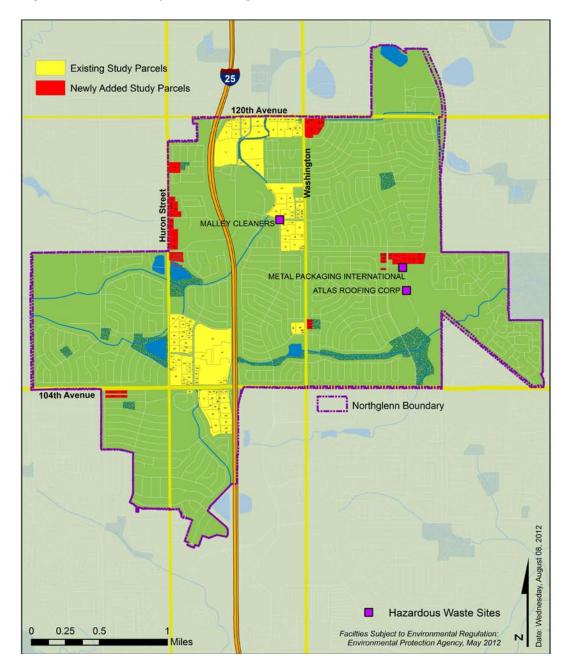
Figure 3: Facilities Subject to EPA Regulations

Multiple factors contribute to unsafe conditions in the Survey Area. Among them is a lack of obvious driveway definitions, high frequency of traffic accidents and unsafe vehicular access, as explained (under b and c) above. Additionally, there are three hazardous waste sites identified by the State of Colorado within the City of Northglenn. Only one these three is located in the Survey Area. The others are located either outside or adjacent to parcels within the Area and neither is considered to present a direct negative impact. (See **Figure 4** illustrating the location of these sites.)

As explained above, there are three hazardous waste sites identified by the State of Colorado within the City of Northglenn. Only one these three is located in the Survey Area. The others are located either outside or adjacent to parcels within the Area, but are not considered to present a negative impact.

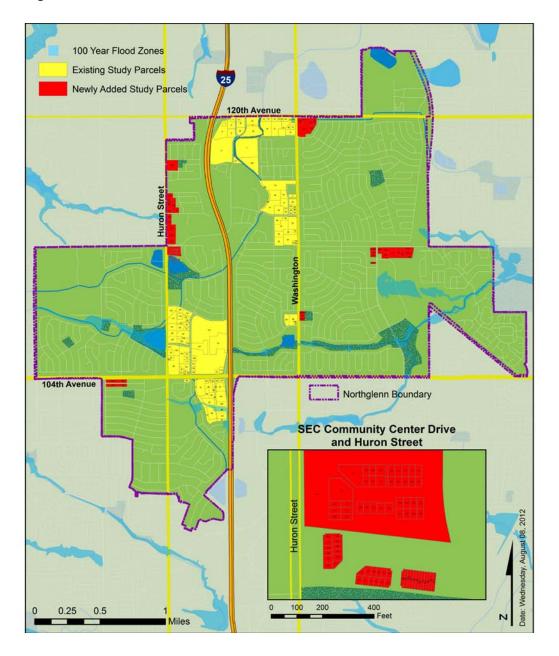
Figure 4: 100-Year Flood Zone

In addition to a hazardous site, there is the presence of a 100-year flood zone in the southern most portion of the Survey Area in the vicinity of the Marketplace (including Marketplace West and South). (See **Figure 4** illustrating the location of the flood zone.)

This factor applies to concerns that threaten site users. Based on a report by representatives of the Northglenn Fire Department, there are numerous instances of buildings that do not have adequate fire protection infrastructure (sprinklers). In addition, as explained under (j) below, there is the presence of a hazardous waste site as reported by the State of Colorado within the Survey Area. Finally, and as discussed above, a 100-year flood traverses properties in the vicinity of the Marketplace – East and South.

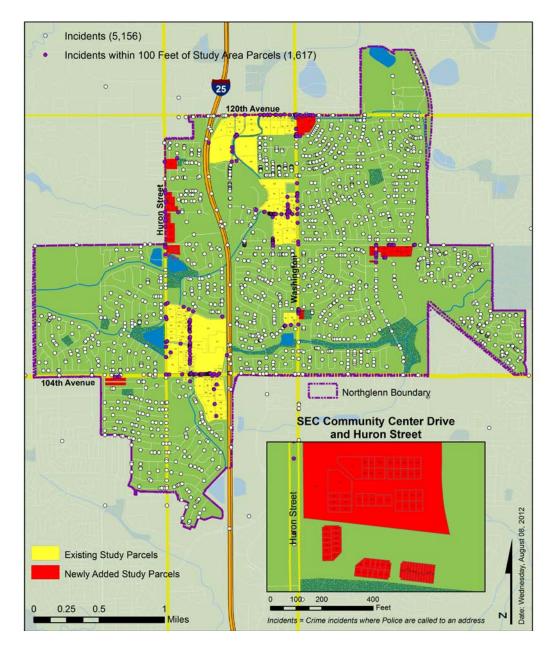
With regard to unsafe conditions associated with criminal incidents, select properties within the Area are associated with a disproportionately high number of 911 calls for occurrences ranging from property damage, to injury accidents to theft based on information provided by the Northglenn Police Department for the period beginning May 2010 and ending May 2011. (See **Figure 5** illustrating the location of the high crime incidents.)

As explained above, properties in the Area report a "high number of 911 based calls for service" in select locations. The types of incidents range from property damage, to injury accidents to theft.

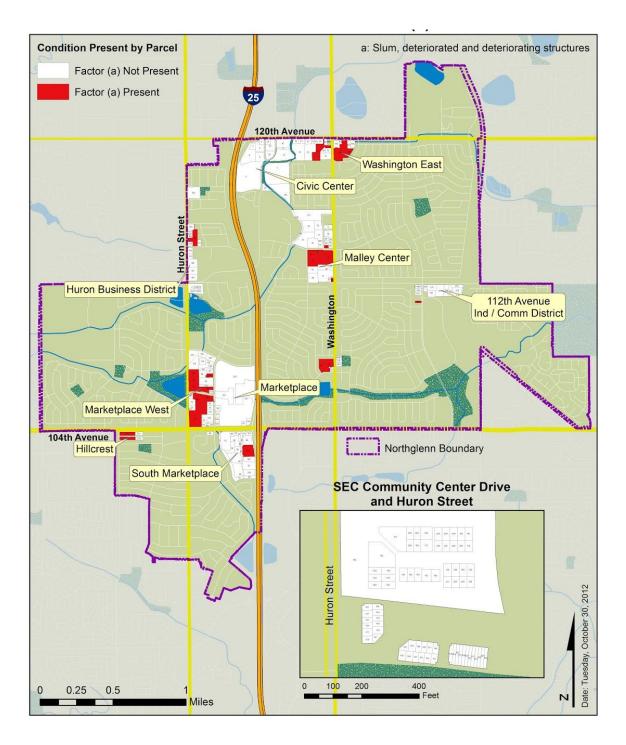
#### (a) Slum, deteriorated, or deteriorating structures

The Study Area hosts a significant number of both new and old commercial structures, many of which have met their useful life. While some of have rehabilitated, others remain in various stages of deterioration. Whereas no

interior inspections of buildings were conducted, deterioration is noted on the exterior of structures.

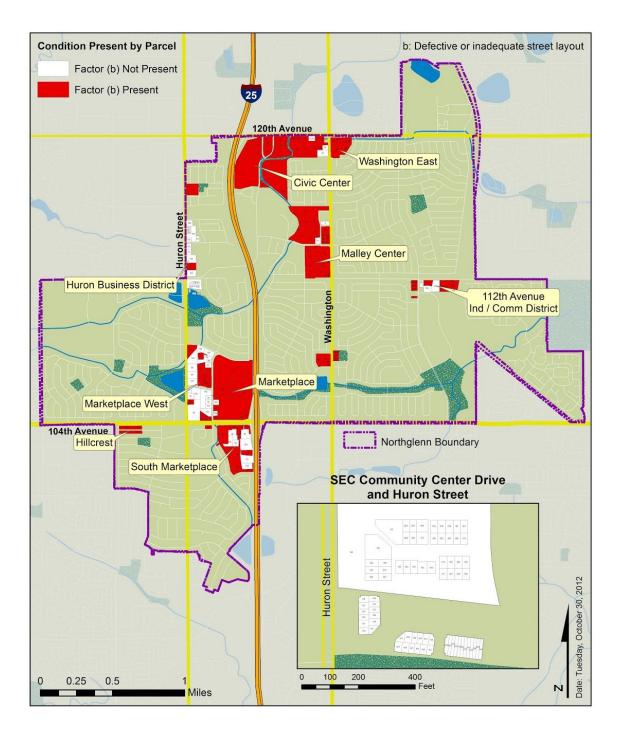
## (b) Predominance of defective or inadequate street layout

Predominance of defective or inadequate street layout can be considered present when existing roads are insufficient to meet the needs of improvements within the Area, or there is a lack of streets or the streets that are in place are deteriorating. Roadways and properties within the Area suffer from both of these conditions – inconsistencies with City standards and a lack of streets. The former condition is most obvious among roadways never built to City specifications and the later condition within major unimproved parcels primarily located in the northern portion of the Study Area. In select locations, new streets will be required in association with future transit improvements.

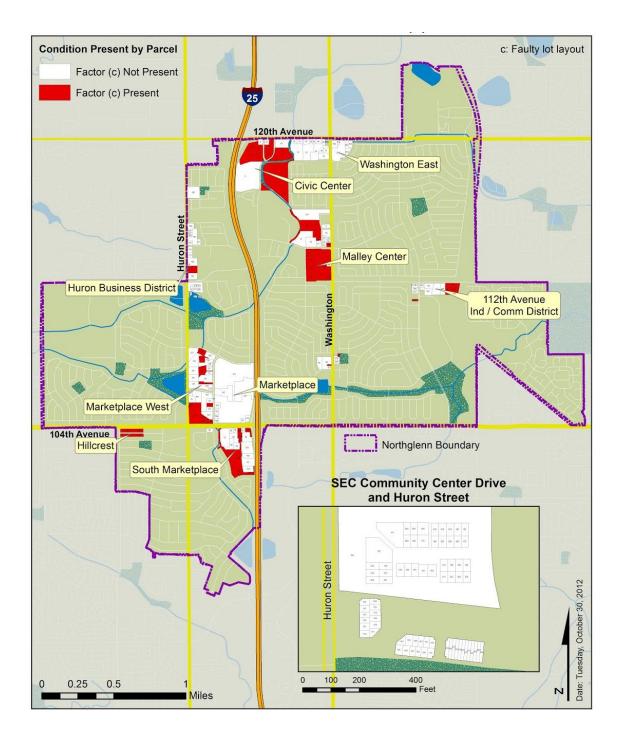
## (c) Faulty lot layout in relation to size, adequacy, accessibility, or usefulness

Because faulty street layouts often correspond with faulty lot layouts, many properties within the Survey Area that suffer from conditions associated with (b) also suffer from this blight factor for the reasons explained under (b) above. In addition, there are instances of lots without utility for site redevelopment given their size or shape. This is not unusual in built environments with a history of property divisions and assemblages.

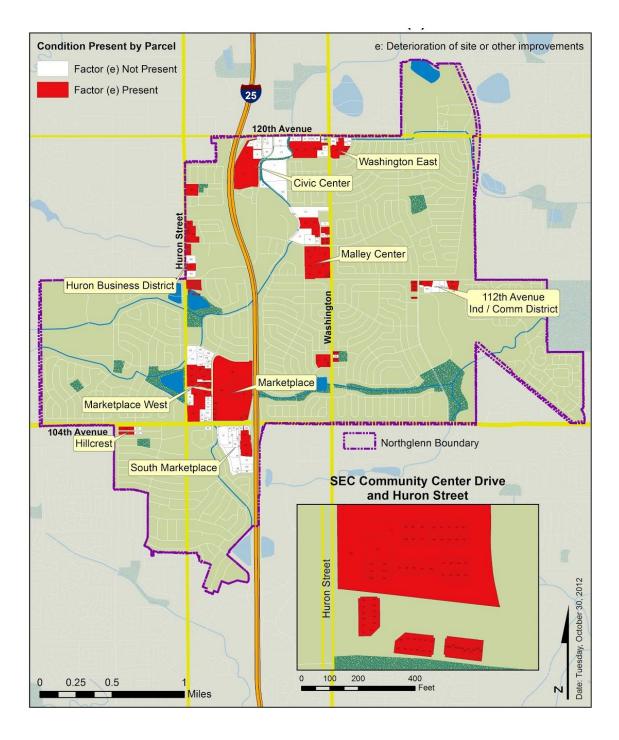
#### (e) Deterioration of site or other improvements

Within private properties in the Area, there are frequent known instances of parking surface deterioration, the presence of trash and weeks, aged and deteriorating signs and a lack of landscaping as per the City Development Code. Within public rights-of-way or utility easements, there are instances of deteriorating and ill-maintained irrigation infrastructure and storm water detention facilities.

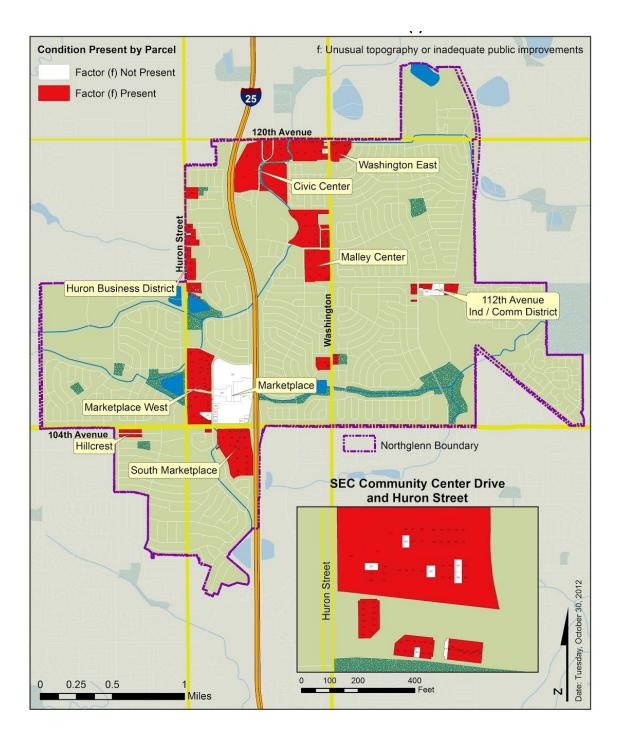
## (f) Unusual topography or inadequate public improvements or utilities

Explained above, although properties within the Area are largely improved and located adjacent to primary and secondary City thoroughfares, the presence of sidewalks is inconsistent. Additionally, several sidewalks that are present are either too narrow for appropriate capacity or too close to the adjacent right-of-way, creating an unsafe environment for pedestrians. Also discussed above, a 100-year flood traverses properties in the vicinity of the Marketplace – East and South limiting development and creating drainage concerns.

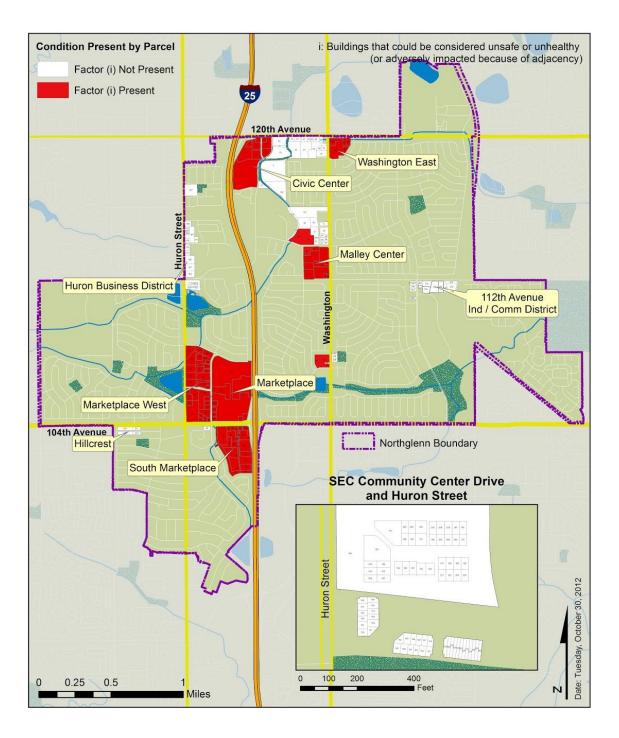
## (i) Buildings that are unsafe or unhealthy for persons to live or work in ...

Because a lack of safety or unhealthy conditions can also be considered to endanger life or property, the Survey Area suffers from this blight factor for the reasons explained under (h) above. In addition to threats resulting from the presence of a flood zone, daily use of select properties within the Survey Area may be unsafe because of high incidents of crime.

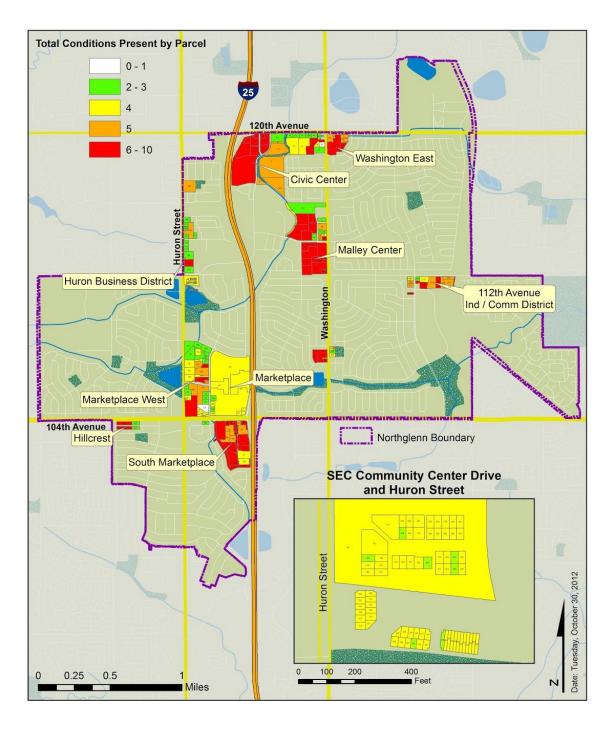
#### **Total Factors**

Table 1 summarizes the findings across all surveyed parcels. As shown, <u>10</u> factors of the 11 total possible factors were found, to some extent, within the Survey Area. Among the parcels that will become part of <u>Northglenn Urban Renewal Plan No. 2</u>, there are 10 factors present. In this case, all 10 factors (as discussed earlier) were present to a degree that appeared likely to have a significantly negative impact on safety, welfare and/or sound development.

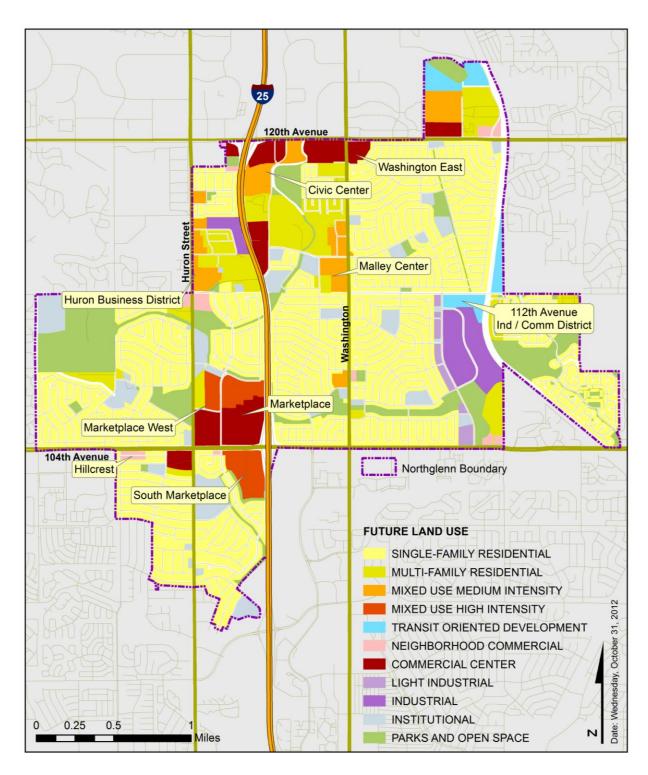
Figure No. 2: General Land Use Plan

The Area, in relation to the City, is reflected on the City's General Land Use Plan map in **Figure No. 2** on the following page.

#### 5.2.1 Map of General Land Use Plan (Figure No. 2)
