**PUBLIC WORKS DEPARTMENT
MEMORANDUM #2011 – 10**

**SUBJECT: C & L Water Solutions, Inc (Emergency Contractor) Invoice
Repair of 20-inch Diameter Ductile Iron Water Main**

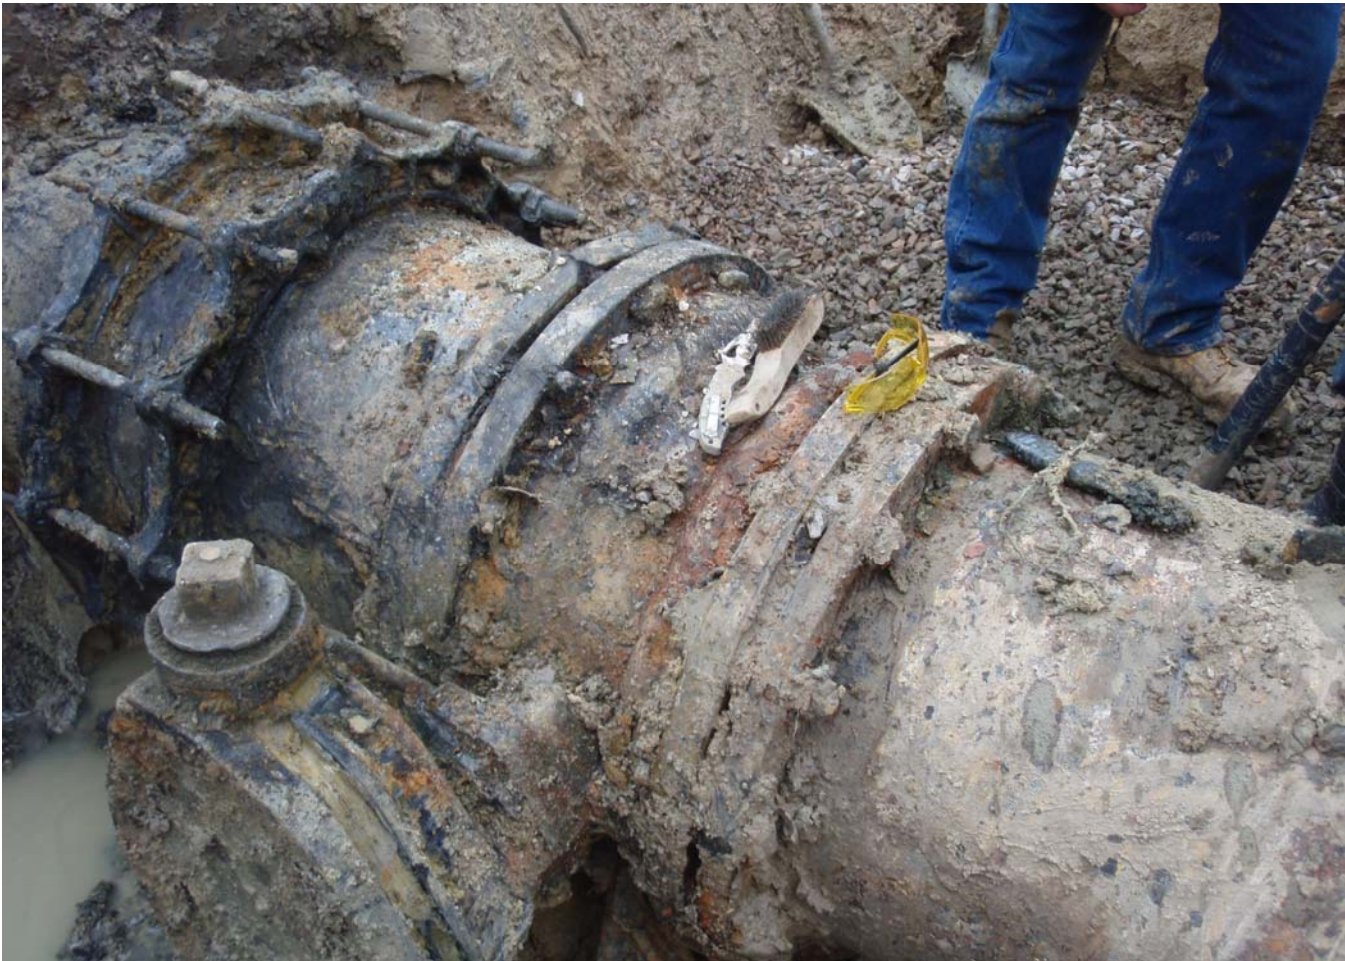
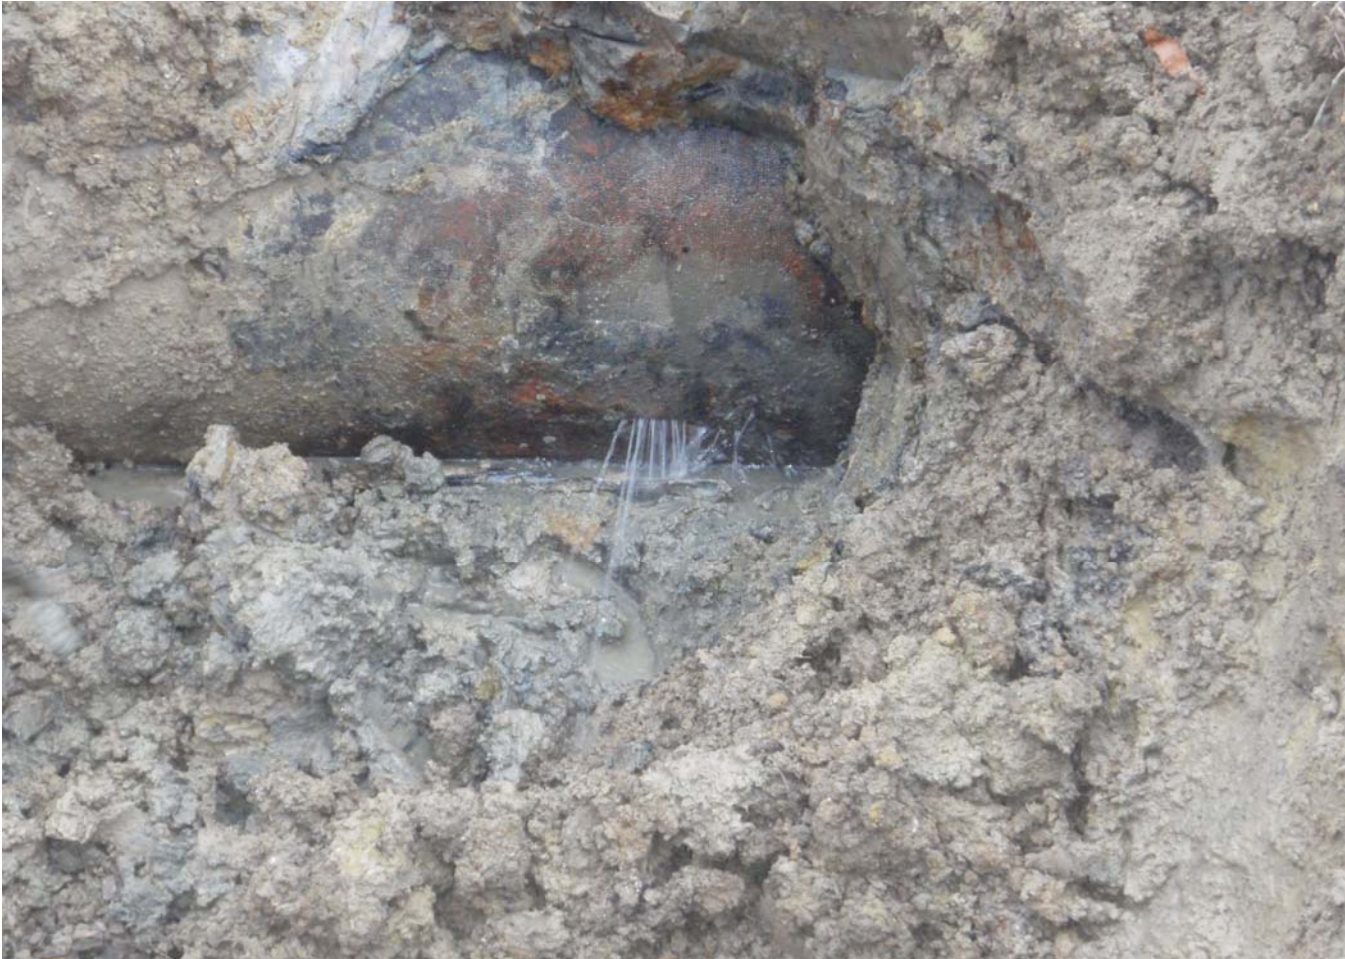
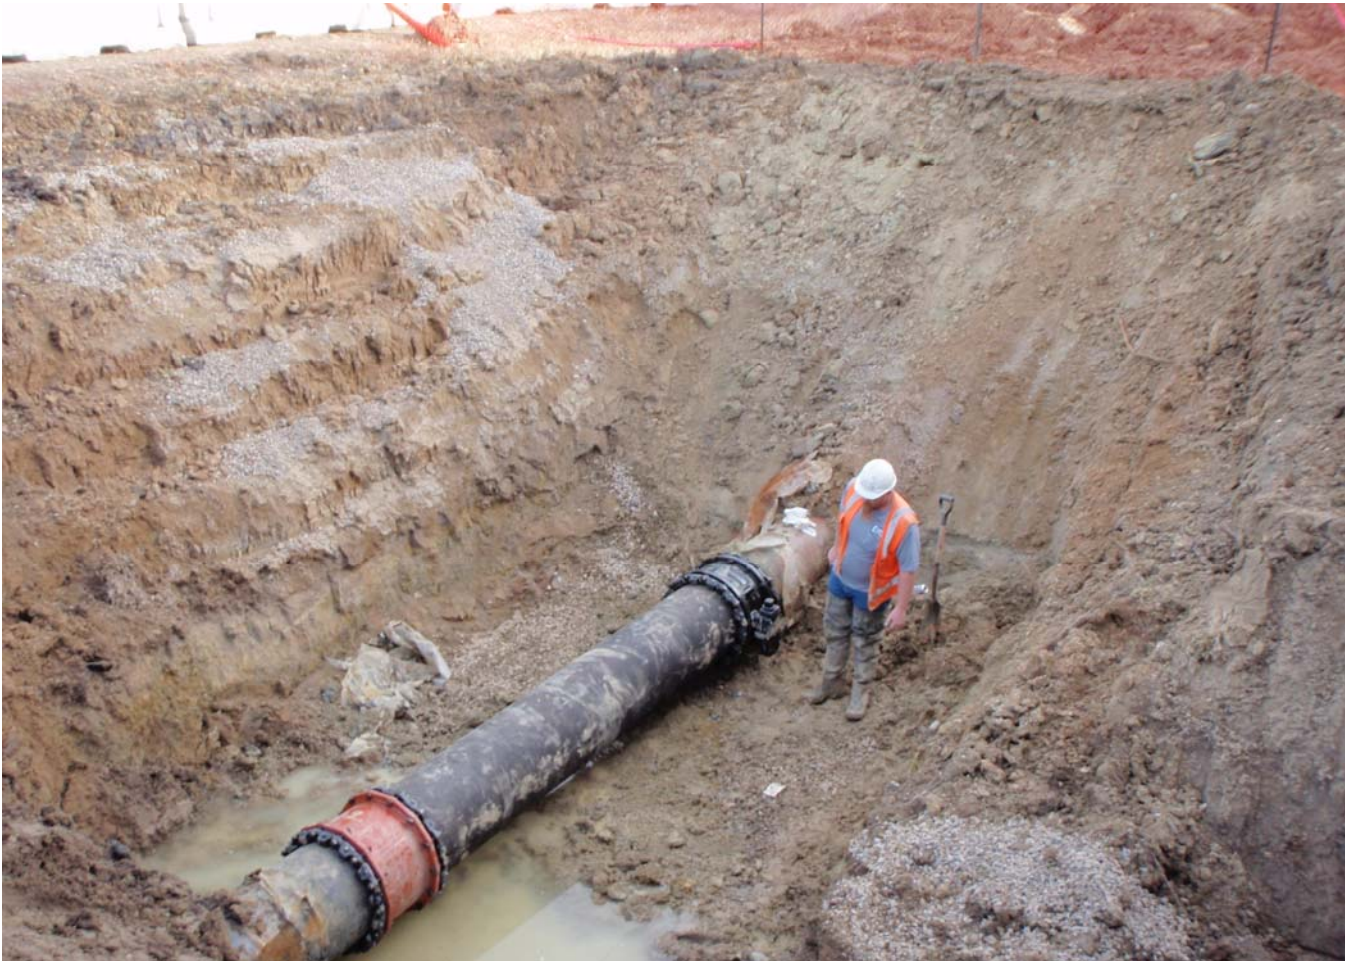
On December 6, 2010 C & L Water Solutions, Inc (C & L), mobilized labor and equipment at West 112th Avenue (near the Water Treatment Plant) to begin excavation and repair of the City's 20-inch diameter high zone water main. There are no service taps on the main. During the second day of the repair operation, upon reaching the water main, it was discovered that there were two leaks within 20 feet of each other. The first leak resulted from rusted connector bolts on a pipe coupling joining a very old valve. And the second leak was due to pipe deterioration. See attached pictures.

All of the parts required to make the repairs were available except the 20" valve which needed to be ordered from the manufacturer. The valve was included in the replacement schedule because of the significant deterioration. When the valve arrived on site three days later, C & L began making repairs. Water from the low zone water main was cross-fed to the high zone booster station while the high zone water main was out of service.

The two repairs were completed promptly, but the excavated soils were extremely saturated and could not be placed back into the excavation. Normally when time and safety permit, the contractor can dry soil at the job site. In this case the excavation was massive and extremely close to the roadway therefore working with the saturated material would not be a safe or practical option. The Public Works Maintenance and Operations field crew let the contractor know that they had a stock pile of dry soil nearby that could be used as backfill material alternatively to purchasing and trucking material from a gravel pit. The contractor utilized the nearby soil reduced trucking time and material cost.
